**Response to Cabinet Comments on the Herrington Lake  
Corrective Action Investigation, Source Assessment, and Risk Assessment Report**

# **CORRECTIVE ACTION INVESTIGATION, SOURCE ASSESSMENT, AND RISK ASSESSMENT REPORT – COAL PILE ADDENDUM**

**E.W. BROWN STATION, HERRINGTON LAKE,  
MERCER COUNTY, KENTUCKY**

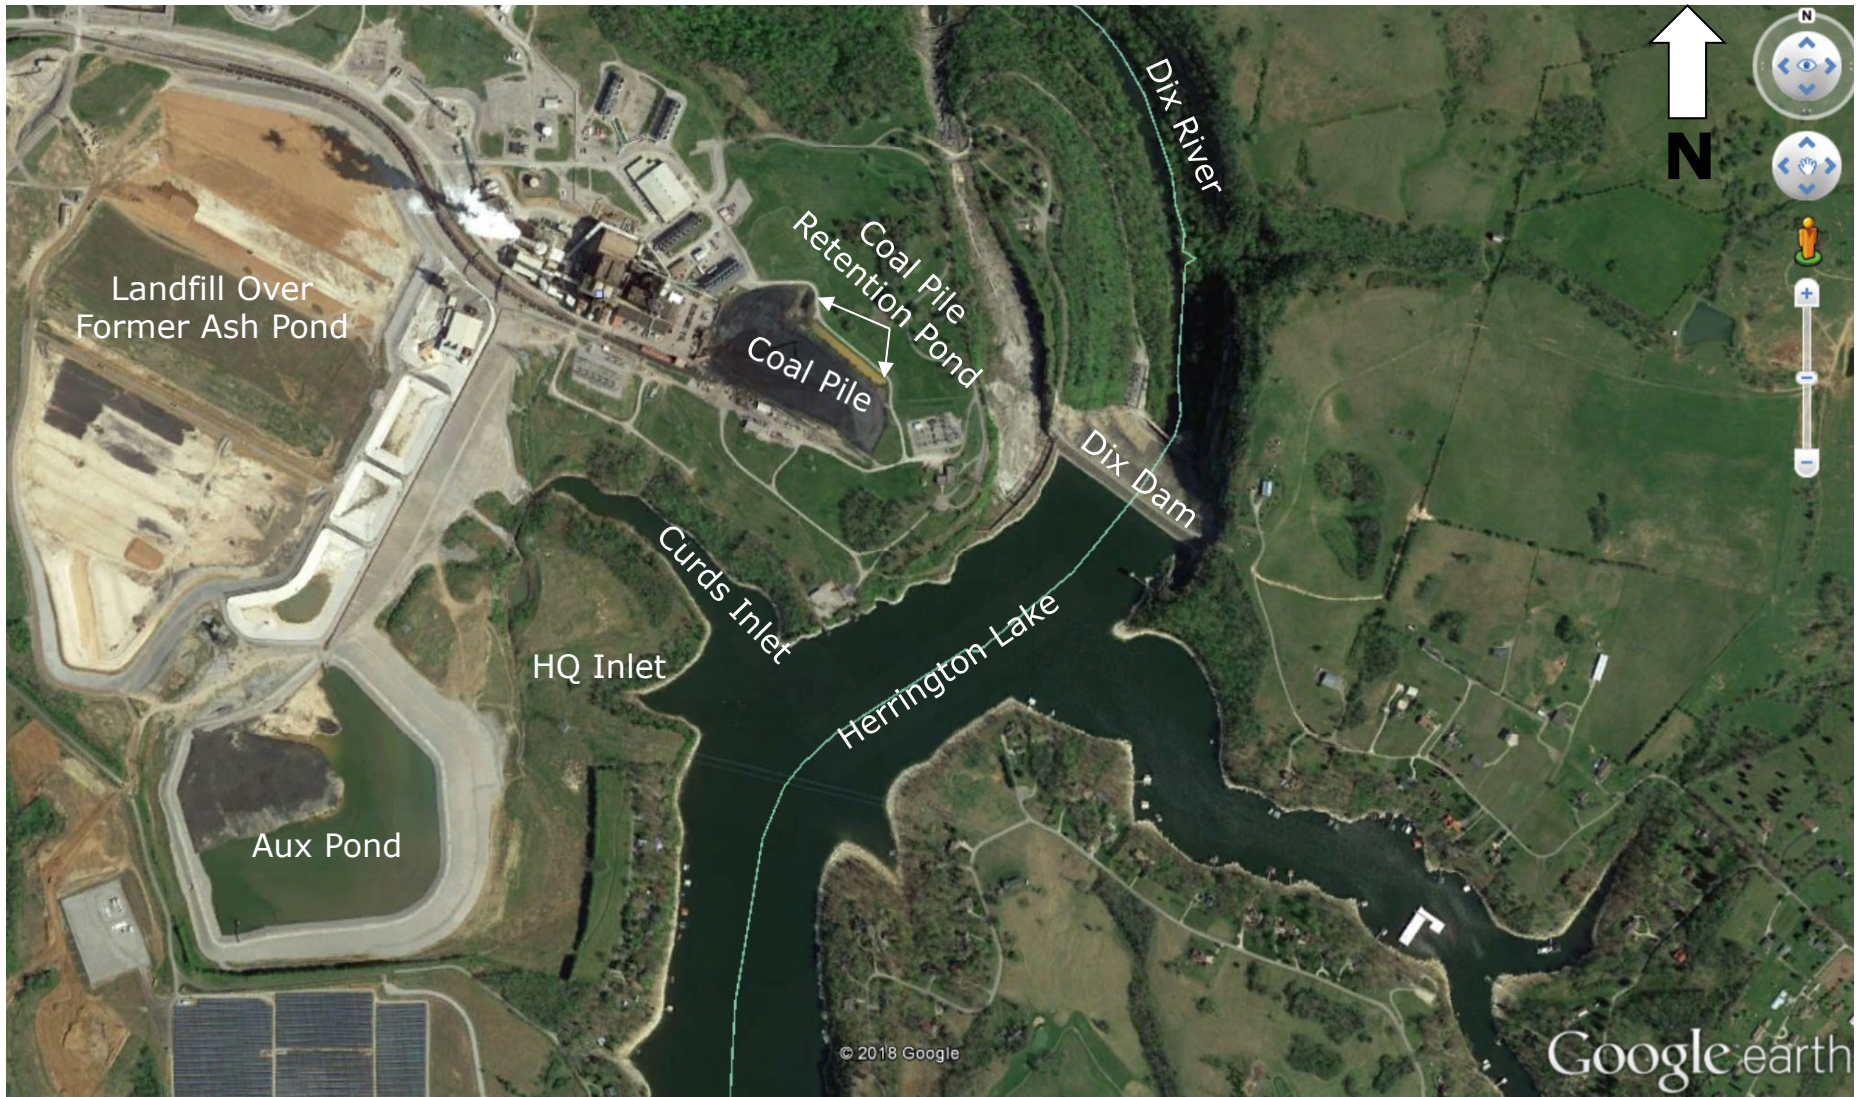
Notes:

- The distance west from the coal pile to the Curds Inlet is greater than 800 feet.
- The distance east from the coal pile to Herrington Lake is greater than 700 feet.
- The coal pile covers approximately 8 to 10 acres.
- The coal pile retention pond (including the 2011 extension of the pond) covers approximately ¾ acres.

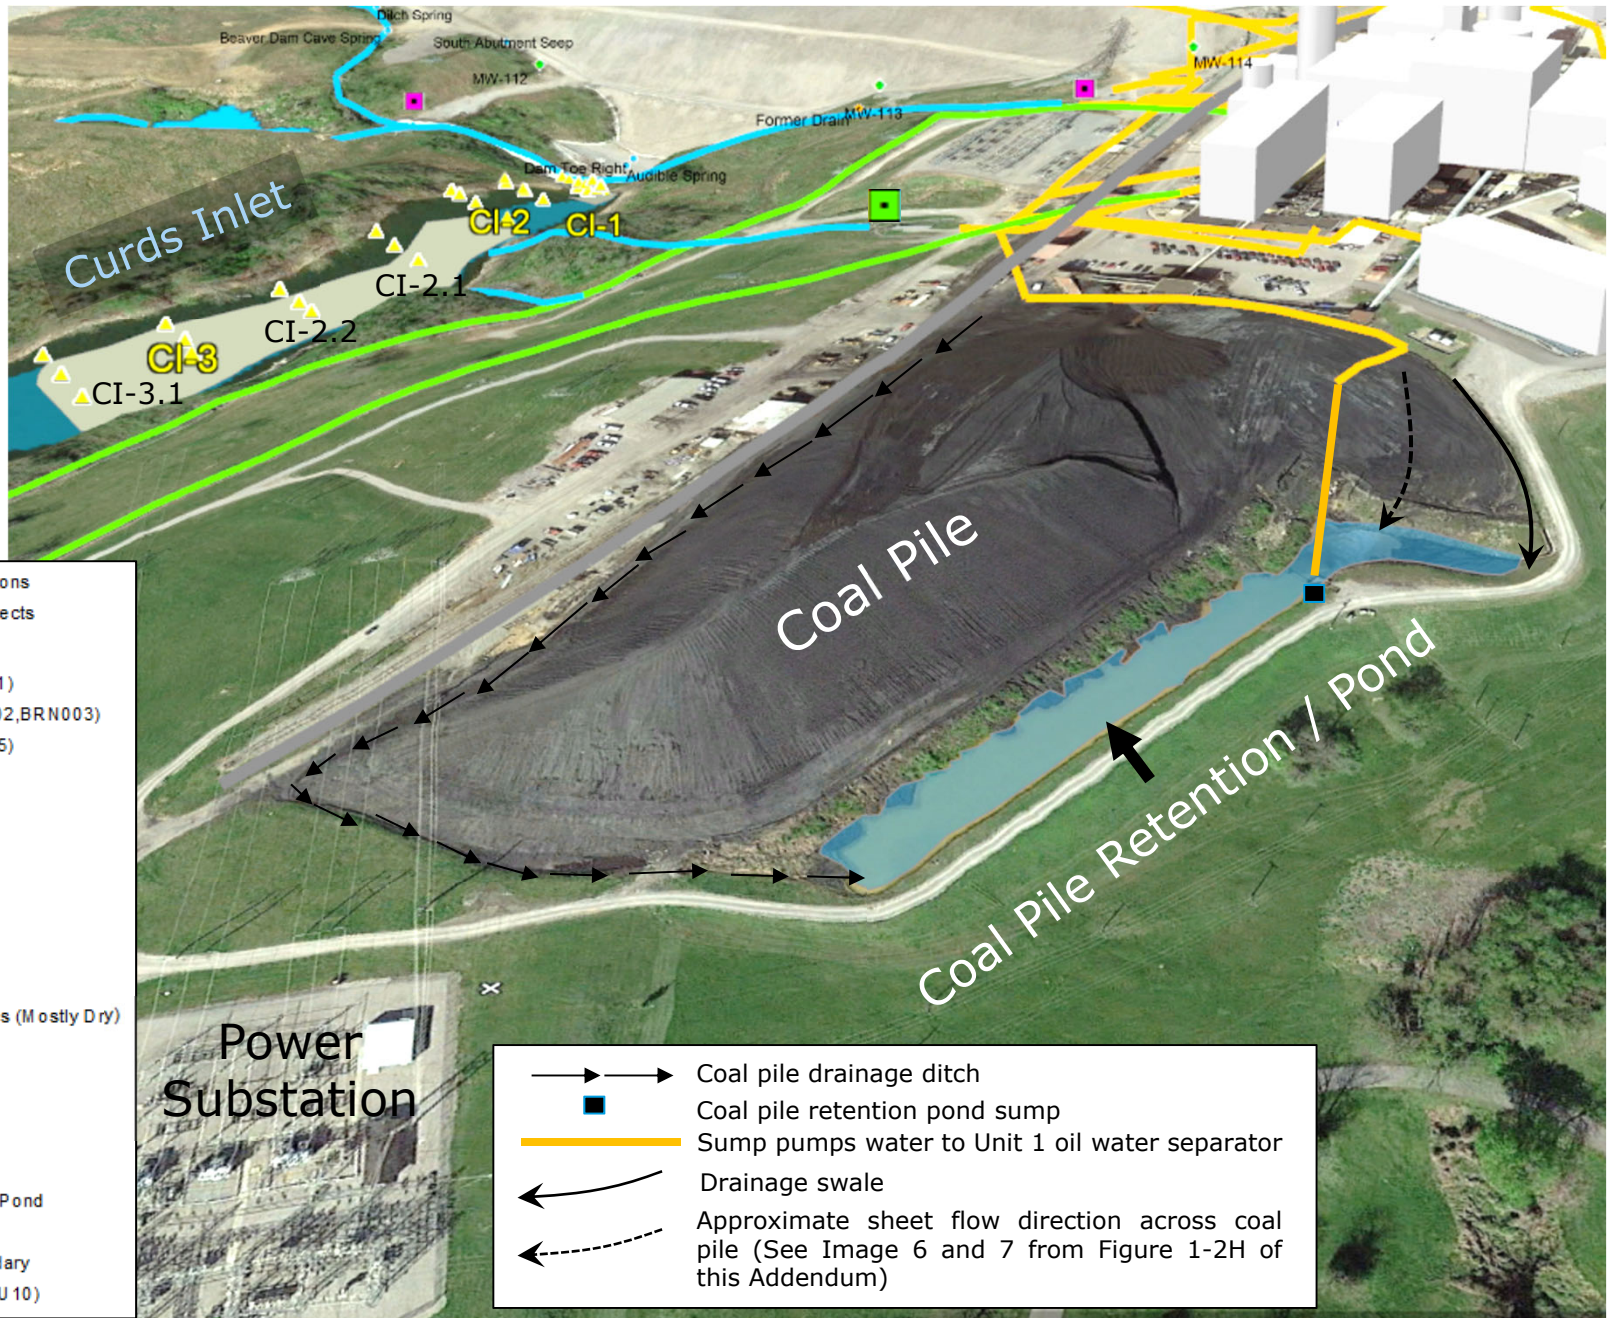
1-2D

- Coal pile drainage ditch
- Coal pile retention pond sump
- Sump pumps water to Unit 1 oil water separator
- Drainage swale
- Approximate sheet flow direction across coal pile (See Image 6 and 7 from Figure 1-2H of this Addendum)

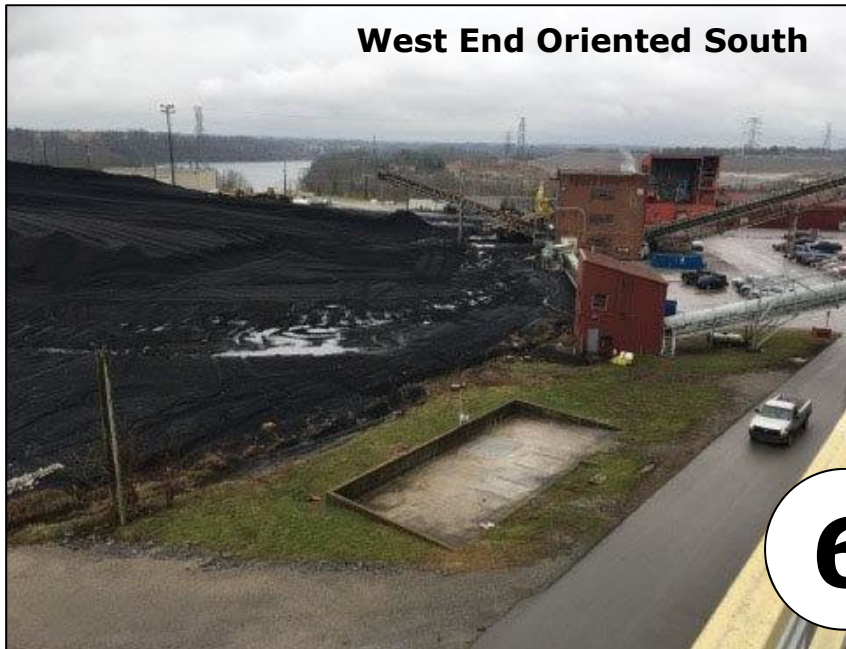
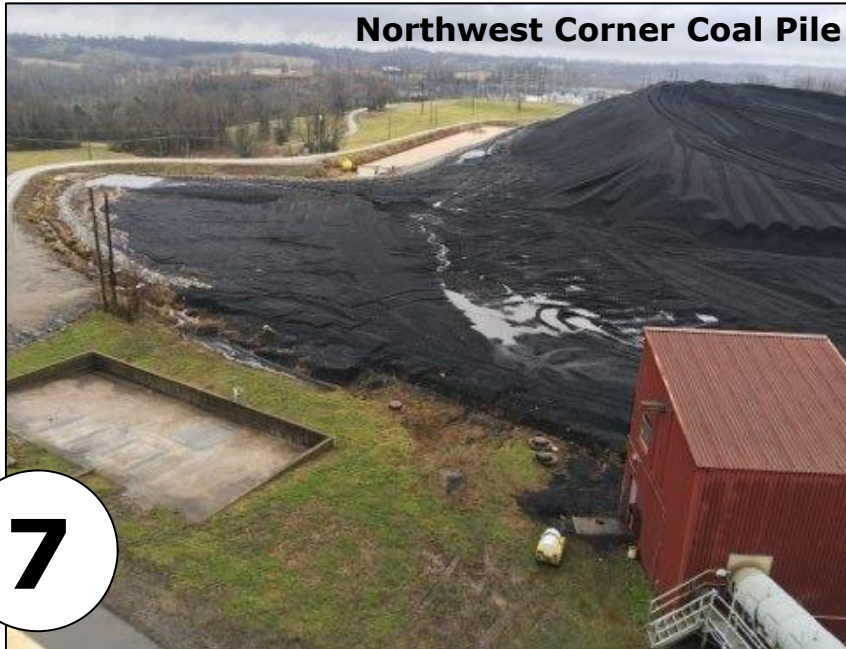
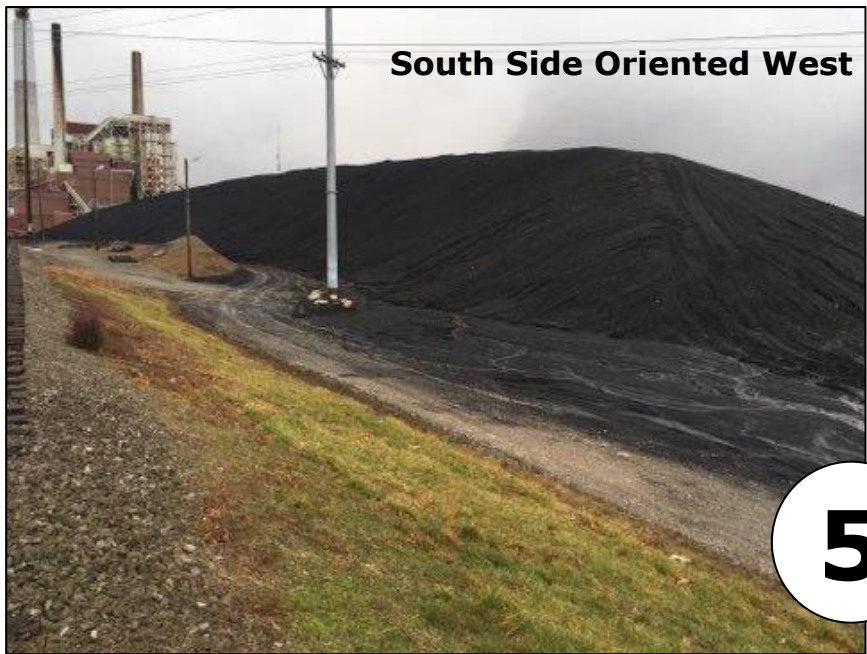
**West End Oriented South**

**Northwest Corner Coal Pile**

**South Side Oriented West**

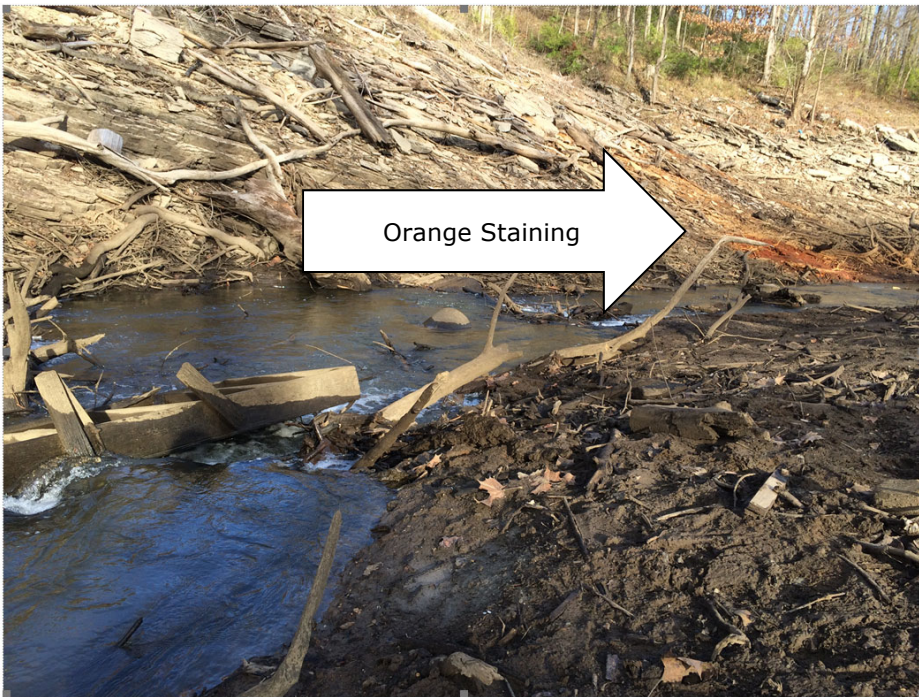
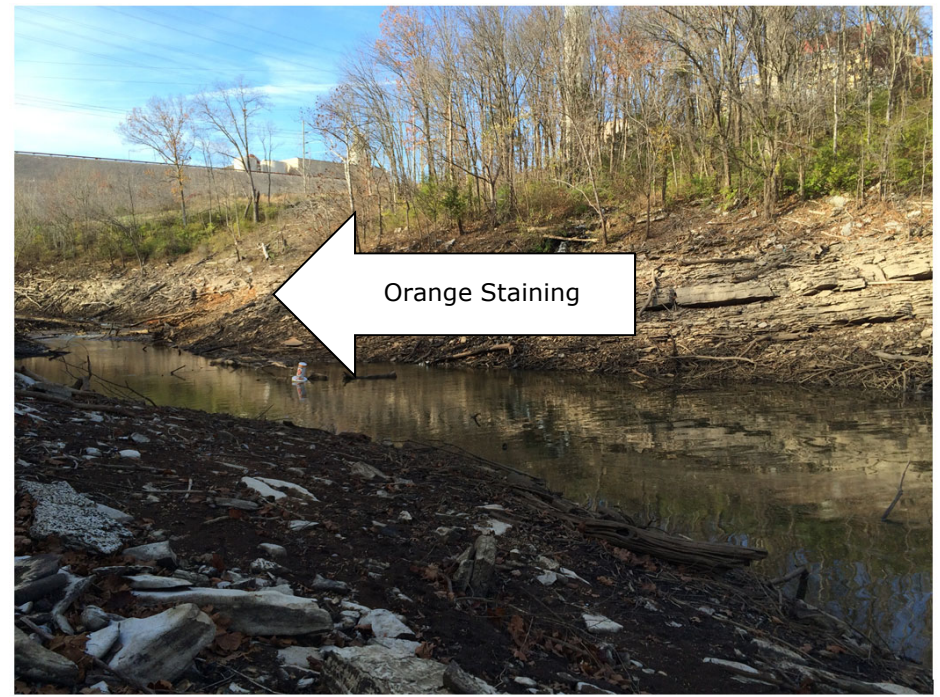
1. November 24, 2015, Lake elevation 721 feet, with photograph taken from the interior of Curds Inlet oriented toward the lake, with orange staining observed on the northern bank of Curds Inlet.

2. November 24, 2015, Lake elevation 721 feet, with photograph taken in Curds Inlet oriented toward the interior of Curds Inlet, with slight orange staining observed on the northern bank of Curds Inlet.

- Estimated area where orange staining was observed. Orange staining can indicate the presence of iron from oxidation at a point of groundwater discharge to the ambient environment.

Figure 2-2A points out a potential seep into Curds Inlet that is visible on the November 24, 2015 images as orange-stained shoreline located near the northwest shore of upper Curds Inlet. The location of the orange staining is also estimated on Figure 2-2B. The orange staining does not exhibit visible waterflow, despite a recent (November 19<sup>th</sup>, 2015) rainfall event of greater than one inch (source: US Climate Data). Figure 2-2A also indicates the estimated location of the stained shoreline relative to the Phase I and Phase II Curds Inlet sampling transects. Considering the proximity of the

staining to the transects, the Phase I and II sampling results account for any groundwater entering upper Curds Inlet at that location.

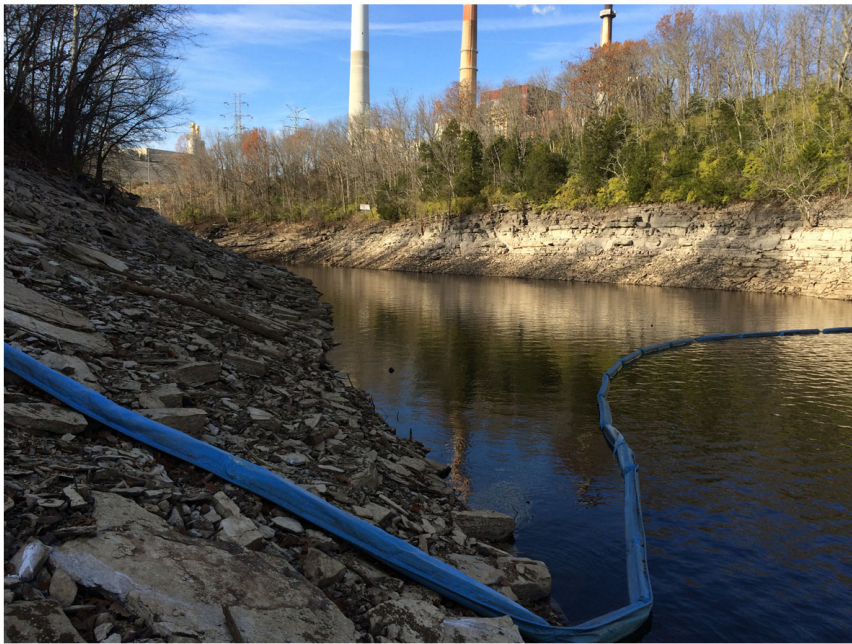
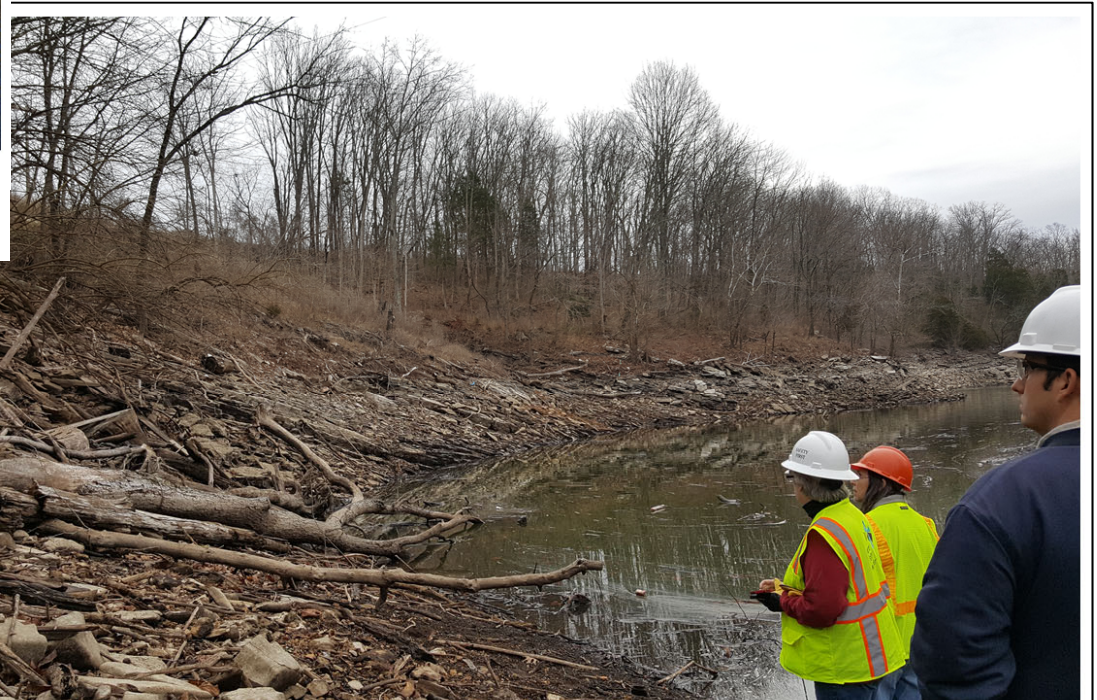
2-2C

1. November 24, 2015, Lake elevation 721 feet, with photograph taken from the interior of Curds Inlet oriented toward the Plant, with orange staining observed on the northern bank of Curds Inlet.

- Estimated area where orange staining was observed. Orange staining can indicate the presence of iron from oxidation at a point of groundwater discharge to the ambient environment.

2. January 19, 2017, Lake elevation 729 feet with no visible evidence of springs or potential groundwater migration to Curds Inlet in an area of Curds Inlet near the coal pile.

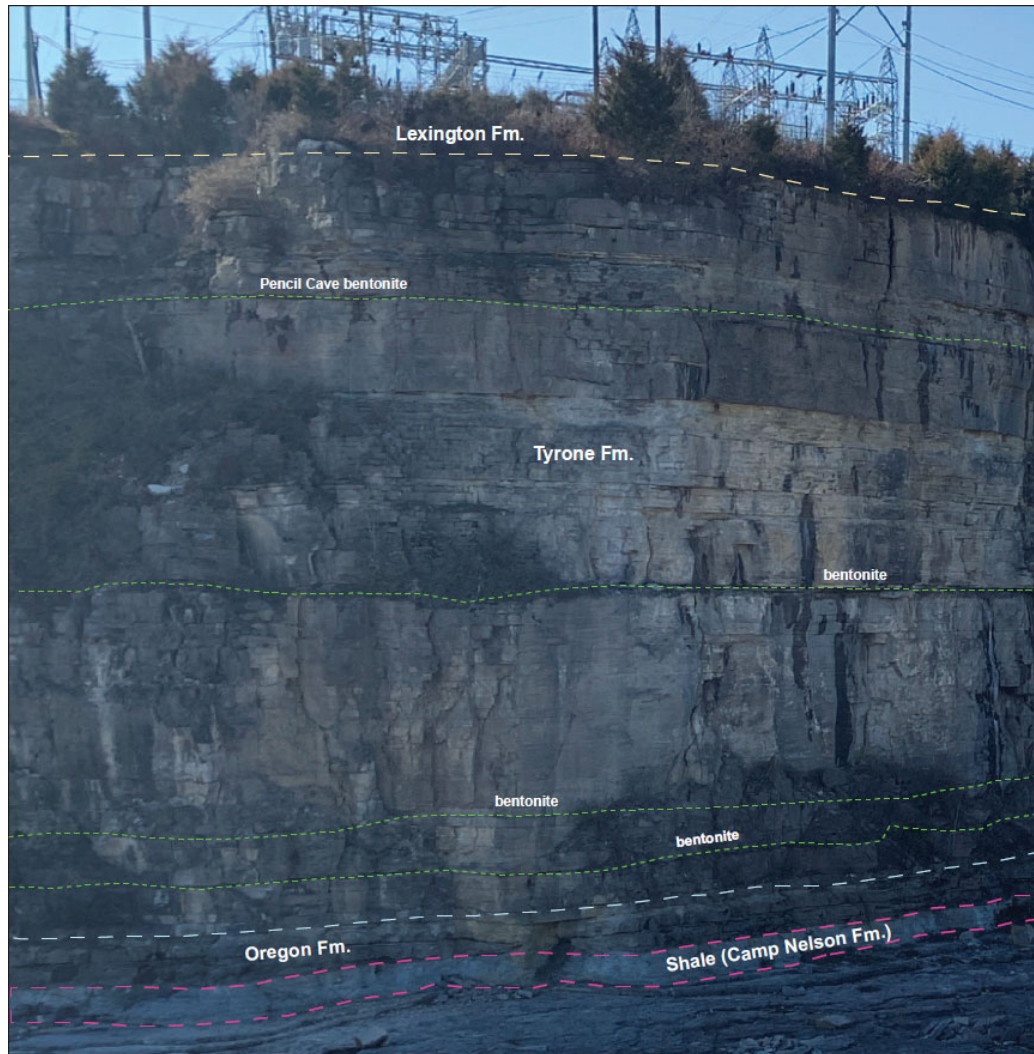
1. These photos were taken of the west wall of the emergency spillway of Dix Dam (February 21, 2020).
2. The dashed lines show approximate geologic contacts between units.
3. The bentonite (green) layers are approximate, and are based on field observations and documented elevations.
4. The images were taken oriented toward the western wall of the emergency spillway (the power station can be seen at the top of the strata).
5. The location of the power station and the image collection location are provided in Figure 1-2A.
6. Source: Ivanowski 2020

At the Dix Dam emergency spillway, any groundwater migration endpoint to the spillway should be readily apparent through seeps or springs along the sheer rock face of the spillway and there were no areas of groundwater upwelling in the spillway observed during the Phase I and Phase II sampling efforts. Attached as Figure 2-3 is a digital image of the exposed rock strata in the western wall of the emergency spillway (Ivanowski 2020). The elevation of the excavated rock spillway channel close to the dam where the digital image was taken is approximately 740 feet asl. At the downstream section directly northeast of the coal pile, where Dix Dam Road crosses the spillway, the elevation of the spillway channel base is approximately 730 feet asl. The rock strata are exposed for the entire length of the spillway down to the Dix River to a base elevation that is 524 feet asl. There are also no known significant areas of orange staining within the section of the Dix Dam spillway that was inspected that would suggest that groundwater containing elevated levels of iron is migrating from the coal pile or the coal pile retention pond to the spillway as a spring or seep. The various exposed strata are described above.

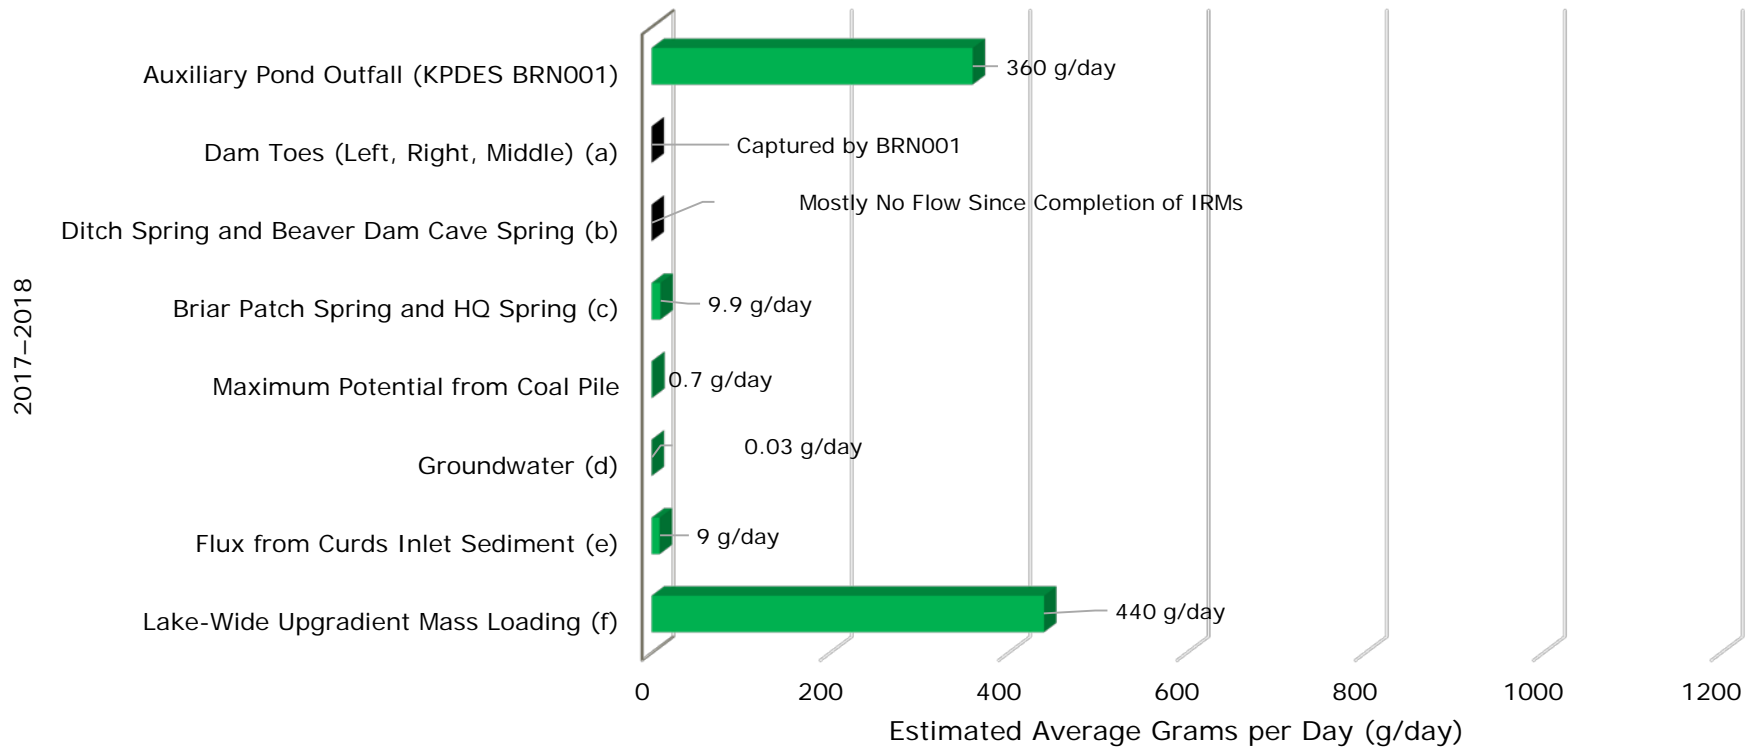
## After IRM Completion: Sources of Selenium

The Auxiliary Pond Outfall KPDES BRN001 is the primary outfall to Curds Inlet. The selenium mass loading ranged from 95–750 g/day, with a weighted average of 360 g/day.

- Dam Toe Springs (Left, Right, and Middle) are now captured by the Toe Drain collection system; therefore, there is no longer direct flow from these springs to Curds Inlet.

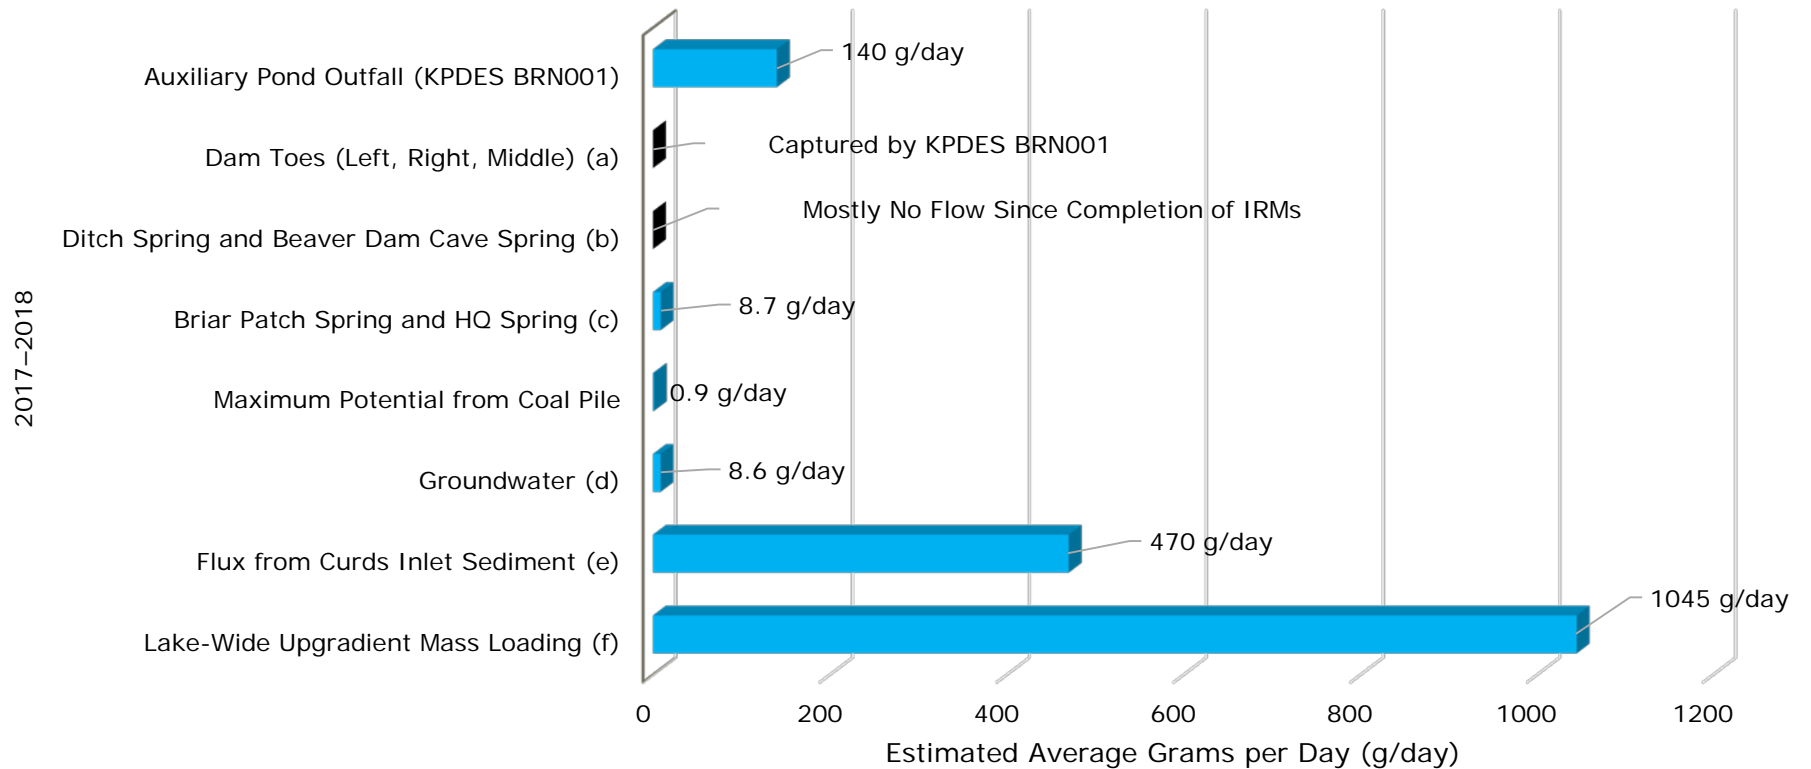
### After IRM Completion: Sources of Arsenic

The Auxiliary Pond Outfall KPDES BRN001 is the primary outfall to Curds Inlet. The arsenic mass loading ranged from 48-210 g/day, with a weighted average of 140 g/day.

- a. Dam Toe Springs (Left, Right, and Middle) are now captured by the Toe Drain collection system; therefore, there is no longer direct flow from these springs to Curds Inlet.
