FY2020 HAZARDOUS WASTE MANAGEMENT FUND

A Report to the General Assembly

Department for Environmental Protection Division of Waste Management 502-564-6716 waste.ky.gov

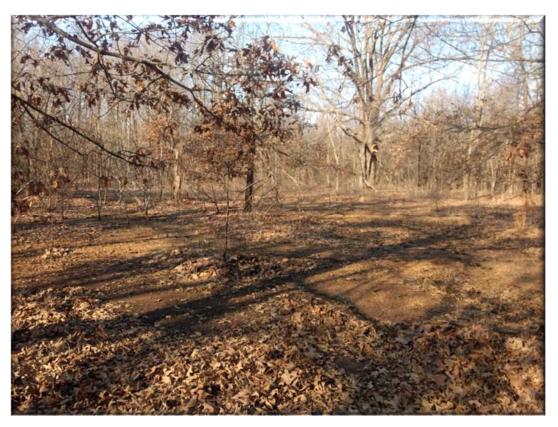
WKWMA wire burn site, former wire burn locations (bare areas).

This site is located within the WKWMA. During the early 2000s, KY Fish & Wildlife employees reported several barren areas within a wooded portion of the WKWMA. These areas were littered with small pieces of various debris including metal fragments, broken glass, and ceramic insulators. This appearance suggested that wire and other electrical equipment were burned in the past for recovery of copper. Soil samples collected by the cabinet detected elevated concentrations of several metals, notably lead, as well as polychlorinated biphenyls (PCBs).

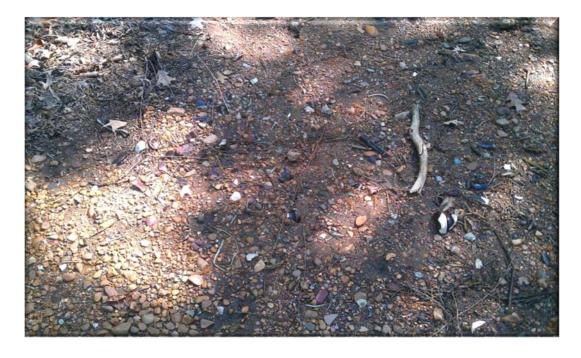
Close-up view of typical debris and barren nature of the former burn areas.

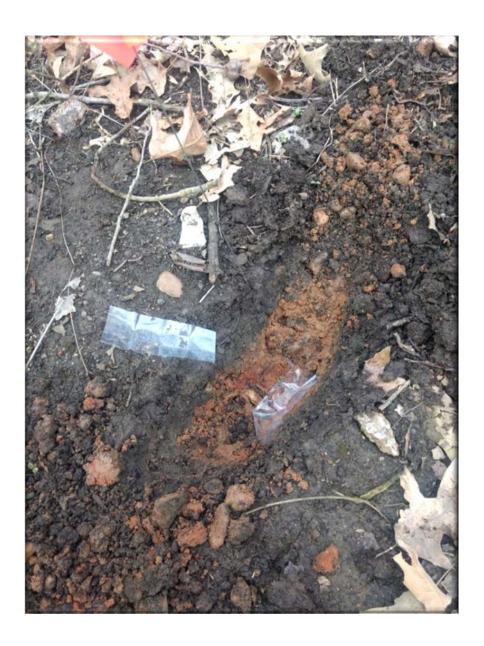
A test excavation reveals a contrast between highly contaminated surface soils (darker color) and "clean" (lighter color) soil beneath. Pieces of plastic are used to keep the XRF unit clean between screening locations.

The Superfund Branch (SFB) used its X-Ray Fluorescence (XRF) units to determine the horizontal and vertical extent of the contamination. An XRF allows real-time measurements of metals concentrations in soil. The Branch's investigation has determined the contaminated areas total just over 1.5 acres. Fortunately, the contaminants extend only a few inches below the ground surface.

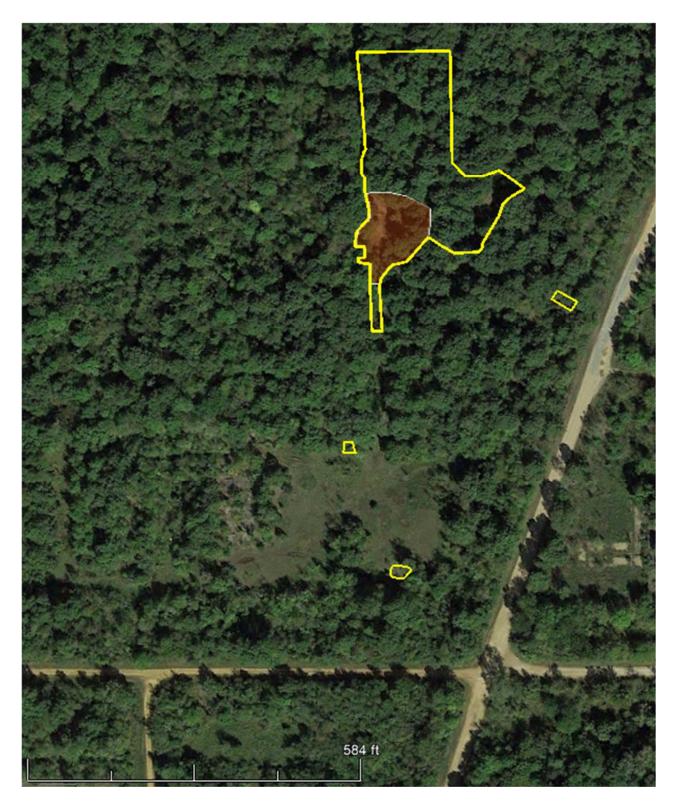
Yellow outlines indicate the contaminated areas. The brown shading indicates the area considered to be a hazardous waste.

Status: During early 2020, SFB collected samples of the contaminated material to determine if the material is a hazardous waste. One portion of the largest burn area was found to be hazardous. The hazardous material will require pretreatment with an additive so it can be disposed of in a sanitary landfill, a cheaper alternative than transporting the material to an out-of-state hazardous waste landfill. The Branch is currently working with Kentucky Fish & Wildlife officials to determine any special conditions that must be followed during soil removal within the wildlife management area. Bid specifications for the removal will be prepared once any special conditions have been determined.

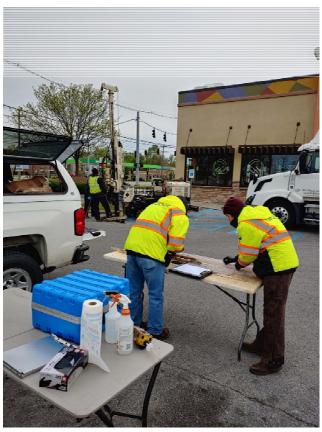
Wood personnel examining the soil cores as the drilling subcontractor works in the background.

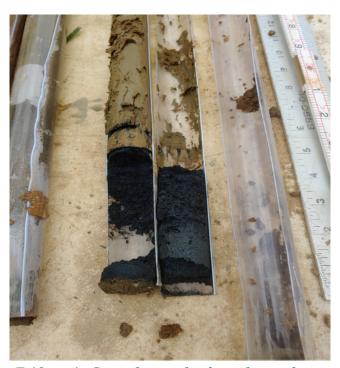
Evidence in Geoprobe sample of petroleum release.

Status: Wood began the assessment of the first site (formerly Kim's Dry Cleaners) during April 2020. Soil and groundwater samples were collected at nineteen (19) locations. The laboratory analysis is still pending. However, field screening and visual evidence detected the presence of chlorinated (dry cleaning solvent) and petroleum compounds. The property was used for a filling station prior to the dry cleaning operations.

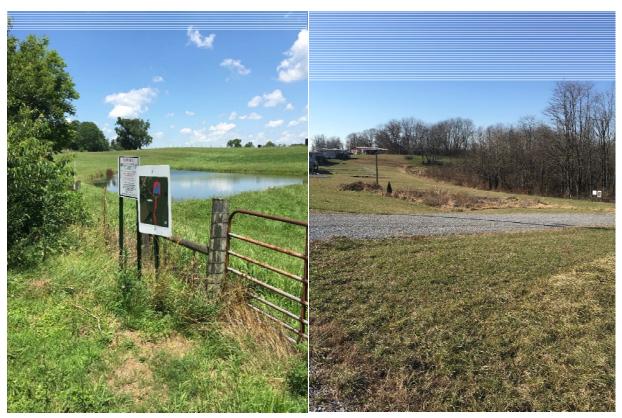
Signs placed at various locations at the site to warn of potential exposures.

October 2019. Signage was placed on and around the outlying areas that have been assessed for elevated levels of Arsenic. These signs were placed in strategic locations warning of possible exposure risks to the public.

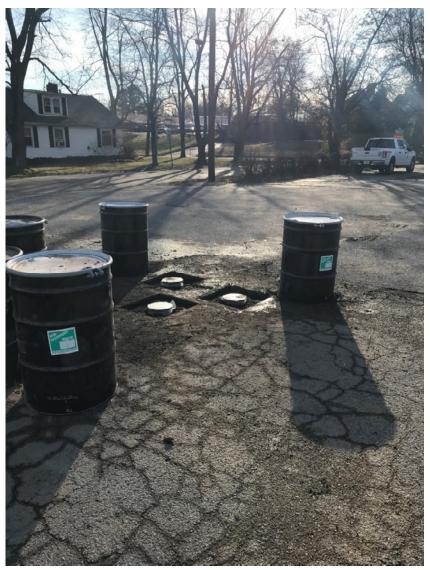
Nested Wells at Parrish Avenue to monitor three groundwater zones. Drums are cuttings to be disposed.

The SFB is gathering groundwater data to determine TCE/PCE concentrations in the wells. The extent of groundwater contamination has been defined and groundwater monitoring or corrective action may be requested in the FY2021-2022 budget cycle.

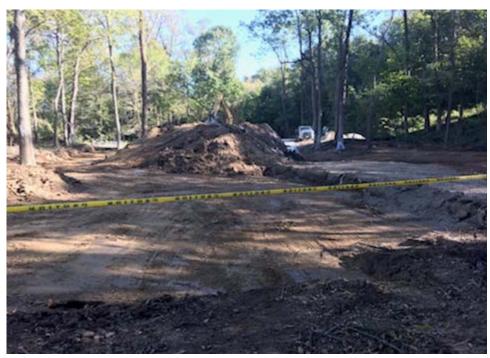
Stockpiling of soil in the pond area for soil amendment before removal.

Tri-State Oil Refinery is believed to have been a collection point/oil water separator in the late 1930s and 1940s. This site was initially discovered during a No Further Remedial Action Planned (NFRAP) review in 2011 and 2012 as part of a Preliminary Site Assessment Investigation. Petroleum sludge, contained in one of two former ponds, was revealed on-site. This pond contained elevated lead, and the sludge was considered flammable. Additional characterization was conducted in 2017 utilizing a combination of state Superfund personnel and the Madisonville Regional Office staff. An impact area was defined by using a combination of XRF field screening, via 36 soil borings that extended 4 to 8 feet below ground surface, and laboratory analysis. During 2017, the cabinet set aside a portion of HWMF funds to conduct remediation for this site. The petroleum sludge will be treated on-site before its disposal at a Subtitle D landfill. Clearing the site and initiating work started on August 29, 2018, under Chase Environmental. A temporary access road was constructed, large debris cleared and TerribondTM soil amendment was ordered to treat generated hazardous waste. XRF screening of the main pit removal area was conducted on October 10-11 as well as confirmatory pit sampling based on 1-405 closeout procedures. Those results indicated that removal was successful for the main impact area. The pond was originally supposed to be a wider area removed down to 4ft bgs (below ground surface), but it ended up being a narrow impact area that went down between 6-8ft bgs. The amount of soil that required amendment and removal was smaller than anticipated. It was around 1560 tons of soil that required amendment.

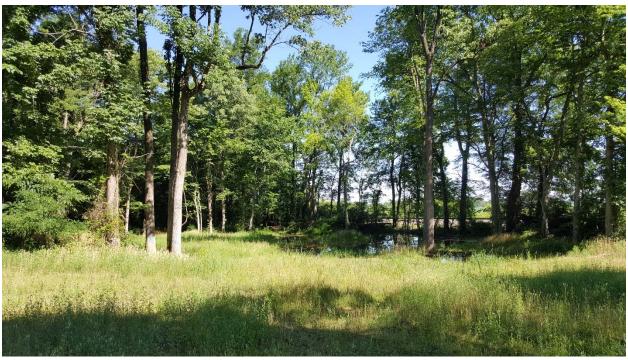
Site conditions post-removal spring 2019.

The site was backfilled, seeded, and the temporary road removed. Additional road repairs had to be conducted on Resinerg Road due to impacts by the Tri-Axel dump trucks leaving the site. Total

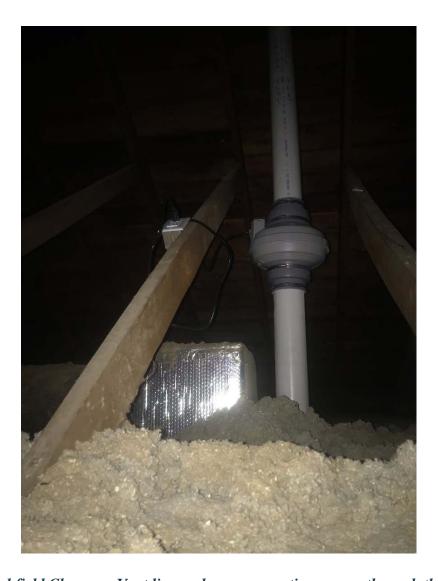
Leitchfield Cleaners -Vent line and vacuum routing vapors through the attic.

As a result of these findings concerning significant impacts to soil, sub-slab, and indoor air vapor, and their associated observed levels, it was necessary for SFB to implement emergency abatement procedures to mitigate the immediate vapor exposures to residents living in the apartment building and eliminate any further on-going human health exposures from this release. The financial

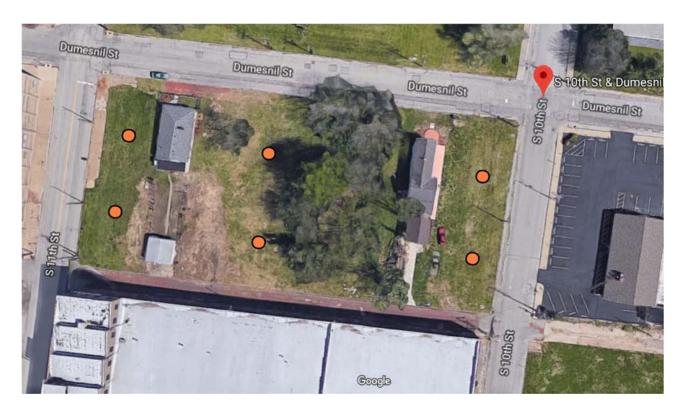
Aerial view of two residential structures and soil vapor probe locations. The former Henry Vogt facility is south (located below the bottom of this photo) of these residences.

Status: Although the March 2020 sampling did not indicate a risk for soil vapor intrusion, the vapor probes will be resampled during 2020. The additional sampling will determine if any seasonal variation results in an increased potential for vapor intrusion.

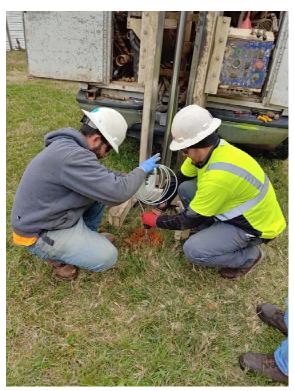
Soil vapor probes installation. Vapor inlet screen installed 15 feet below the surface. Flexible tubing attached to probe and extends to surface. Steel box and concrete pad constructed to protect tubing.

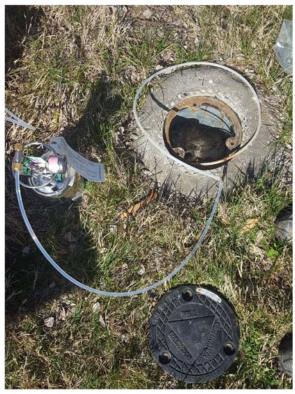
Vapor sample collected from a soil vapor probe. Summa canister (left) under vacuum that is used to extract soil vapor from probe via flexible tubing.
