**MAXEY FLATS DISPOSAL SITE
ANNUAL REPORT
2004**

March 21, 2005

Environmental and Public Protection Cabinet
Department for Environmental Protection
Division of Waste Management
Superfund Branch

Maxey Flats Disposal Site
2597 Maxey Flat Road
Hillsboro, KY 41049
606-784-6612

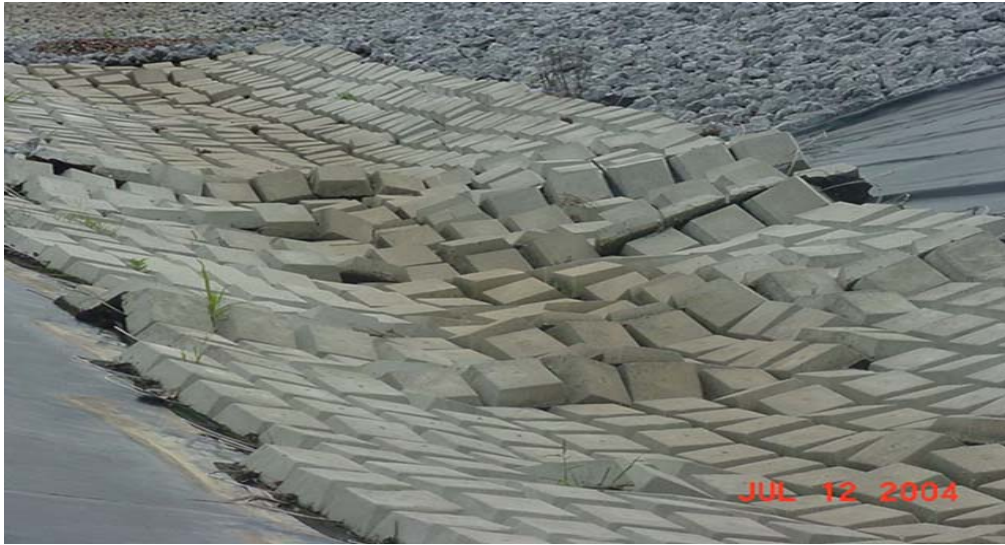
A rain event on July 12, 2004 caused major movement of the AB mats in the South Channel. The damage caused by this incident was beyond the scope of site resources. The Commonwealth notified the U.S. Environmental Protection Agency and *de maximis, inc.* of the occurrence in July 2004. In accordance with the Consent Decree, the contractor was responsible for making the repairs.

Photo 1 shows the AB mats in the South Channel following the rain event in July 2004. Photo 2 shows AB Mats being lifted for realignment. As mats were lifted, debris was removed from under each mat. Photo 3 shows a new cc45 mat being installed to replace a damaged cc45 mat.

Photo 1
AB mats in South Channel
following major rain event.
Photo by Jeff Stamper.

Following an evaluation of the disturbance of the AB mats by David Schaad of Marshall, Miller & Associates in August 2004, conference calls were scheduled to discuss the action to be taken. During the conference call on October 13, 2004, the Commonwealth and USEPA were notified that a workplan was being prepared by SHAW (the former lead contractor for site remediation) to make the necessary repairs.

The connecting cable clamps were then removed to allow realignment and replacement. A 200-ton crane was mobilized on November 9, 2004 for this task. The six cc45 (8 ft x 16 ft) AB mats at the end of the south channel were replaced with twelve larger-sized cc70 (4 ft x 16 ft) AB mats. Nine other cc45 AB mats that were damaged beyond usability were also replaced. Following this procedure, the stainless steel clamps were reinstalled.

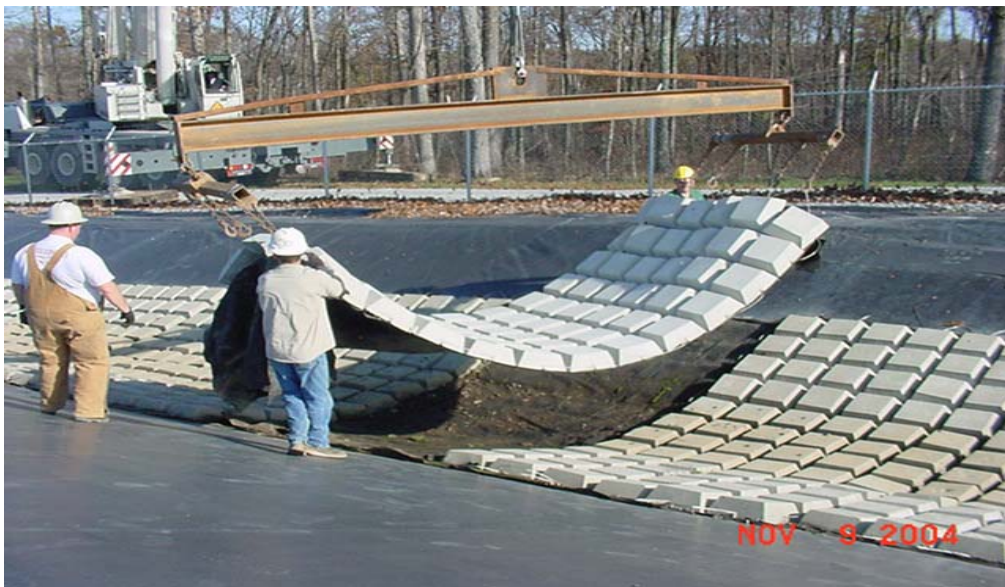
Photo 2
AB mats in Southeast channel
being lifted for realignment
Photo by T. Stewart
