**FOURTH FIVE-YEAR REVIEW REPORT FOR
MAXEY FLATS DISPOSAL SITE
FLEMING COUNTY, KENTUCKY**

SEPTEMBER 2017

**U.S. Environmental Protection Agency
Region 4
Atlanta, Georgia**

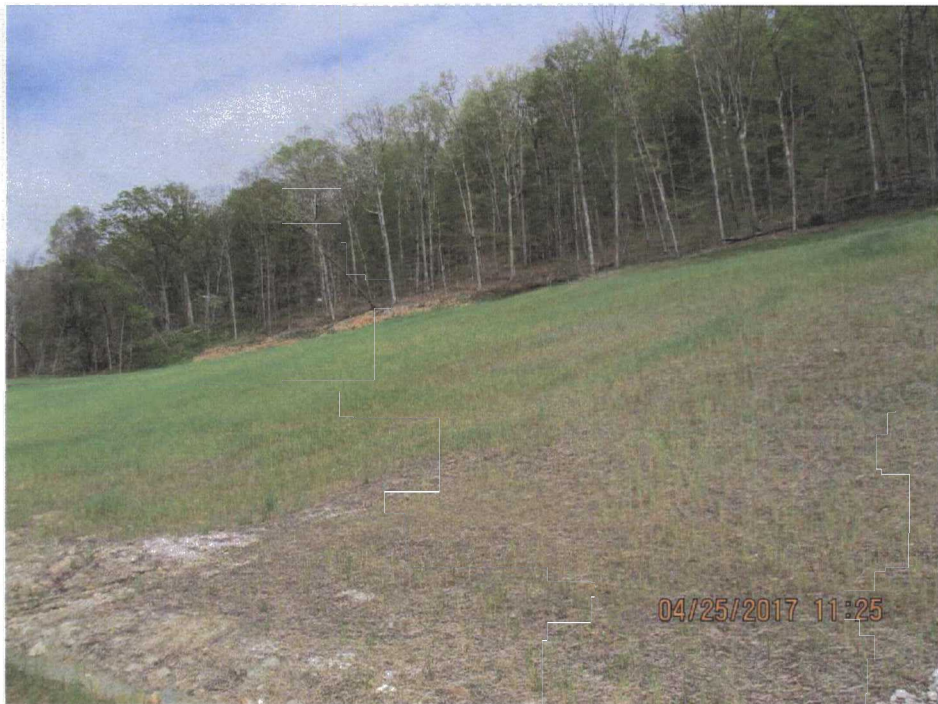
87. Hillside where slip occurred in Borrow Area #4.

88. Hillside where slip occurred in Borrow Area #4.

On January 15, 2016, the Kentucky Geologic Survey visited the MFDS to make preliminary observations of a landslide complex that had damaged an embankment along the toe of the southwest facing slope of the landfill due to the excavation of soil borrow pits for construction of the final cap. The main landslide area lies within the Estill Shale. The purpose of the visit was to observe the ground conditions, local geology, geomorphic setting, landslide features, property damage, and report the findings. Several landslide features were observed along the southwest slope below the storage facility. The toe of the slope had been excavated in September 2015 in order to mitigate a preexisting landslide, and to harvest soil material for the disposal facility cap. After excavation, the soil material was re-compacted to form an embankment with a similar slope angle to pre-excitation. Accelerated landslide movement began in late September 2015. It was determined that the causes of the slide are a complex interaction between slope modification and the physical properties of the rocks, soil, and slope morphology. The weak bedrock geology, weak soils, steep slopes, and groundwater flow are cumulative causes that when triggered (by a combination of slope modification and rainfall), produce stress conditions leading to slope failure. Preexisting landslide activity, slope modification, varying lithology, geomorphology, soil strength, and hydrologic conditions are all complex variables, and the forces that act on a slope combined with these variables make landslide hazard assessment difficult. Landslide monitoring and an in-depth geotechnical investigation were recommended in order to confirm the extent of the hazard and address possible mitigation techniques.

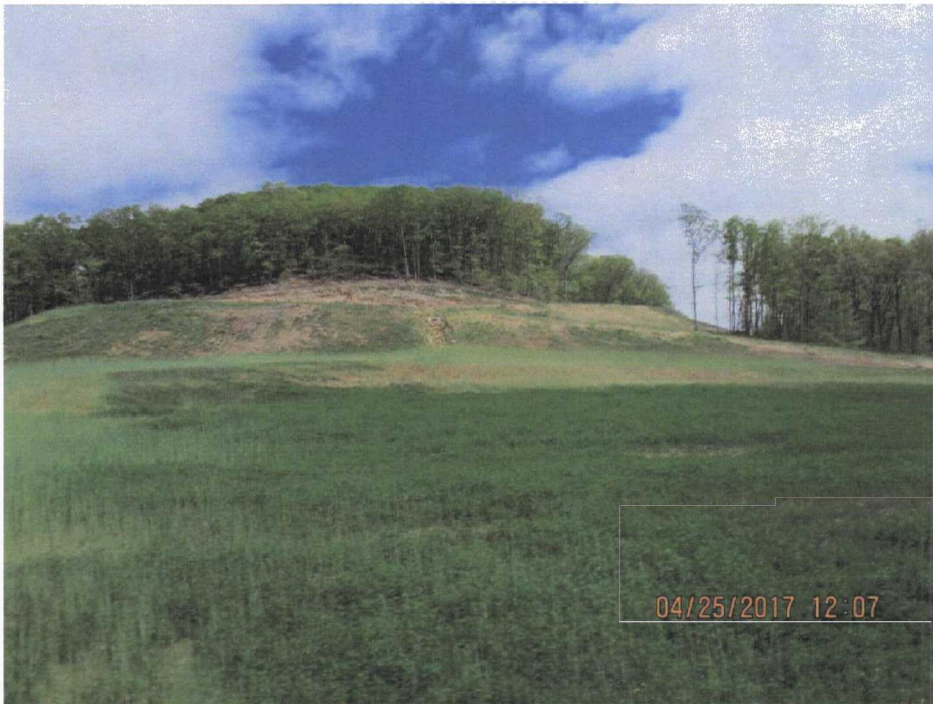
111. Borrow Area #3 where a slip occurred. The slip was repaired and surface drains were installed.

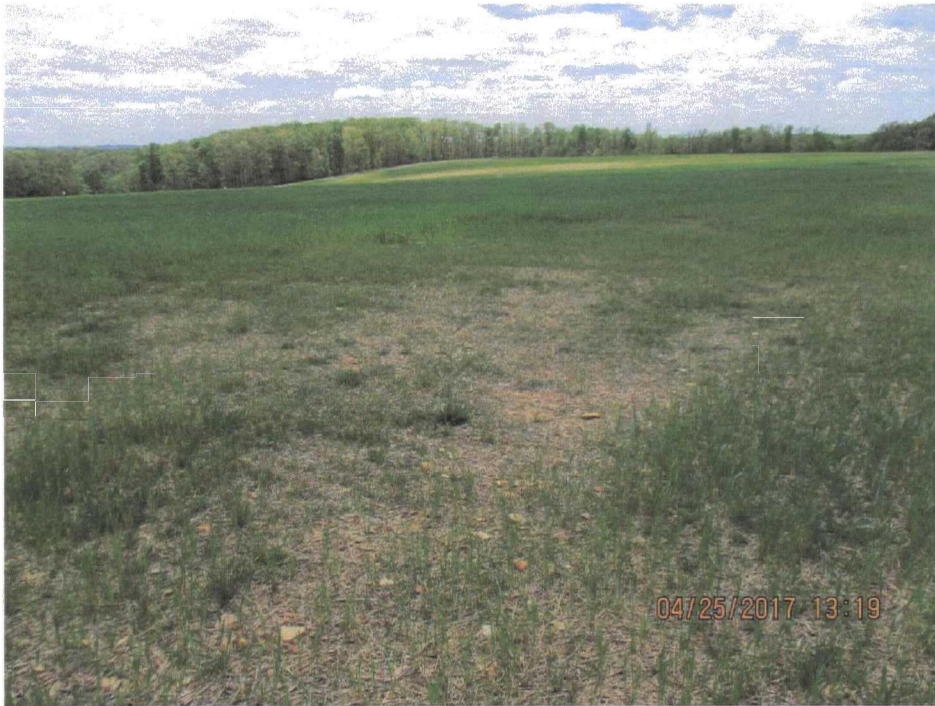
131. An area with sparse vegetation near the highest point in the LF.

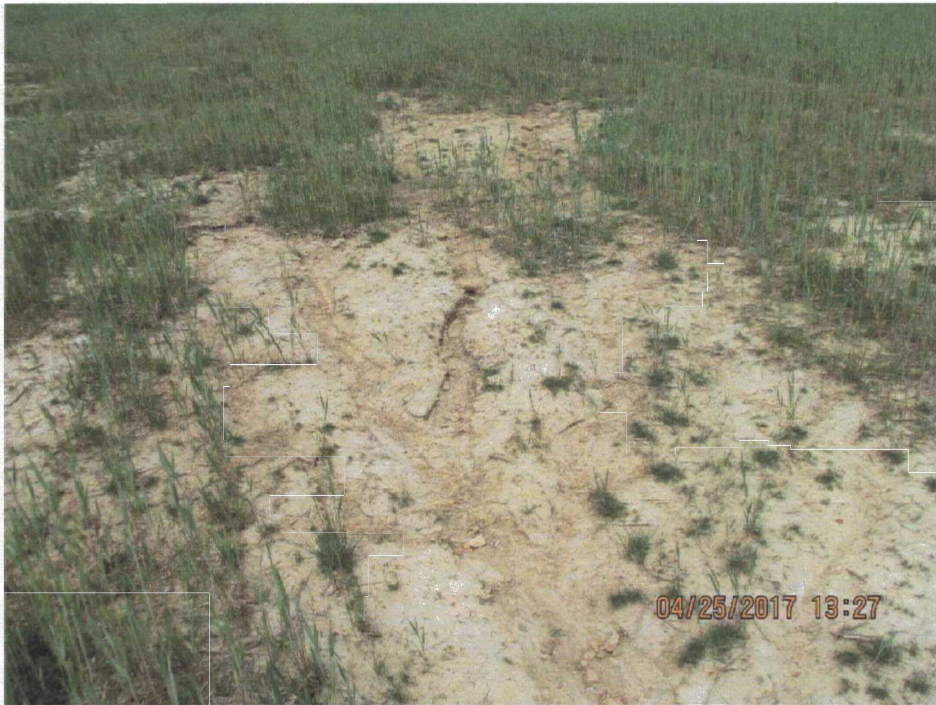
135. A small area with some soil erosion/channeling near the LF monument marker located near the center of the LF.

136. A small area with some soil erosion/channeling near the LF monument marker located near the center of the LF.

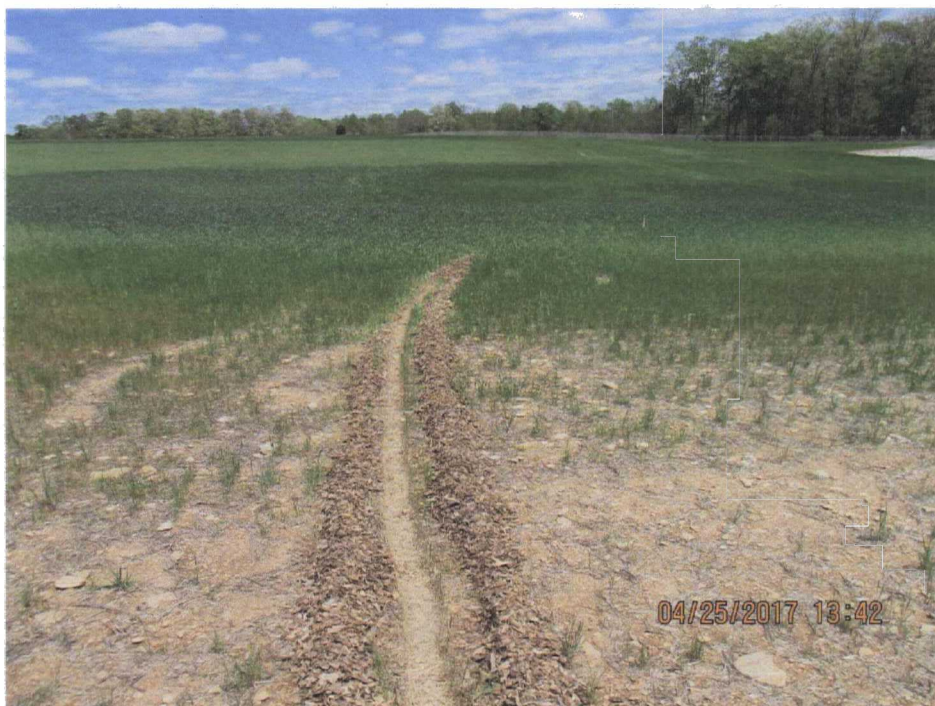
148. Wood chips from erosion control sock remaining on the LF after removal of the outer fabric, located near the East Basin.

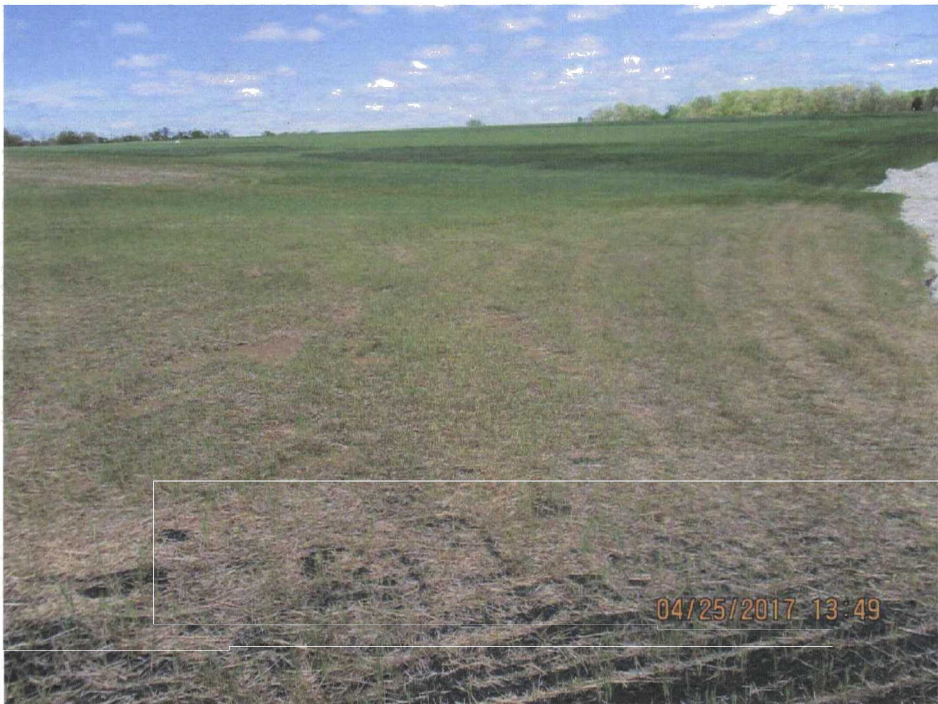
156. An area with sparse vegetation located to the southwest of the East Basin.

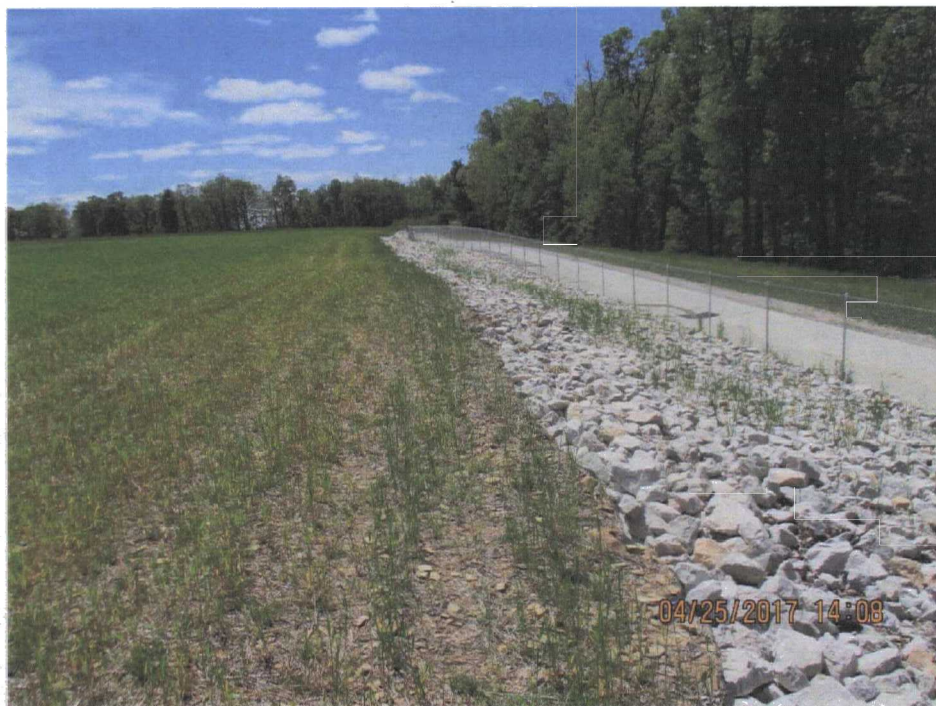
165. Sparse vegetation on the haul road near the southwestern corner of the LF.

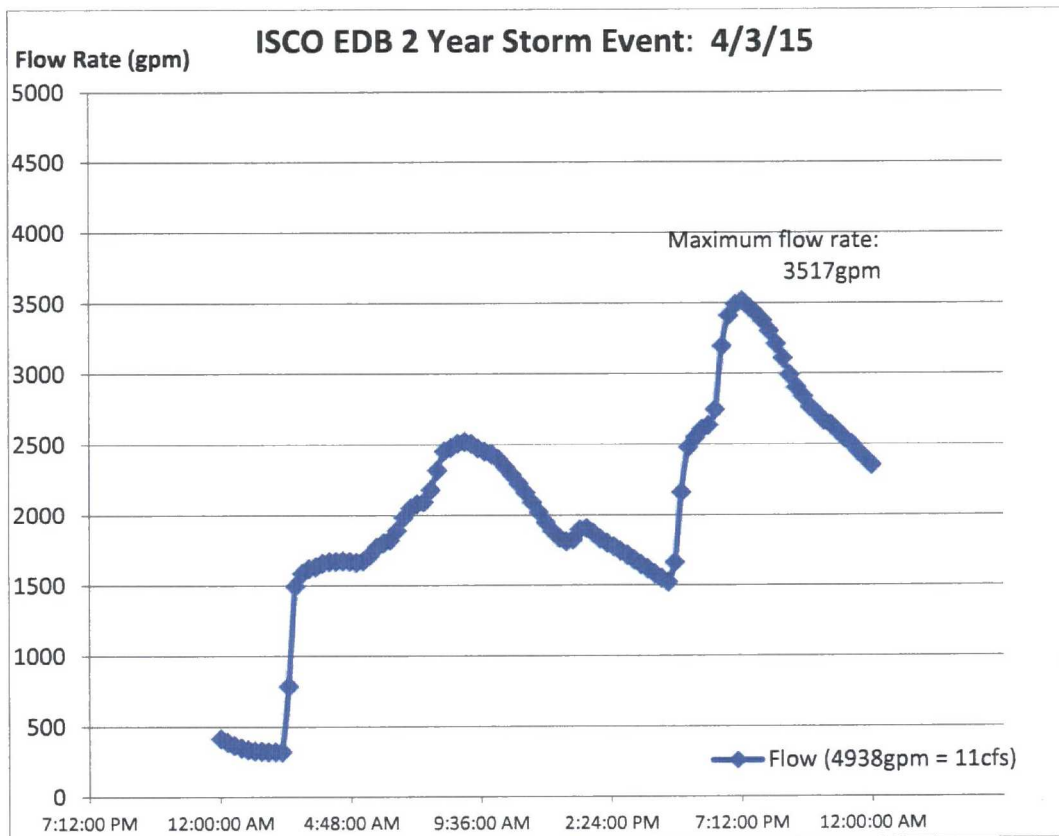
Pursuant to the ROD and Initial Remedial Phase (IRP) design, discharge from the East Detention Basin is released into the East Main Drainage Channel at a rate not to exceed predevelopment flow conditions. Following a 2.8 inch, two year storm event or greater, the Commonwealth is required to conduct an inspection of the interim cap and all three drainage channels, and report findings. The East Drain rain gauge recorded a two year storm event on April 3rd with a rainfall depth of 2.9 inches. A comparison of the discharge flow at the EDB flume to a predevelopment flow rate of 11 cfs confirms the predevelopment rate was not exceeded. Figure 3-1 details the 4/3/15 storm event.
