UST QUARTERLY

A Newsletter of the Kentucky Underground Storage Tank Program

Volume 6, Issue 1
2014

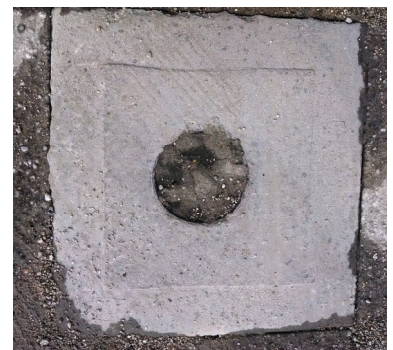
The monitoring well shown is not properly decommissioned. In this example, the well pad and protective cover were left in place. Photo: Michael Albright

According to 401 KAR 6:350 Section 11 (2) the surface casing, monitoring well casing, well screen, filter pack, bentonite seal, and well pad must be removed during the abandonment process. The borehole must then be plugged with approved sealing material, according to manufacturer's recommendations. The top 2 feet of the borehole must be filled with materials consistent with the surrounding ground surface. A **blanket variance** was established for monitoring wells installed at UST sites. According to this variance, monitoring wells with depths of less than 30 feet in unconsolidated material are exempt from the over drilling requirement of 401 KAR 6:350 Section 11 (2). A no further action letter from the Kentucky UST Branch serves as written approval for the blanket variance but does not exclude the site from Kentucky Division of Water abandonment requirements.
