# **Dry Creek Watershed Plan**

The Dry Creek Watershed-based Plan (WBP) outlined all point and nonpoint pollution sources in the watershed, quantified the pollution coming from each source, and made recommendations for Best Management Practices (BMPs) to improve water quality in Dry Creek.

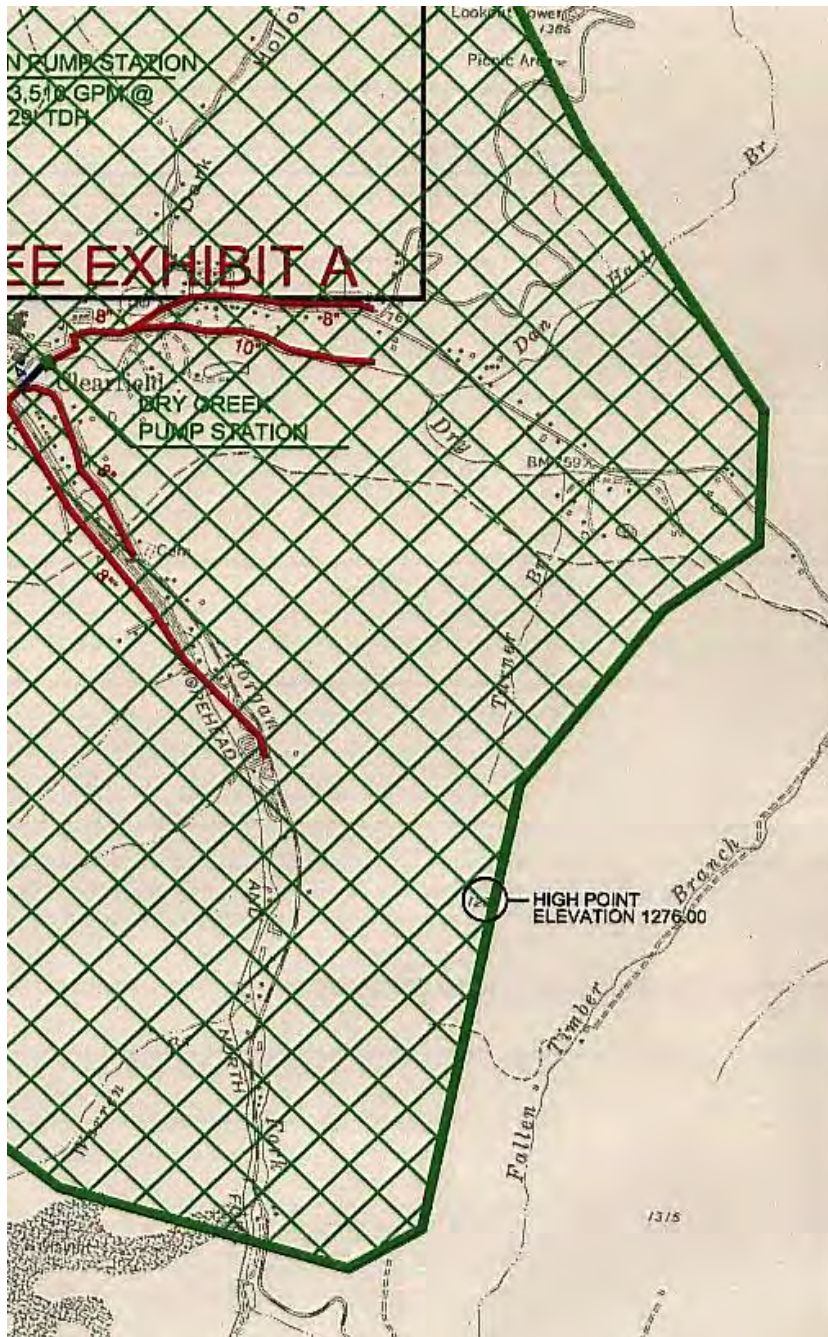
Figure 2.7. City of Morehead Sanitary Sewer System Layout and Planning Area from Morehead Utilities Plant Board 201 Plan showing the Dry Creek Watershed area.

Only a portion of the Dry Creek watershed is included in part of the 201 plan. The sections that are covered are part of the 0-2 year plan and presently have city sewer available. The areas that are not showing planned sewer projects are the less populated areas. These areas include the area of Dry Creek about Tower Road. The red lines on the map below represent existing sewer lines. The green grid shows the area that is part of the MUPB 201 plan.

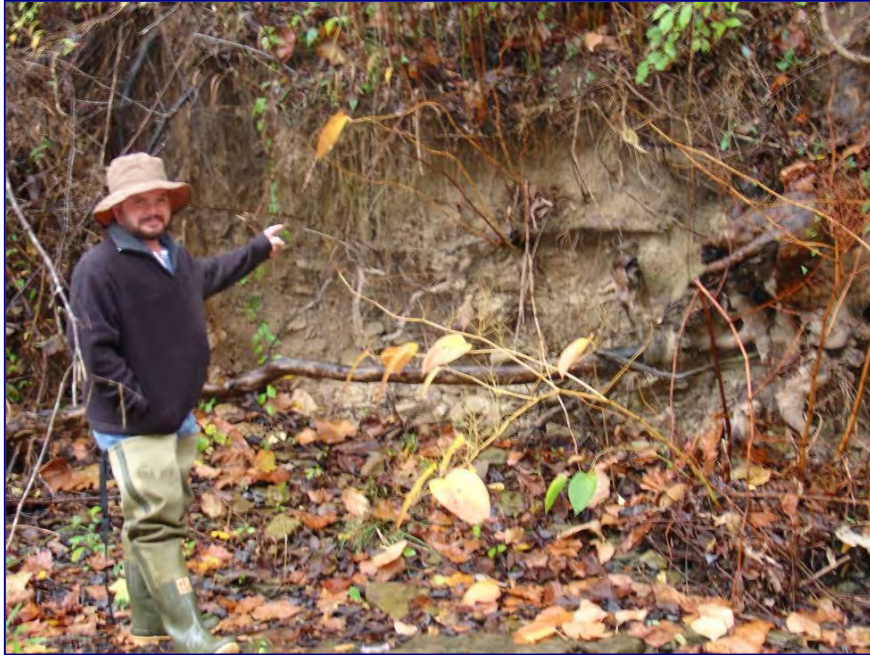
Figure 2.14 Photo showing erosion and mass wasting at a site on Dry Creek.

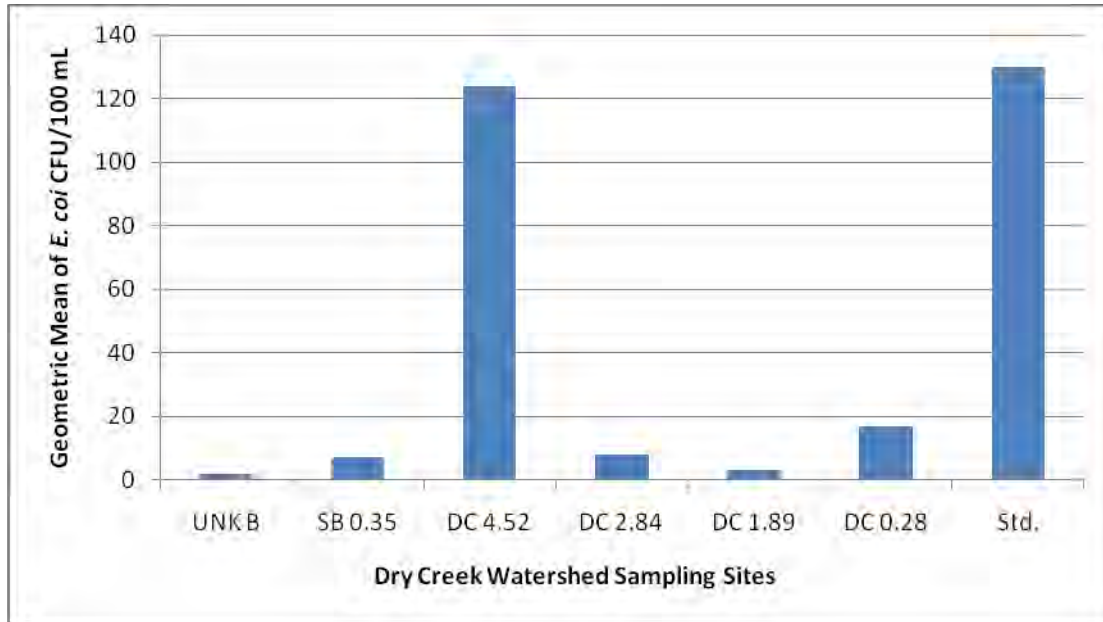
Figure 3.3 Geometric means of *E. coli* counts in the Dry Creek watershed, March-April 2008.

Figures 3.3 and 3.4 show the geometric means of *E. coli* counts for sites in the Dry Creek Watershed for spring and summer 2008.

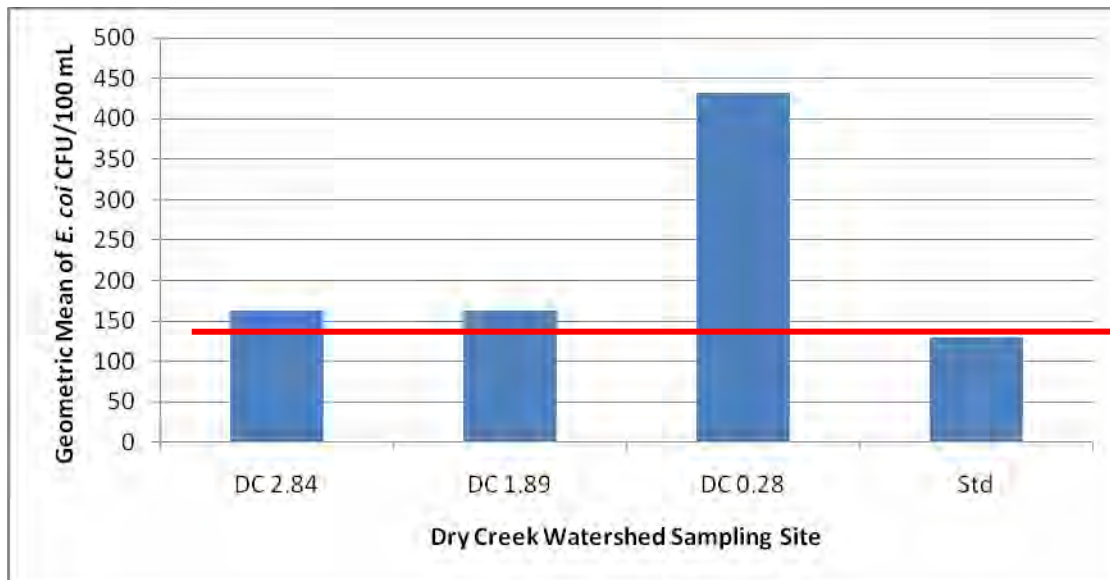
Figure 3.4. Geometric means of *E. coli* counts in the Dry Creek Watershed, August-September 2008. The red bar indicates the KDO limit of 130 *E. coli*/100 mL.

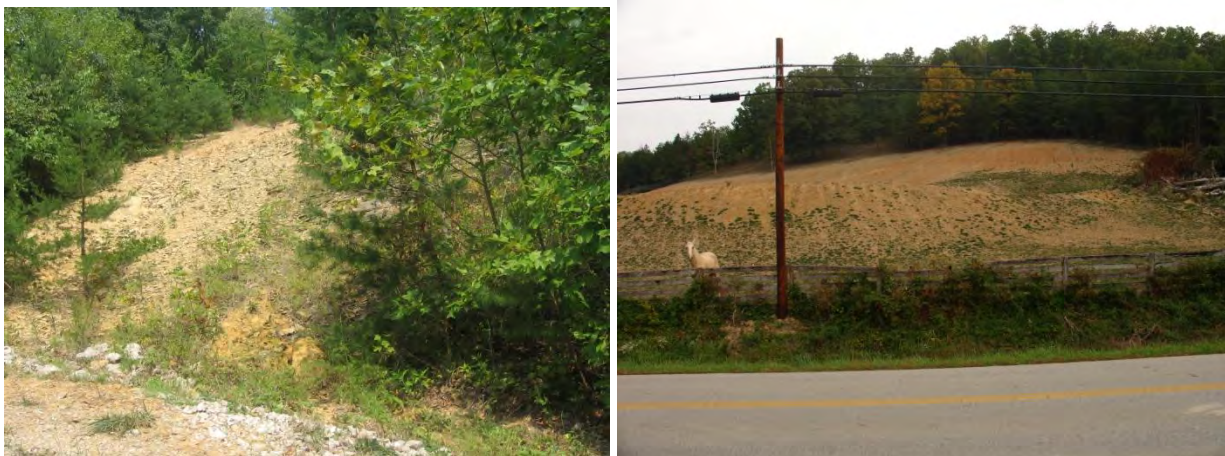
Figure 3.5. Example of vegetative cover being removed and not replanted.

As discussed in Chapter 2, various land use practices negatively impact the water quality of Dry Creek and its tributaries. An EPA Watershed Inventory Form, which was downloaded from the EPA Watershed web site, was used to conduct a visual watershed inventory for the Dry Creek Watershed. Results of this inventory identify the presence of 10 bridges, 15 drain pipes, 7 drainage ditches, 1 storm drain, 3 vehicle crossings, and 4 natural gas pipeline crossings on Dry Creek. Approximately 1 mile of 5.8 miles of Dry Creek has been straightened. In addition, there are signs of ATV use along and in Dry Creek for short sections as well as obvious use of equipment (e.g., Bobcats or front-end loaders) to move large quantities of gravel. The alterations described above do not include Dry Creek tributaries, only Dry Creek itself. Figures 3.5 through 9 show examples of commonly observed, poor land use practices.

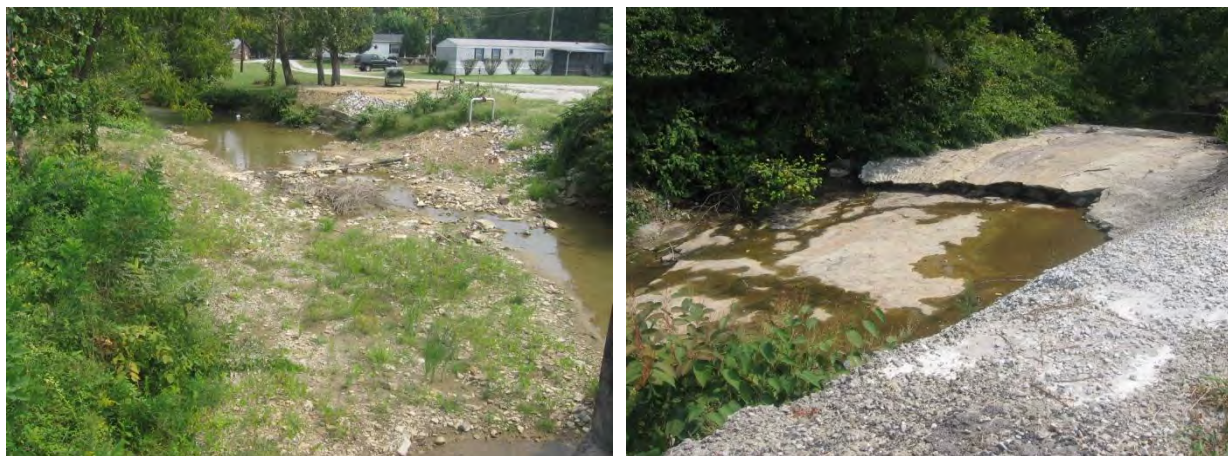
Figure 3.6. Examples of pipeline crossings on Dry Creek.

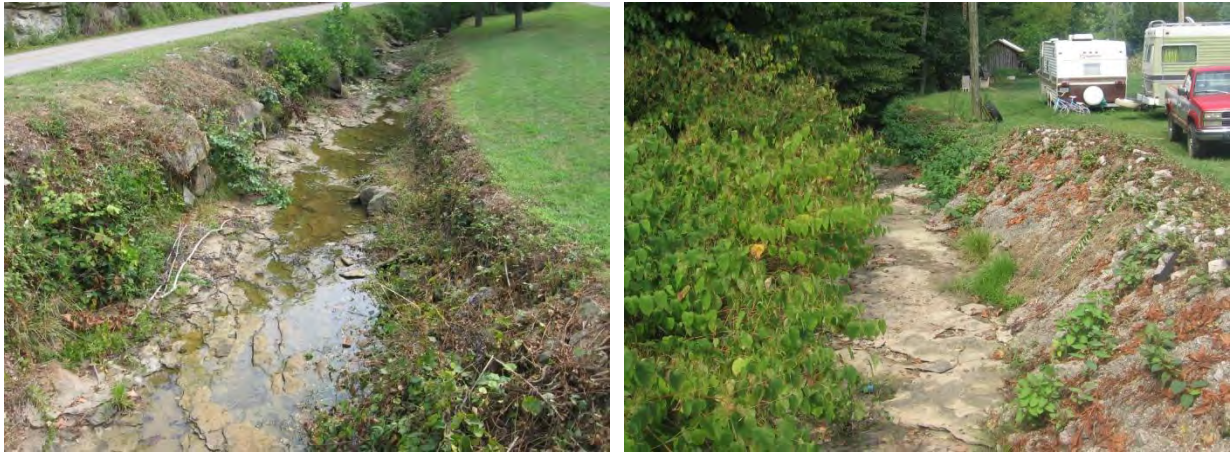
Figure 3.7. Examples of stream straightening and private bank armoring.

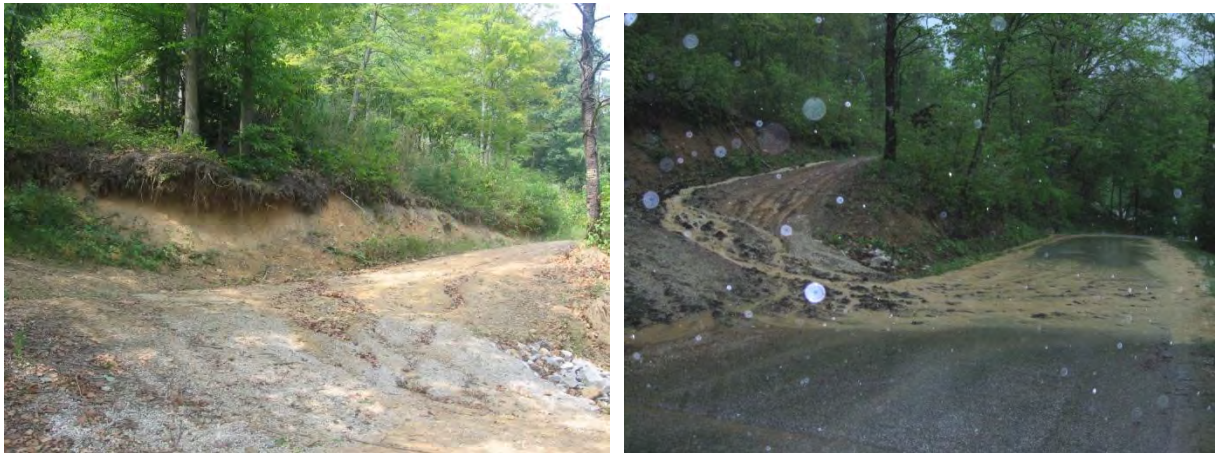
Figure 3.8. An example of poor land use. The photo on the left is a road cut into a hillside. Note the overhanging, eroded bank and gullied road. The photo on the right is the same site during moderate rainfall.

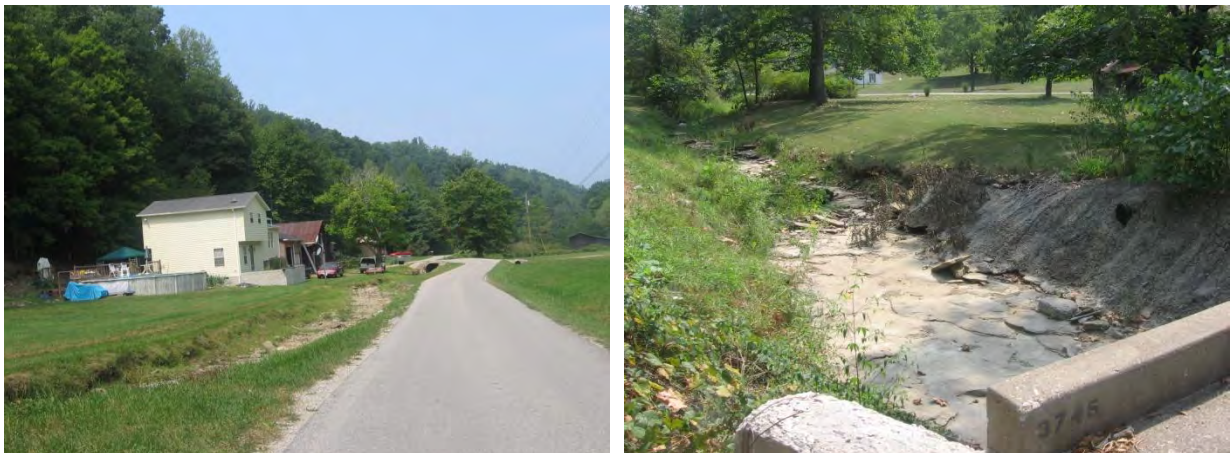
Figure 3.9. Removal of trees from riparian zones (left) and channelization/bank armoring (right).

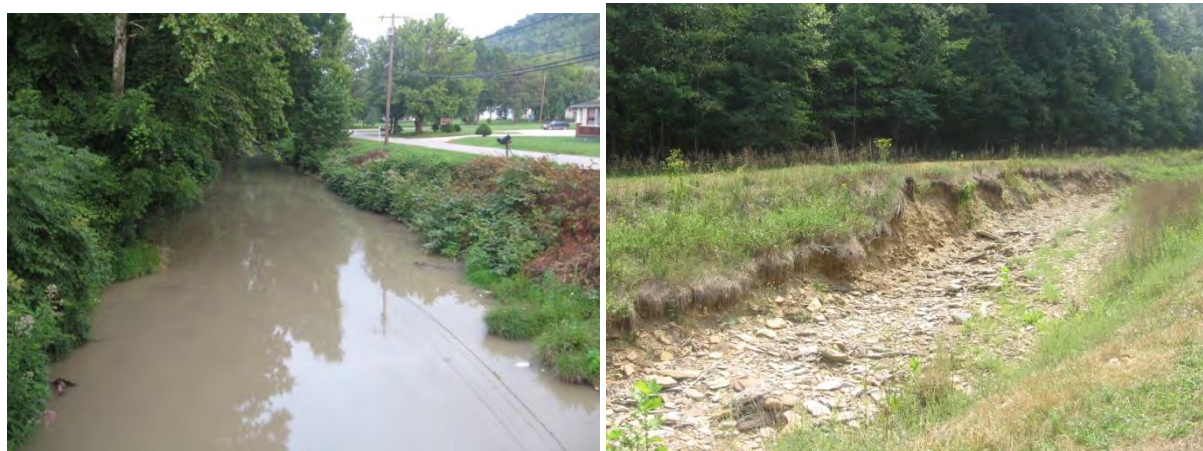
Figure 3.10. Photos of sites with best (DC-0.28, left) and worst habitat scores (SB-0.35, right).

Habitat quality varies widely throughout the watershed (Table 3.18). Riparian zones have been extensively altered. Trees have been removed from one side and, in many cases, both sides of streams. The best score for the sites investigated was 126 (DC-0.28, Figure 3.10) and the worst score was 51 (SB-0.35, Figure 3.9).

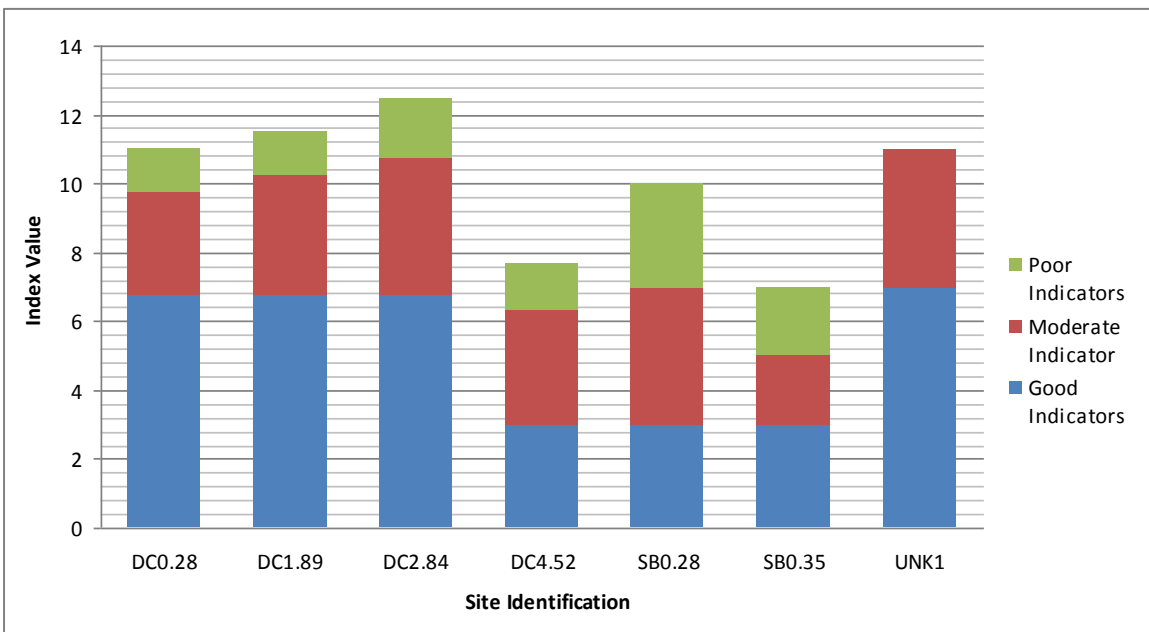
Figure 3.11. A summary by site of the average index value for each taxa group.

The good water quality indicator species increased in locations where water was present all year. A predominance of positive water quality indicators was present at UNKA. This site does not have houses upstream and is mostly wooded. At site SB-0.28, aquatic worms were often observed in large quantities, which accounts for the high amount of Group 3 (bad) indicators.

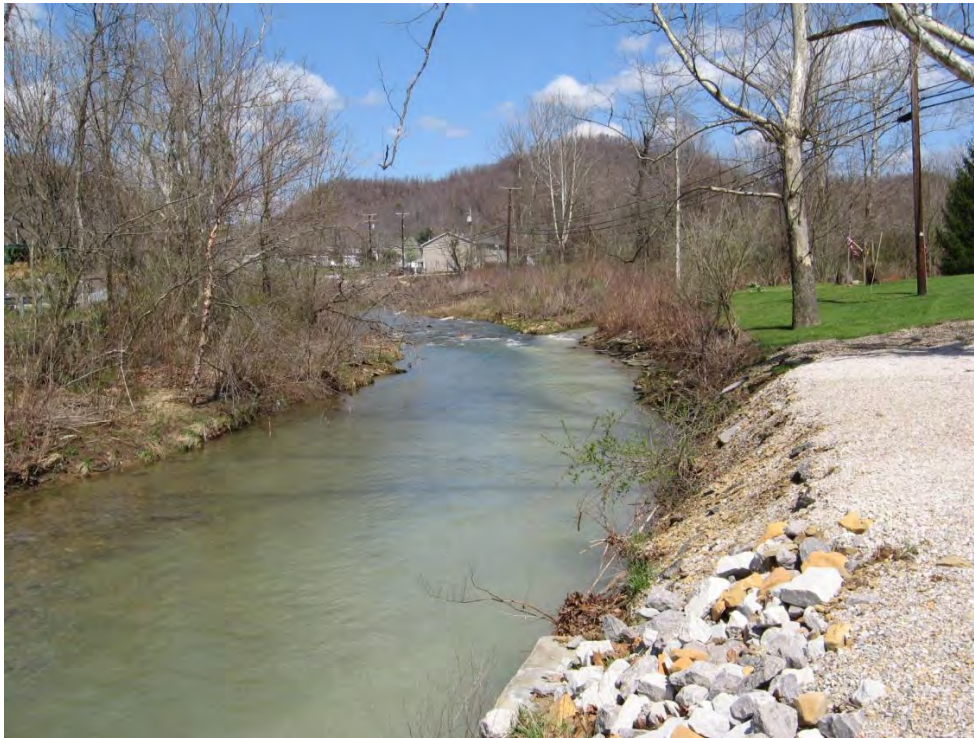
Figure 3.13: View of Morgan Fork and Dry Creek confluence looking upstream from near KY 519 bridge. Note high suspended sediment load (cloudy water) coming from Morgan Fork on the right side of Dry Creek.

Sediment influx into the lowest reaches of Dry Creek (near DC-0.28) during the monitoring period was extreme due to construction on KY 519. Extreme SSC and suspended sediment loads from Morgan Fork (Figure 3.13) dramatically affected data at DC-0.28 (Tables 3.13 and 3.14). The ultimate cause of the very high SSC, loads, and yields from Morgan Fork and the lowest reaches of Dry Creek were complete denudation of vegetative cover and the use of heavy machinery in and near the streams. But the problem was much worse than it should have been because contractors did not install erosion prevention and sediment controls during most of the construction project (Figure 3.14). A few erosion prevention and sediment controls appeared after a resident of the Dry Creek watershed complained to the local Kentucky Division of Water office.

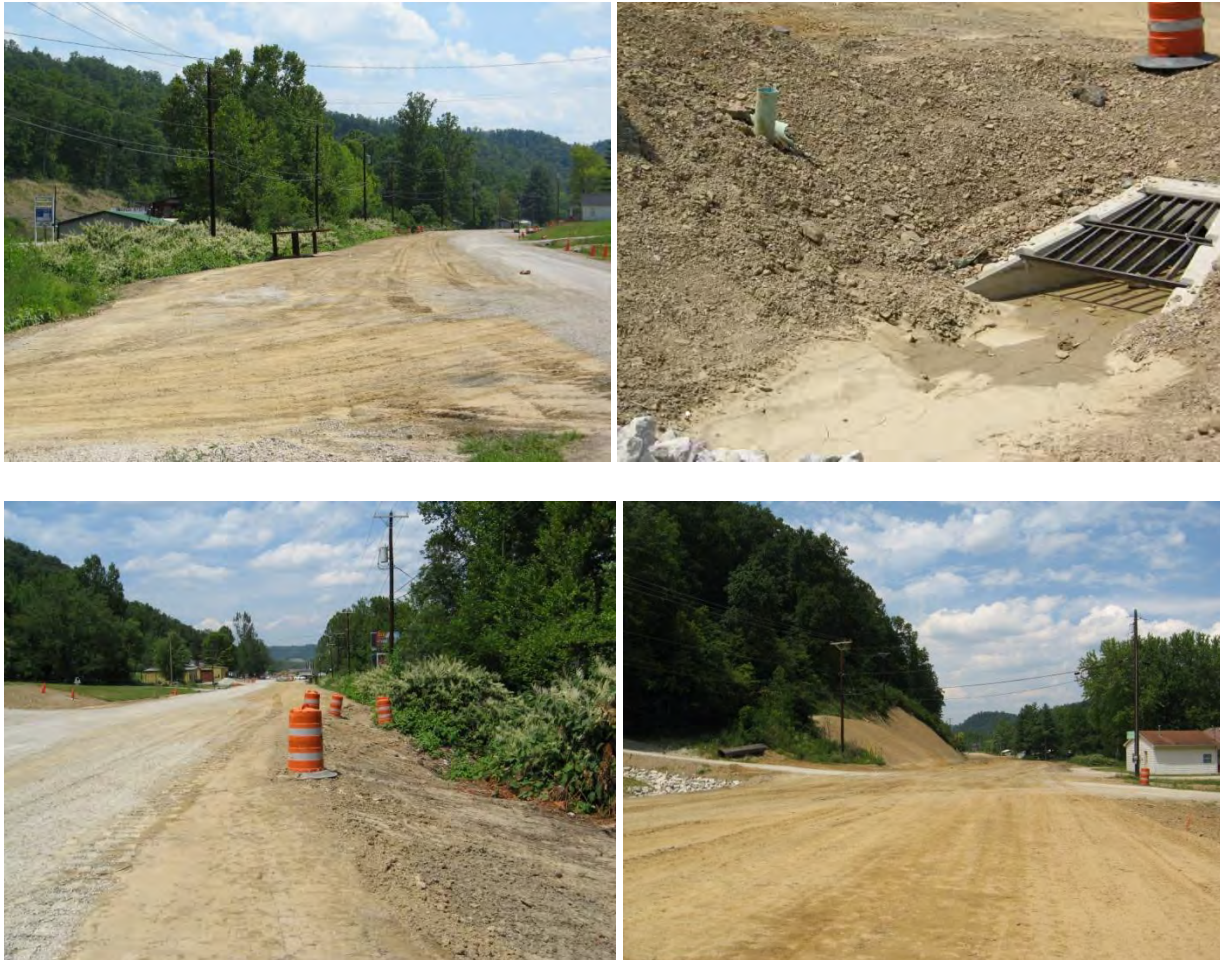
Figure 3.14: Sample of images taken during KY 519 construction, which show a complete absence of the erosion prevention and sediment controls required by state contracts.

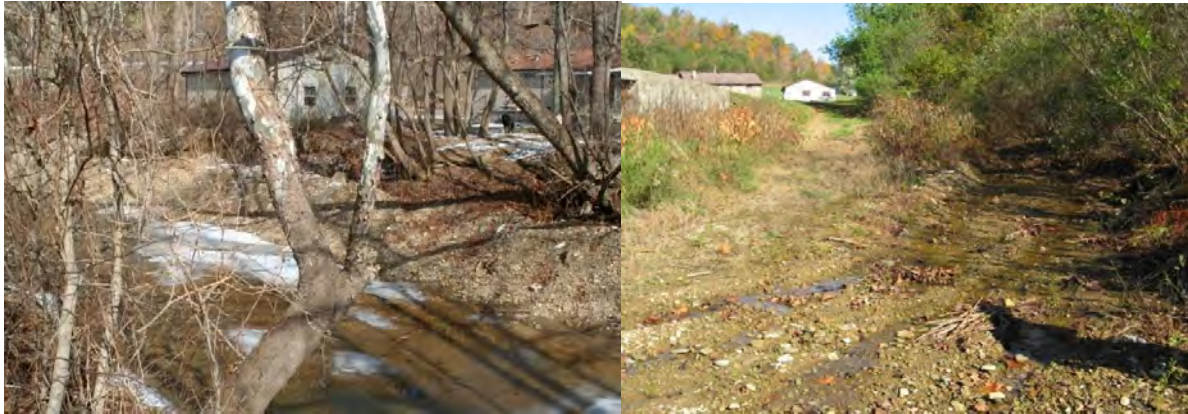
Figure 3.17: Gravel mining in Dry Creek. In left image, gravel has been scraped down to bedrock and piled against the bank as a form of armoring. Note leaning and curved trees caused by bank erosion and undercutting. Right image shows access road to streambed and obvious signs of gravel mining, including tire tracks leading from the streambed to this loading area.

Channel alteration and gravel mining have and probably will continue to cause a variety of problems in the watershed. Habitat destruction is obvious based on assessments conducted for this study. Complete removal of gravel bars near pools and riffles has eliminated spawning areas from many parts of Dry Creek. The rapid appearance of “new” gravel due to colluvium and bedrock erosion (Figures D2 and D3, Appendix C) virtually assures that disruptive gravel mining will continue. All of these practices tend to increase flow velocity and accelerate down-cutting and bank erosion. Channel entrenchment is likely to worsen in the future.

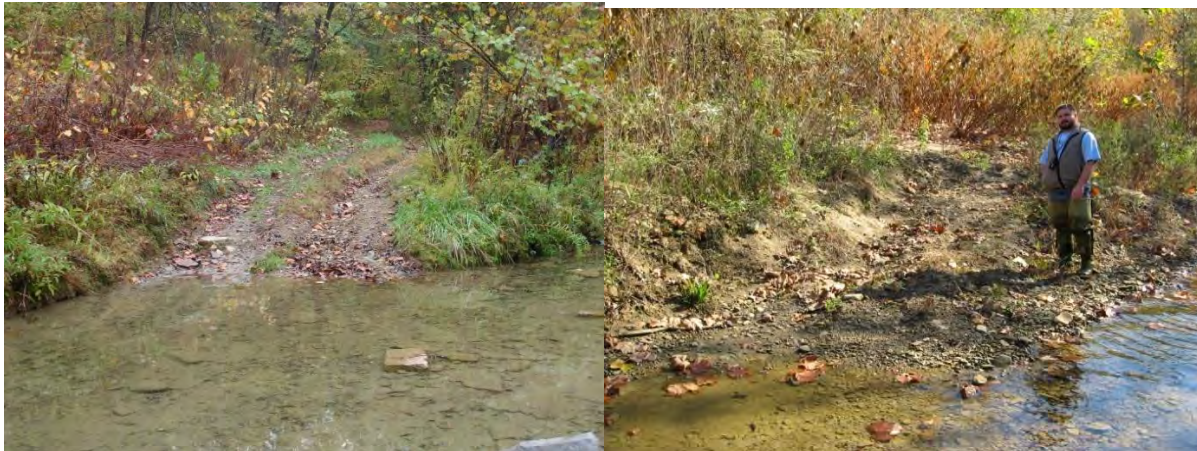
Figure 3.18: More unimproved access roads to Dry Creek streambed. Note fine-grained sediment deposited on the channel bottom, an example of impairment due to sedimentation/siltation. Most of the gravel has been removed in both images.

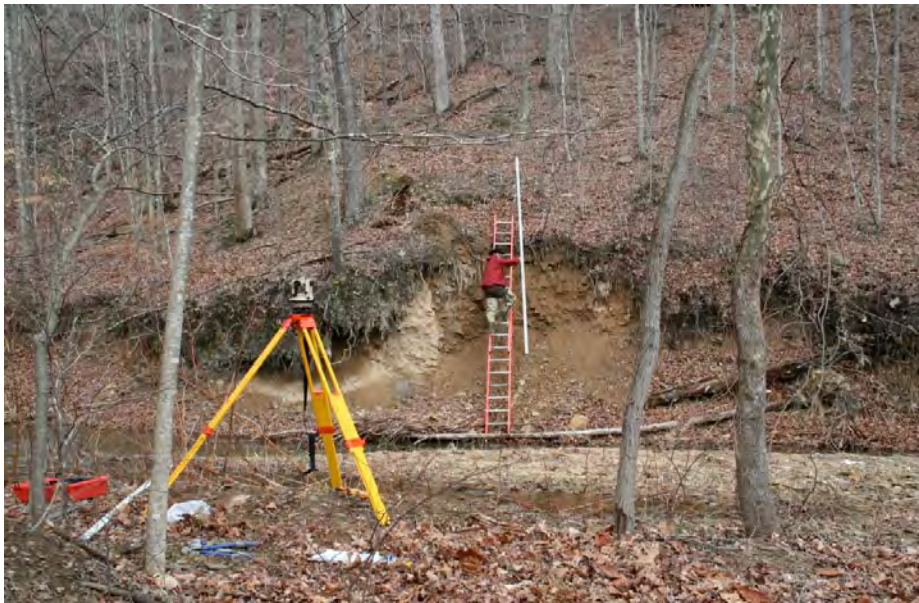
Figure D1: Monitored channel cross-section (SB-0.23a) within 170 ft reach just downstream of SB-0.23 where Sugar Branch erodes colluvium at the base of a steep slope.

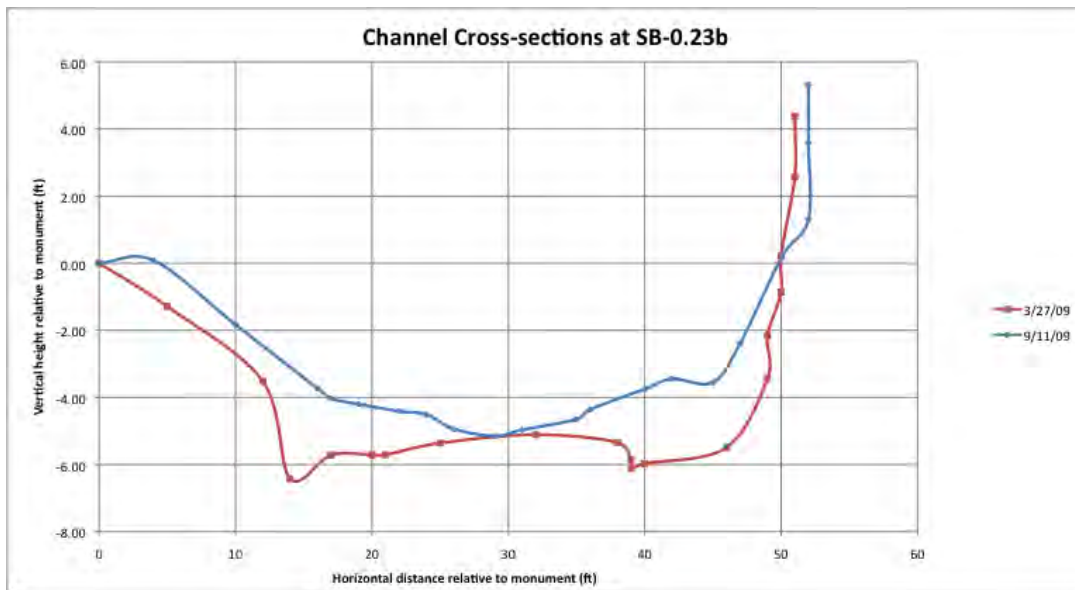
Figure D3: Comparison of same channel cross-section (43 feet downstream of SB-0.23a) measured on different dates. Upper half of right side shows lost material (blue line right of red line). The rest of the channel is covered in new gravel bars (blue line above red line).

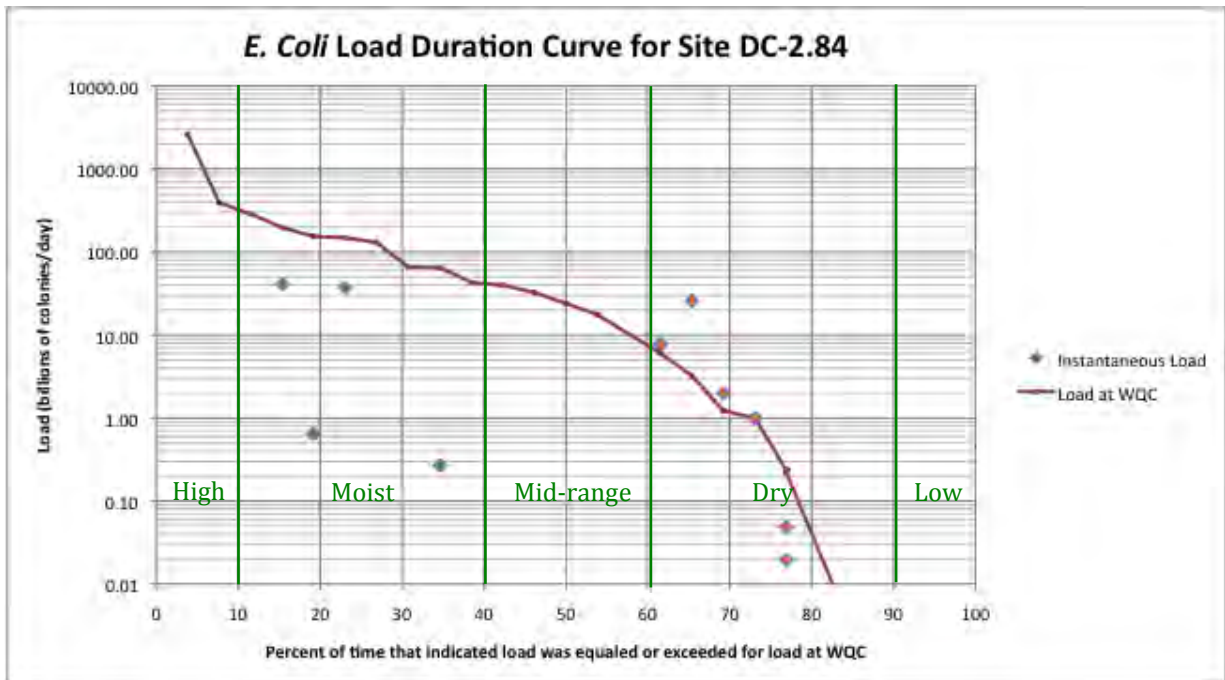
Figure D6: Load duration curve for DC-2.84 (bridge over Sugar Branch). Orange diamonds are instantaneous loads for samples collected during the recreation season.
