# Canoe Creek Watershed Health Report

Department for Environmental Protection - Division of Water

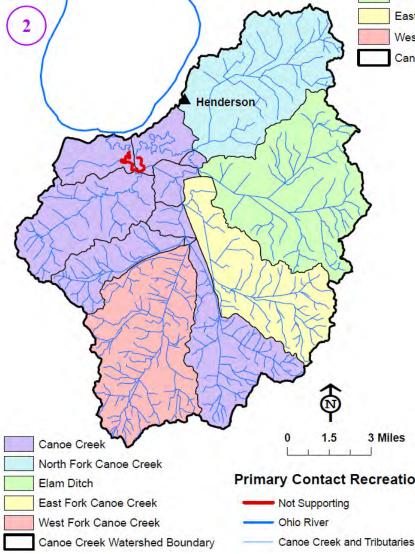
**Designated uses** for Canoe Creek Watershed are **Aquatic Habitat (map 1)** - water quality promotes a healthy population of plants and animals that live in the water and **Primary Contact Recreation (map 2)** - water is safe for human swimming. In the maps on this page, segments that have been assessed are highlighted in (1) orange if the water quality is fair and the use is only partially supported and (2) red if the water quality is poor and the use is not supported. If a segment is **blue**, its uses have not yet been assessed.

**Impaired** waters are those that are highlighted in orange or **red** since the **designated use** is not fully supported. In stream segments with impaired Aquatic Habitat, fish and aquatic bug communities have reduced numbers or types. Stream segments impaired for Primary Contact Recreation have bacteria concentrations that exceed the level considered safe for swimming at least 20 percent of the time from May through October.
