# Stoner Creek Watershed Health Report

Department for Environmental Protection - Division of Water

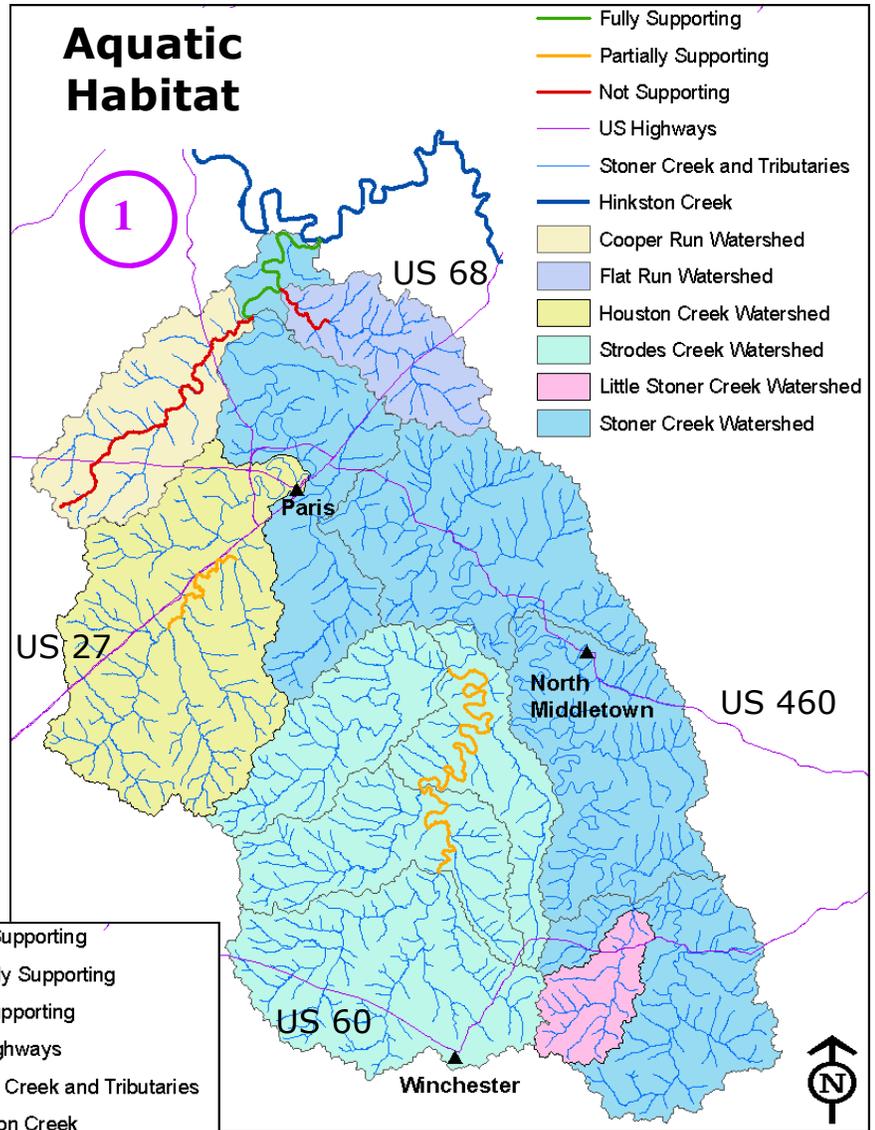
## Aquatic Habitat

**Designated Uses** for Stoner Creek Watershed are **Aquatic Habitat (map 1)** - water quality promotes a healthy population of plants and animals that live in the water and **Primary Contact Recreation (map 2)** - water is safe for human swimming. In the maps on this page, segments that have been assessed are highlighted in **(1) green** if the water quality is good and the use is supported, **(2) orange** if the water quality is fair and the use is only partially supported and **(3) red** if the water quality is poor and the use is not supported. If a segment is blue, its uses have not yet been assessed.

**Impaired** waters are those that are highlighted in **orange** or **red** since the **designated use** is not fully supported. To be impaired for Aquatic Habitat, the fish and aquatic bug populations have reduced numbers or types. To be impaired for Primary Contact Recreation, bacteria concentrations exceeded the level considered safe for swimming at least 20 percent of the time from May through October.

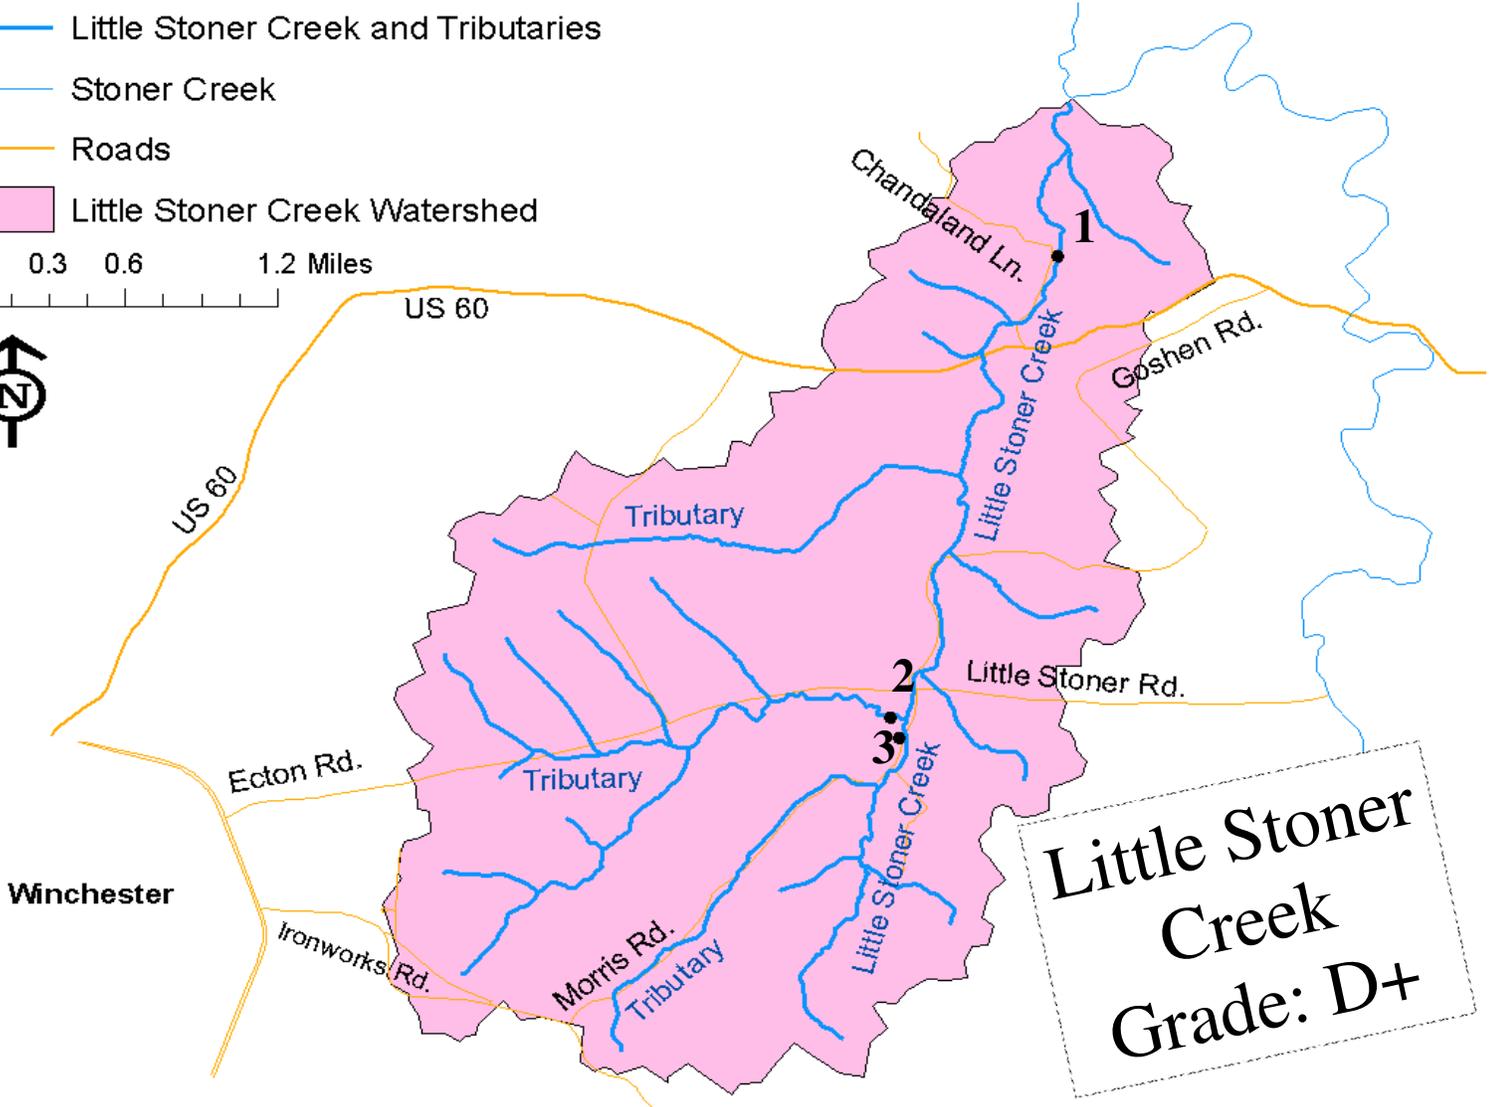
Little Stoner Creek Watershed

Site Grade
1	Little Stoner Creek	D+	C		F					D
2	Tributary to Little Stoner Creek	D	B		D					C-
3	Little Stoner Creek	C+	C		F					D+
	<b>Sign Grade</b>	<b>C-</b>	<b>C+</b>		<b>F+</b>

At site 2, specific conductivity received a B, the best grade received. Along this tributary, there are fewer dissolved solids in the water, which contributes to good water quality.

DO and specific conductivity levels were outside their optimal ranges, which could negatively impact fish and aquatic bug communities.

*E. coli* levels were above the standard considered safe for swimming 80 to 100% of the time if the grade was an F, or 60 to 80% of the time if the grade was a D.

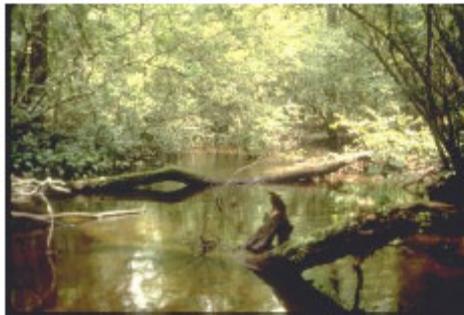
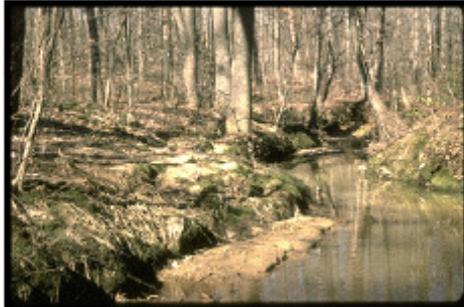
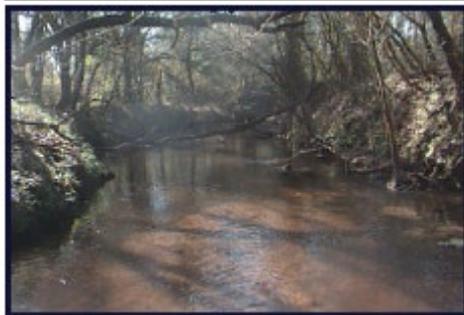
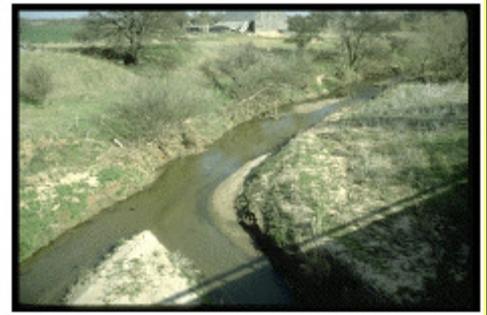
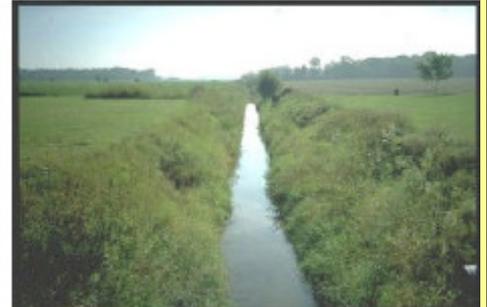
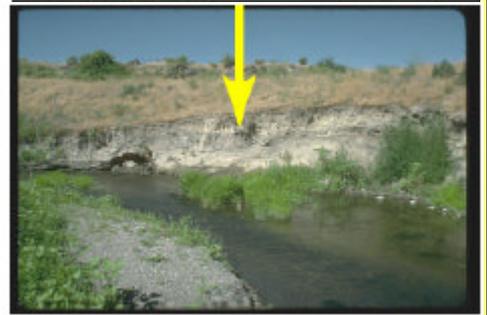
## Habitat 101 Corner

- Compare the amount of instream material for aquatic bugs and fish to utilize for colonization, hiding and feeding.
- Compare the amount of food sources.
- Compare the amount of stream shading.
- Compare the number of stream bends, which slow water and reduce its energy, thereby reducing flood potential.
- Compare the stability of the banks.
- Compare the potential for sediment from the banks to erode when vegetative protection is lacking.

\*Photos from Barbour et al. 1999

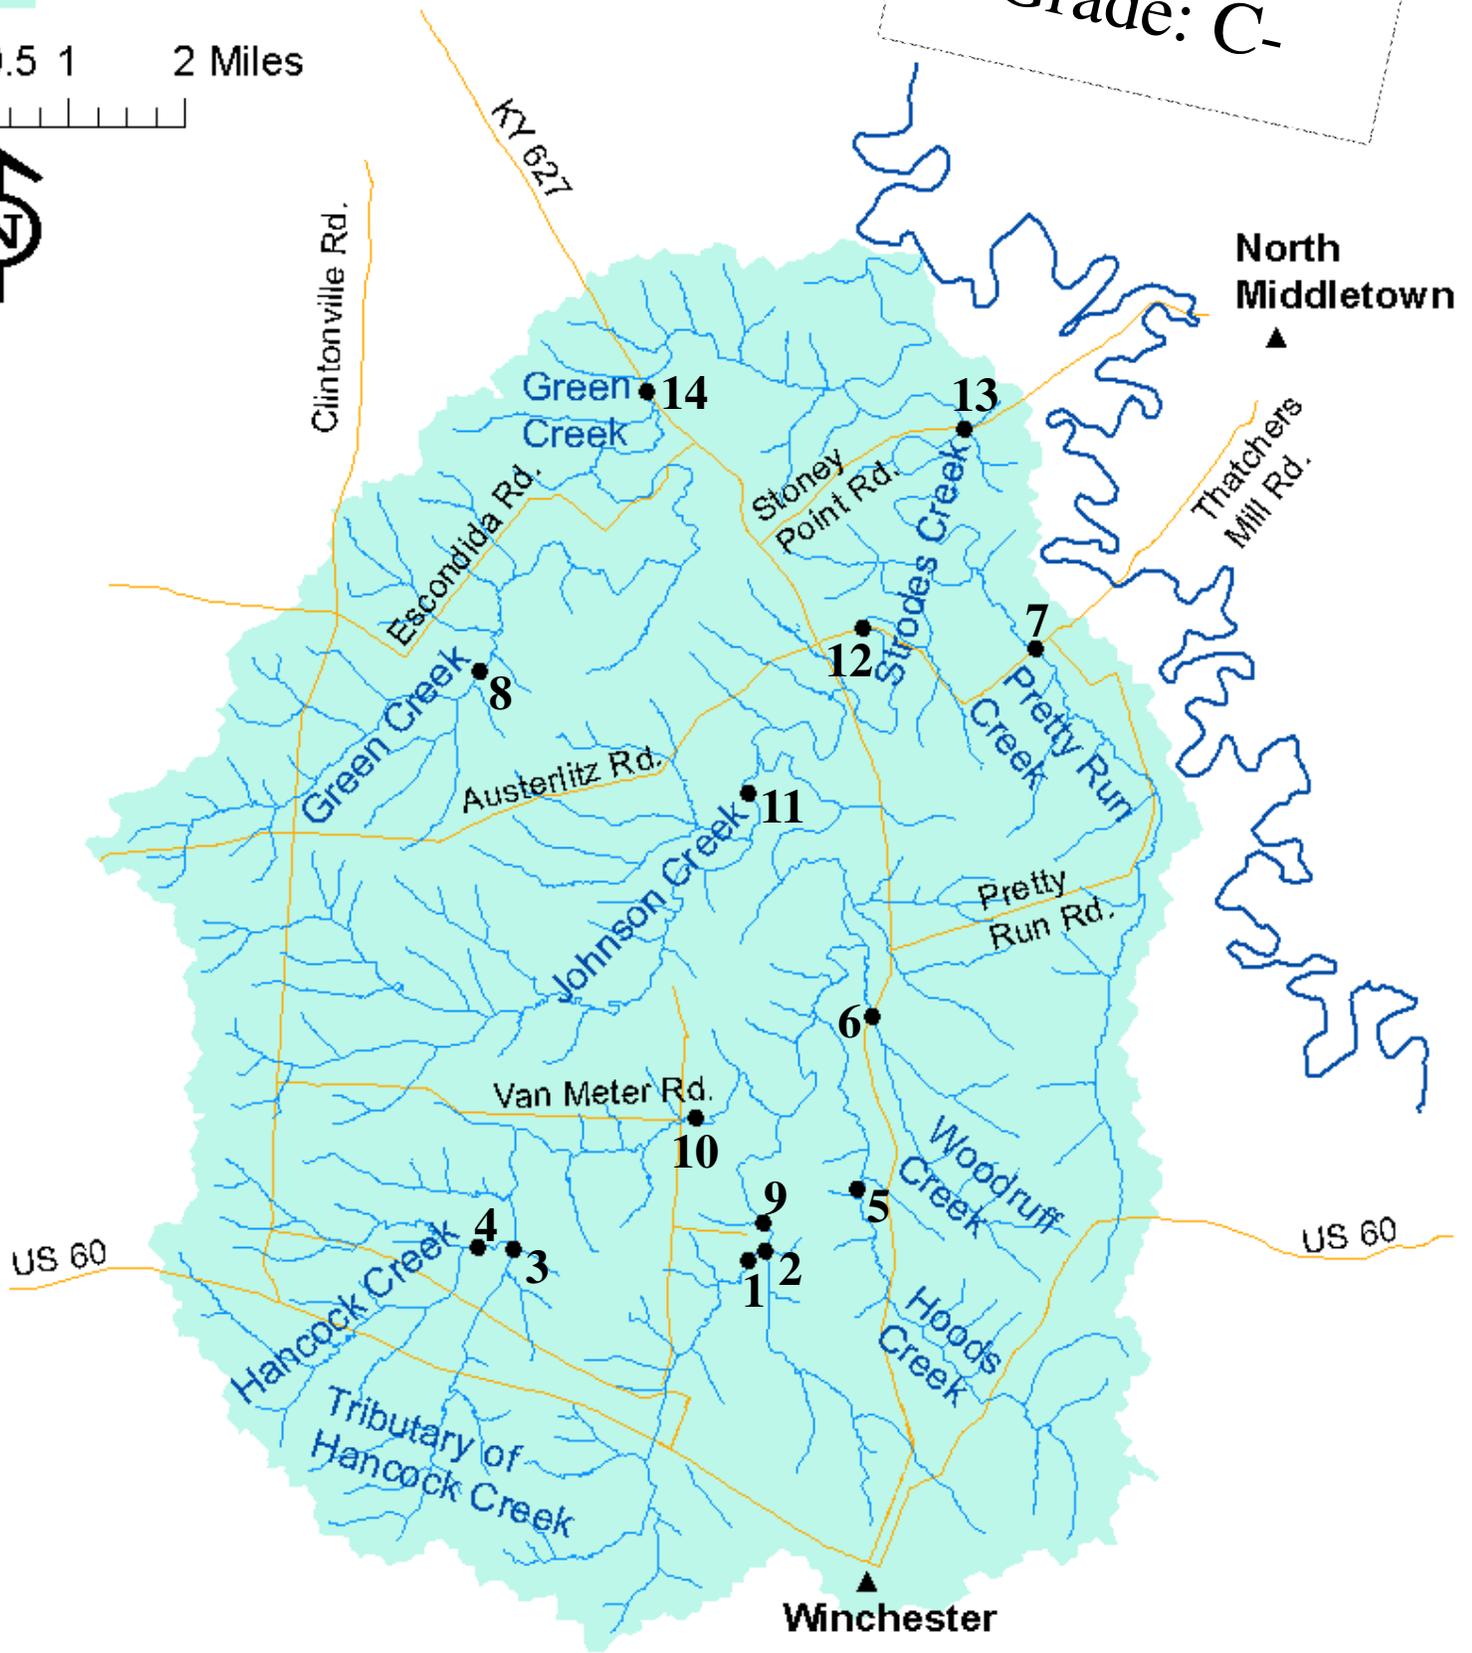
Strodes Creek Watershed

DO levels, for the most part, were suitable for fish and bugs. Lower DO grades at a few sites (2, 6, 7, 12, 13, and 14) probably resulted from over growth of algae that occurs when loss of tree cover reduces stream shading and nutrients runoff into streams.

For the most part, nitrogen and phosphorous levels were reasonable but rose following rain events due to pollution entering the stream with runoff, failing septic systems or wastewater treatment bypasses.

Similarly, TSS levels rose following rain events due to a lack of vegetation and streamside grazing, which destabilizes stream banks, and development, which exposes sediment that can then be washed away.

Specific conductivity levels were outside their optimal ranges, which could negatively impact fish and bug communities since dissolved solids can interfere with normal behavior.

Bug communities averaged a C- throughout the Strodes Creek Watershed. A combination of increased nutrients, specific conductivity and TSS levels with reduced habitat, riparian zones and available cover is negatively impacting bug communities of Strodes Creek.

Available cover is greatly reduced throughout the watershed. Not only is available cover an important place for fish and bugs to live, feed, hide from predators and mate, it also provides habitat for beneficial bacteria, which are eaten by the bugs that are then eaten by the fish.

The width of the riparian zone was usually less than 6 yards. When trees are cut and banks are cleared algal communities bloom and water temperatures increase due to a lack of shade, banks become less stable, which increases erosion, and habitat for fish and bugs is reduced.

Habitat, which provides the building blocks for diverse groups of fish and bugs, was almost entirely absent, with every site receiving an F except for site 13, which received an A and was one of the best sites within the watershed.

Strodes Creek  
 Grade: C-

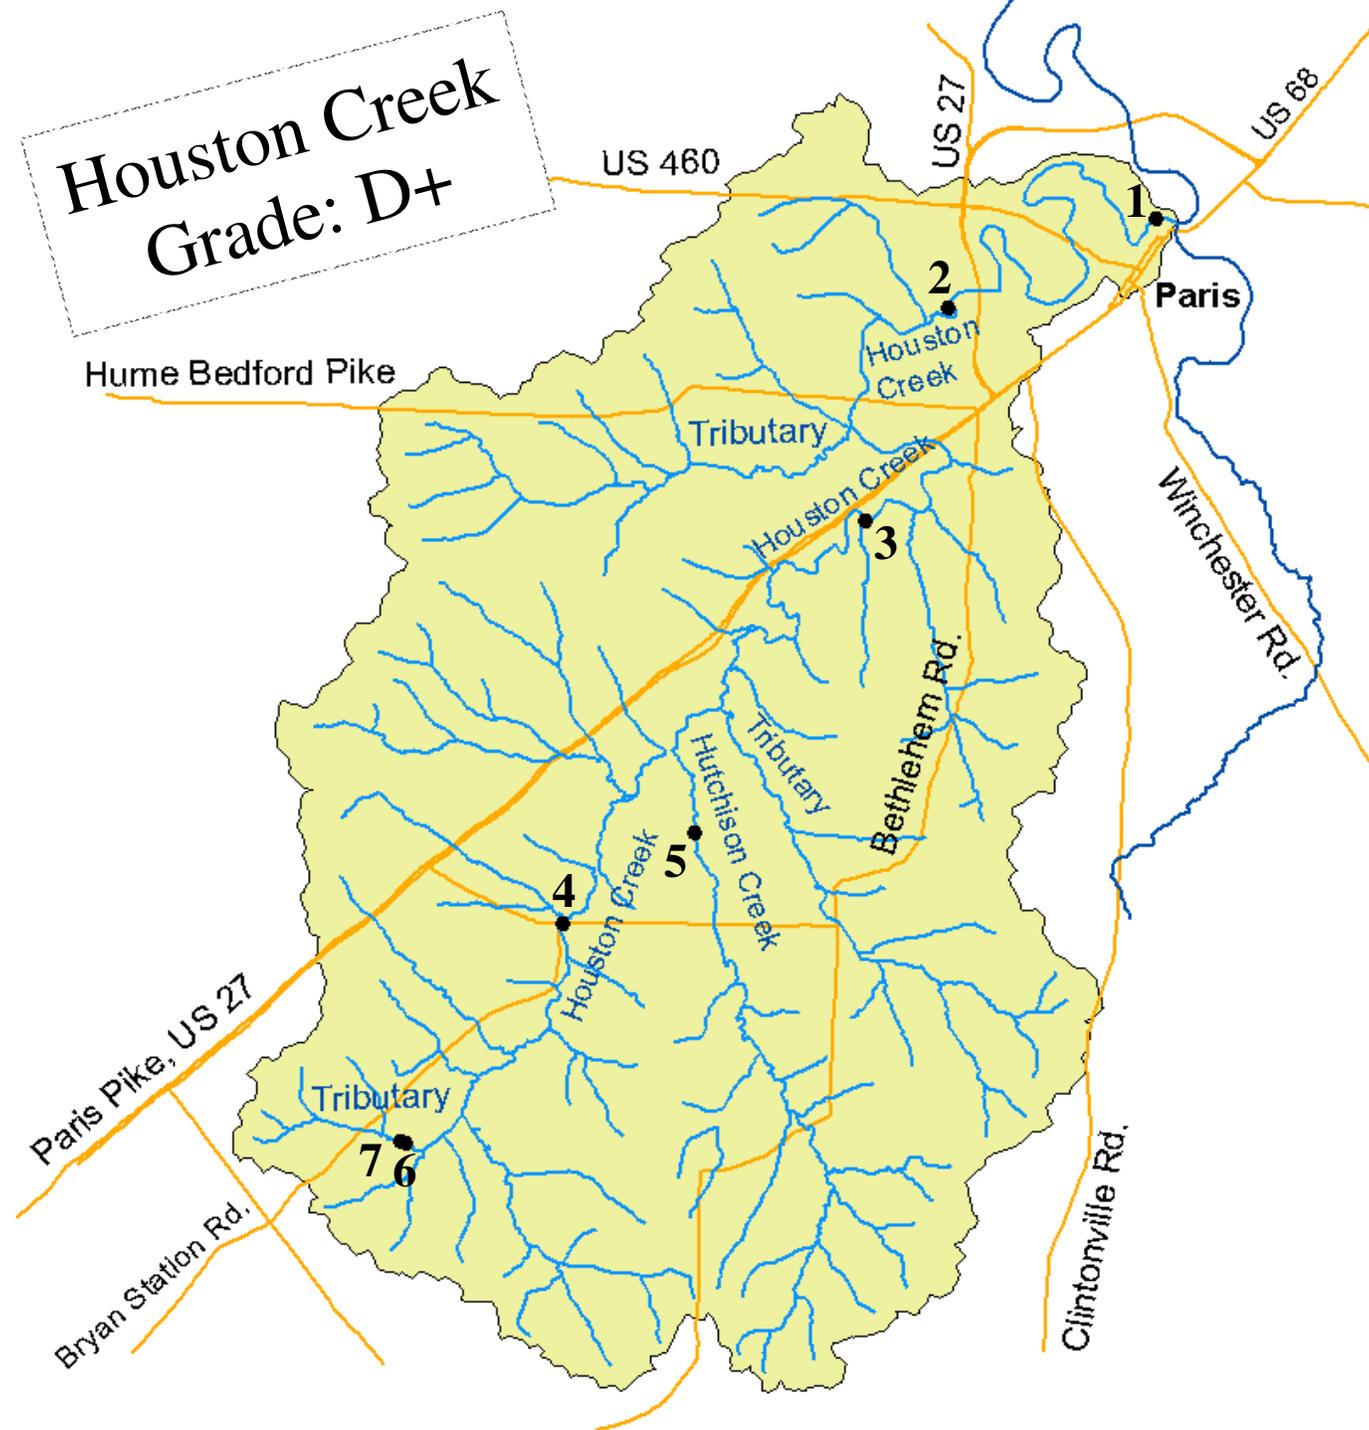
Houston Creek Watershed

Specific conductivity was fairly good, indicating reasonably low dissolved solids throughout Houston Creek. However, a few sites (1, 2, and 6) had elevated levels of specific conductivity, indicating some type of discharge is increasing the dissolved solid content.

For the most part, nitrogen and phosphorous levels were reasonable but rose following rain events due to pollution entering the stream with runoff or failing septic systems.

Similarly, TSS levels rose following rain events due to a lack of vegetation and streamside grazing, which destabilizes stream banks, and development, which exposes sediment that can then be washed away.

*E. coli* levels were above the standard considered safe for swimming 80 to 100% of the time if the grade was an F or 60 to 80% of the time if the grade was a D.

Available cover is greatly reduced throughout the watershed. Not only is available cover an important place for fish and bugs to live, feed, hide from predators and mate, it also provides habitat for beneficial bacteria, which are eaten by the bugs that are then eaten by the fish.

The width of the riparian zone was less than 6 yards if the site received an F or between 6 and 12 yards if the site received a D. When trees are cut and banks are cleared algal communities bloom and water temperatures increase due to a lack of shade, banks become less stable, which increases erosion, and habitat for fish and bugs is reduced.

Habitat, which provides the building blocks for diverse groups of fish and bugs, was almost entirely absent. All sites received Ds and Fs in the Houston Creek Watershed.

Consequently, the bug communities were also poor throughout the watershed, receiving one C and three Ds. Without bugs to eat, many fish will leave the stream in search of food elsewhere.

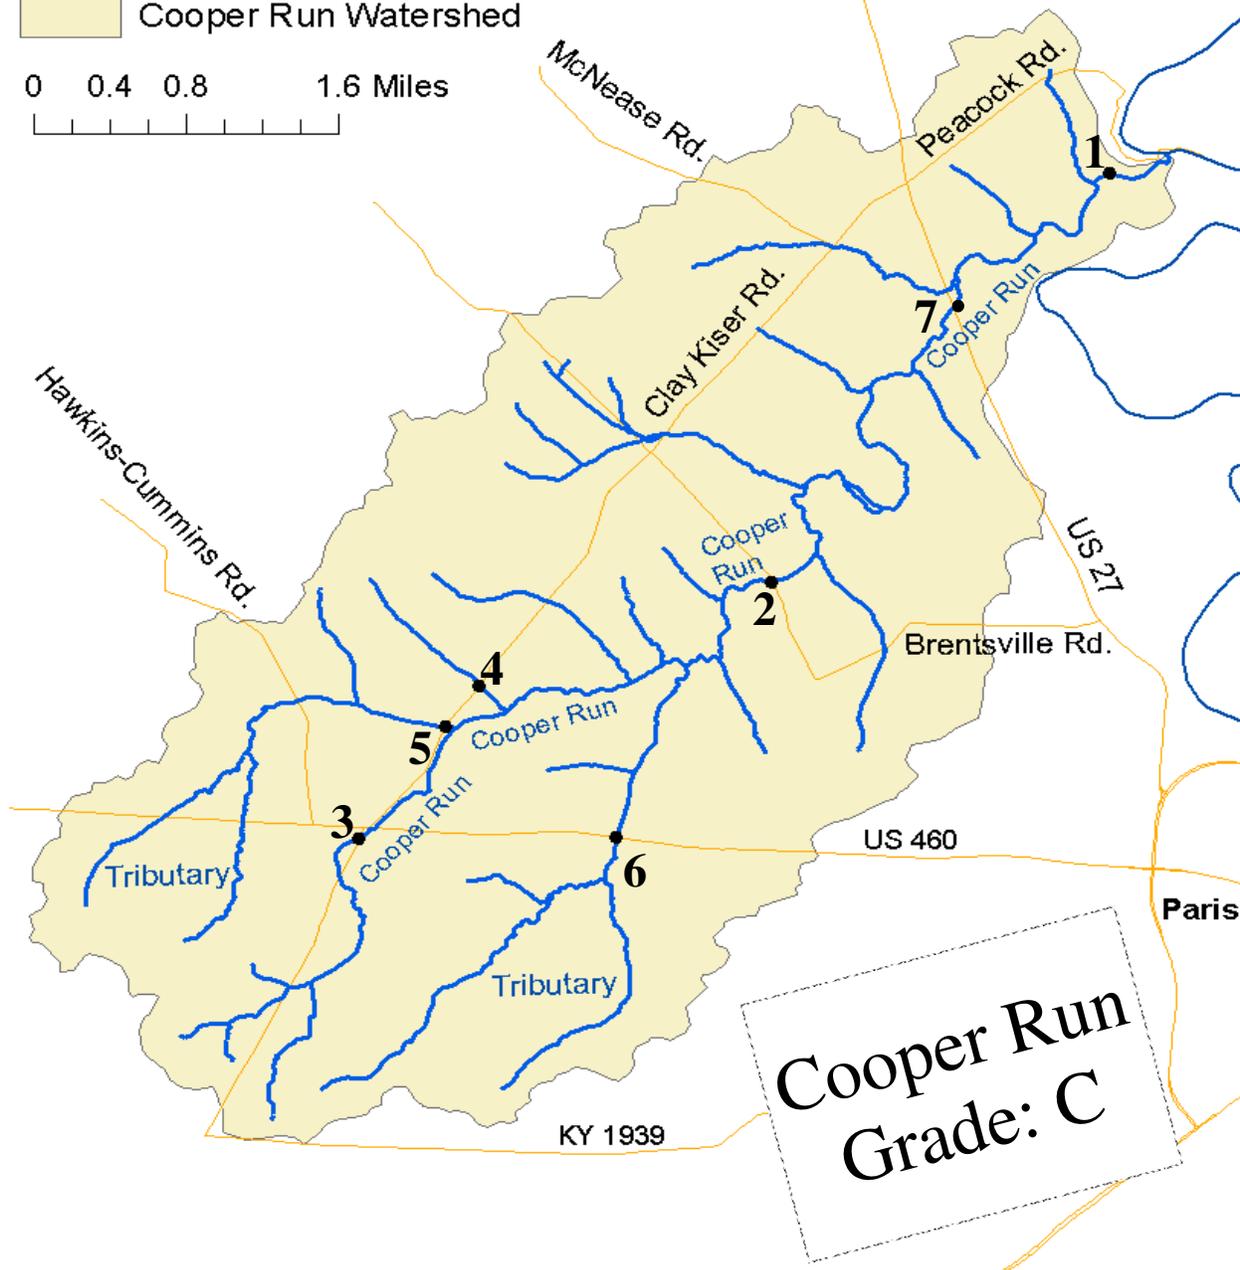
Specific conductivity was fairly good, indicating reasonably low dissolved solids throughout Cooper Run. However, a couple sites (3 and 5) had elevated levels of specific conductivity, indicating poor land management.

TSS levels were lower in the Cooper Run Watershed when compared to other tributaries of Stoner Creek, although higher levels were present at sites 2 and 5.

For the most part, nitrogen and phosphorous levels were reasonable but rose following rain events due to pollution entering the stream with runoff or failing septic systems.

DO levels at sites 1, 3 and 7 were suitable for fish and aquatic bugs. At the remaining sites, oxygen levels were less stable, indicating that an overgrowth of algae is causing extreme highs and lows in DO levels.

Habitat was only measured at sites 1, 5 and 7 where they received a B, F and A. Habitat changed quickly in the Cooper Run Watershed. Sometimes it was suitable, while other times it was lacking or absent. The available cover and bug grades reflect these shifting levels of habitat, indicating the importance of habitat in biological health.

As discussed above, available cover followed the same pattern as habitat. Available cover is especially important because it provides habitat for beneficial bacteria, which are eaten by the bugs that are then eaten by the fish.

Aquatic bugs were only identified at sites 1 and 5 where they received a B and C. Degraded water quality and shifting habitat probably account for these mid-level grades.

*E. coli* levels were above the standard considered safe for swimming 80 to 100% of the time if the grade was an F or 60 to 80% of the time if the grade was a D.

The width of the riparian zone was less than half of what is considered ideal. When trees are cut and banks are cleared algal communities bloom and water temperatures increase due to a lack of shade, banks become less stable, which increases erosion, and habitat for fish and bugs is reduced.

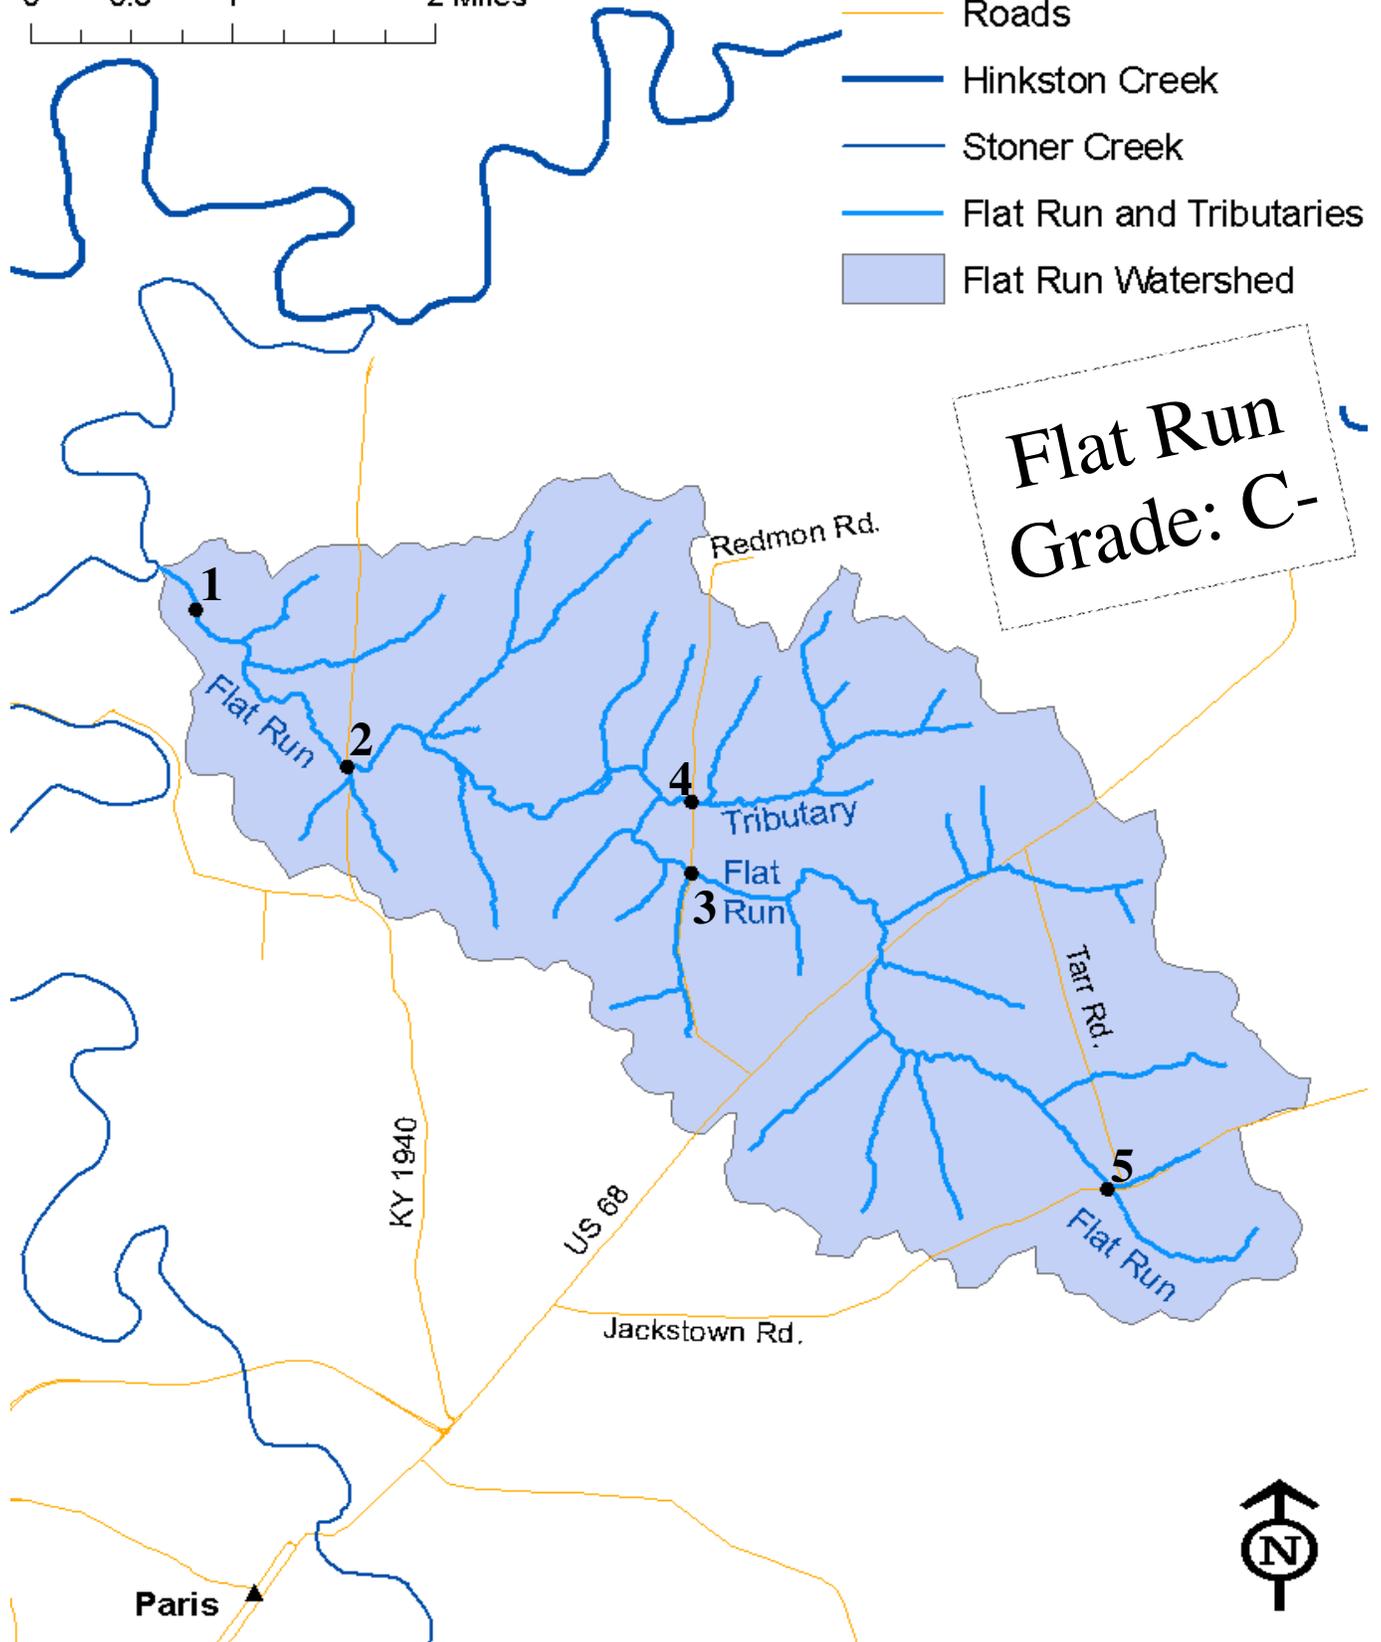
- Roads
- Hinkston Creek
- Stoner Creek
- Flat Run and Tributaries
- Flat Run Watershed

DO levels, for the most part, were suitable for fish and bugs. Lower DO grades at a few sites probably resulted from over growth of algae that occurs when loss of tree cover reduces stream shading and nutrients runoff into streams.

Specific conductivity was fairly good, indicating reasonably low dissolved solids throughout Flat Creek. However, a few sites (4 and 5) had elevated levels of specific conductivity, indicating poor land management.

For the most part, nitrogen and phosphorous levels were reasonable but rose following rain events due to pollution entering the stream with runoff or failing septic systems.

Similarly, TSS levels rose following rain events due to a lack of vegetation and streamside grazing, which destabilizes stream banks, and development, which exposes sediment that can then be washed away.

Bug communities averaged a C- throughout the Flat Run Watershed. A combination of increased nutrients and TSS levels with reduced habitat, riparian zones, and available cover is negatively impacting bug communities of Flat Run.

*E. coli* levels were above the standard considered safe for swimming 80 to 100% of the time if the grade was an F or 60 to 80% of the time if the grade was a D.

Available cover is greatly reduced throughout the watershed. Not only is available cover an important place for fish and bugs to live, feed, hide from predators and mate, it also provides habitat for beneficial bacteria, which are eaten by the bugs that are then eaten by the fish.

Habitat, which provides the building blocks for diverse groups of fish and bugs, was entirely absent; every site within the Flat Run Watershed received an F.

The riparian zone was also entirely absent within the Flat Run Watershed; every site received an F. When trees are cut and banks are cleared algal communities bloom and water temperatures increase due to a lack of shade, banks become less stable, which increases erosion, and habitat for fish and bugs is reduced.

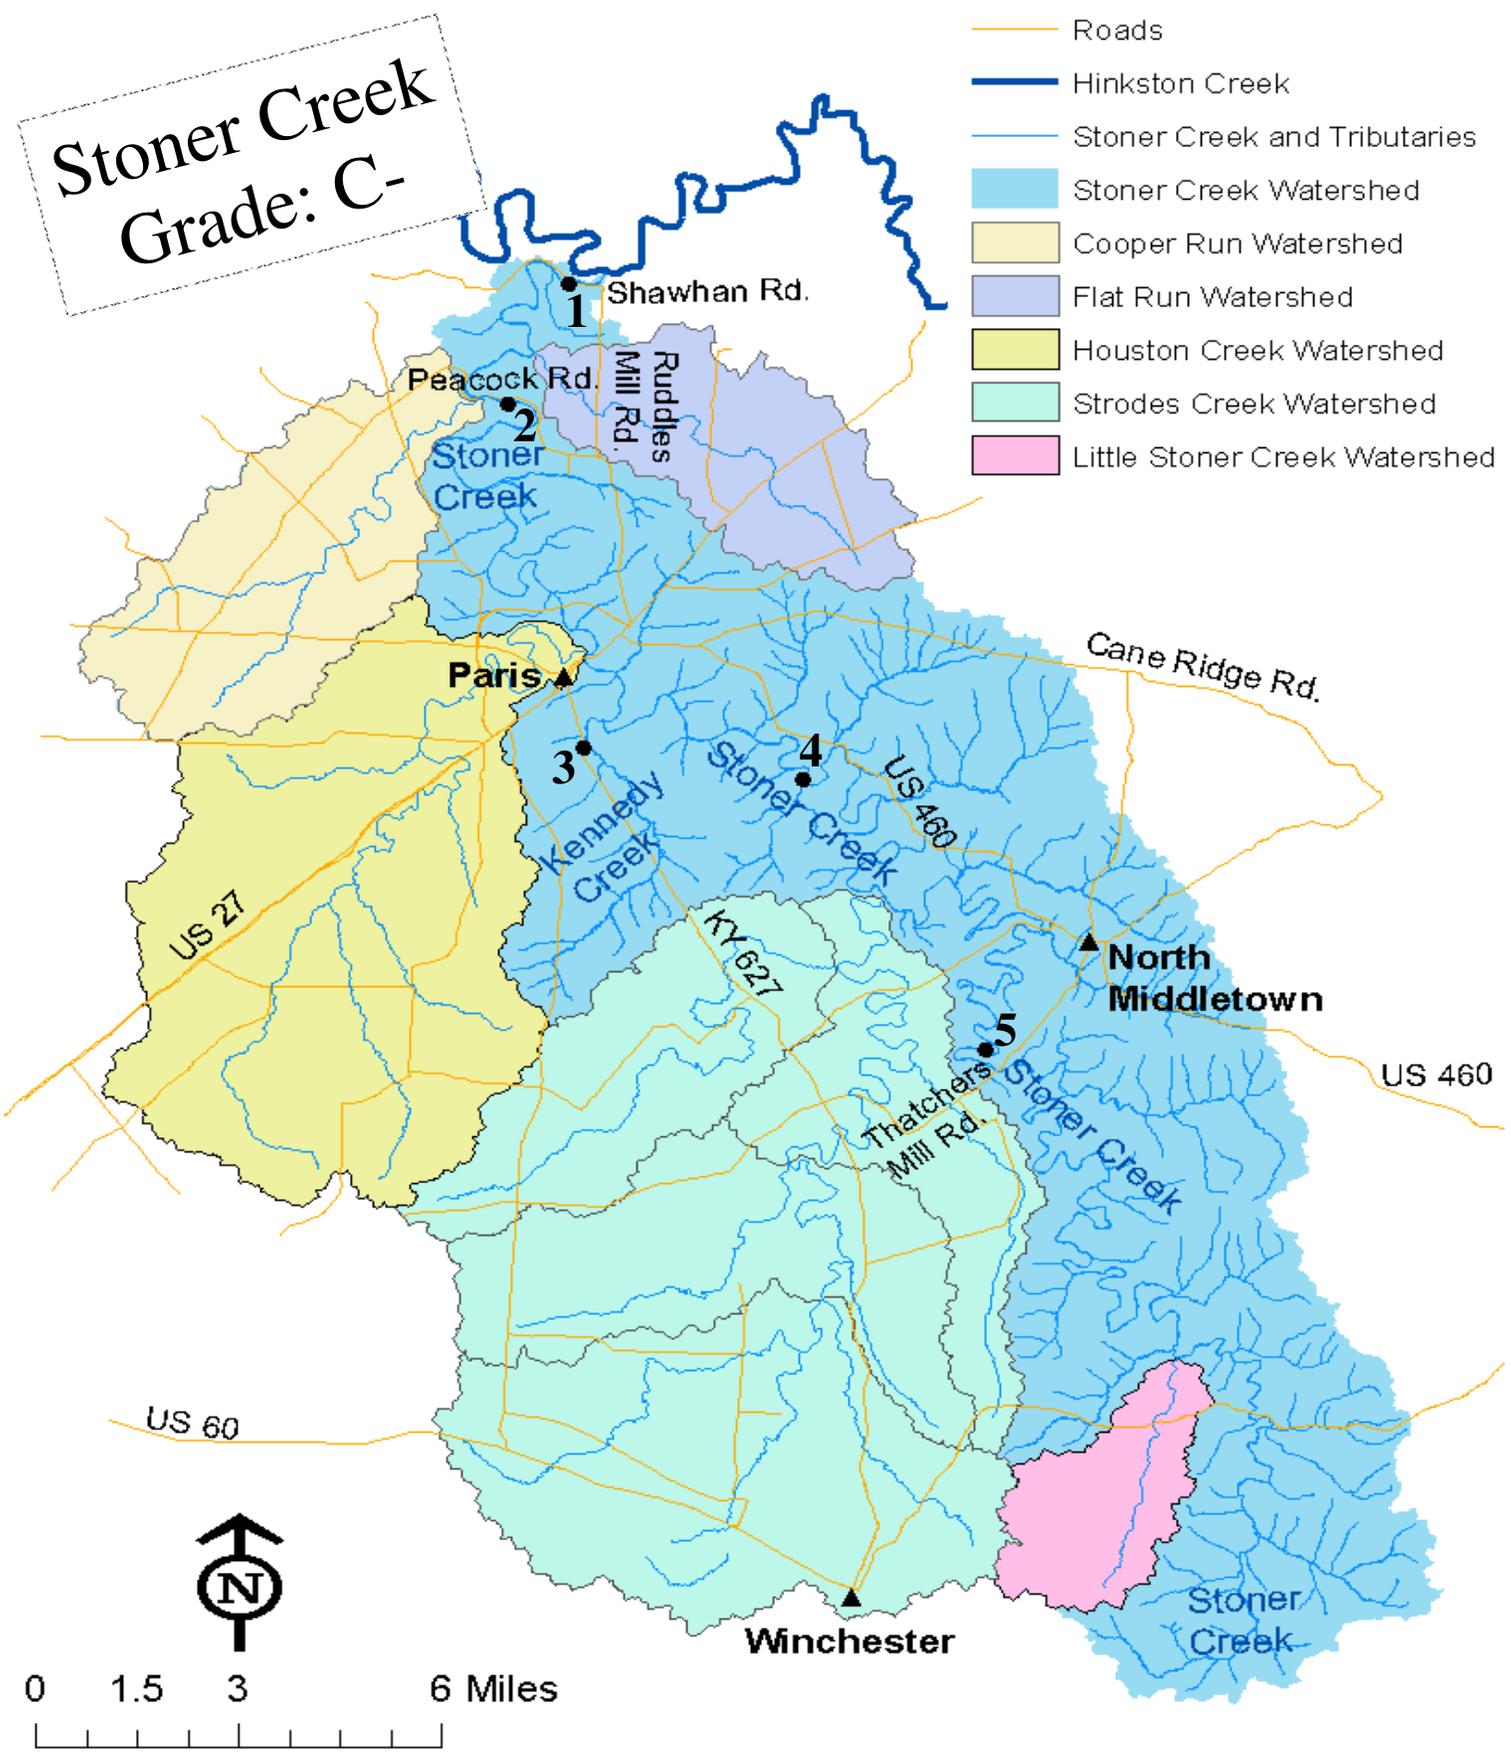
Specific conductivity was fairly good, indicating reasonably low dissolved solids throughout Stoner Creek. However, a few sites (2 and 4) had elevated levels of specific conductivity, indicating some type of discharge or poor land management is increasing the dissolved solid content.

*E. coli* levels were lower in the Stoner Creek Watershed when compared to its tributaries, although higher levels were present at site 5. *E. coli* levels were above the standard considered safe for swimming 40 to 60% of the time if the grade was a C or 20 to 40% of the time if the grade was a B.

DO levels were consistently at the C grade level throughout the Stoner Creek Watershed. These suboptimal oxygen levels have the potential to negatively affect fish and aquatic bugs.

Aquatic bugs were only collected at Site 1, where they received a B. Site 1 also received the highest site, habitat and riparian zone grades in the watershed. Therefore, it is likely that the aquatic bug communities at the other sites, which had lower site, habitat and riparian zone grades would have also had lower aquatic bug grades.

Habitat, which provides the building blocks for diverse groups of fish and bugs, was almost entirely absent. All sites received an F except for site 1, which received a C.

The extent of the riparian zone shifted throughout the Stoner Creek Watershed, receiving grades B through F. On average, the riparian zone was between 6 and 12 yards wide, equating to a D+. When trees are cut and banks are cleared algal communities bloom and water temperatures increase due to a lack of shade, banks become less stable, which increases erosion, and habitat for fish and bugs is reduced.

Available cover is greatly reduced throughout the Stoner Creek Watershed. Not only is available cover an important place for fish and bugs to live, feed, hide from predators and mate, it also provides habitat for beneficial bacteria, which are eaten by the bugs that are then eaten by the fish.
