FACT SHEET: DREDGING

Kentucky Division of Water

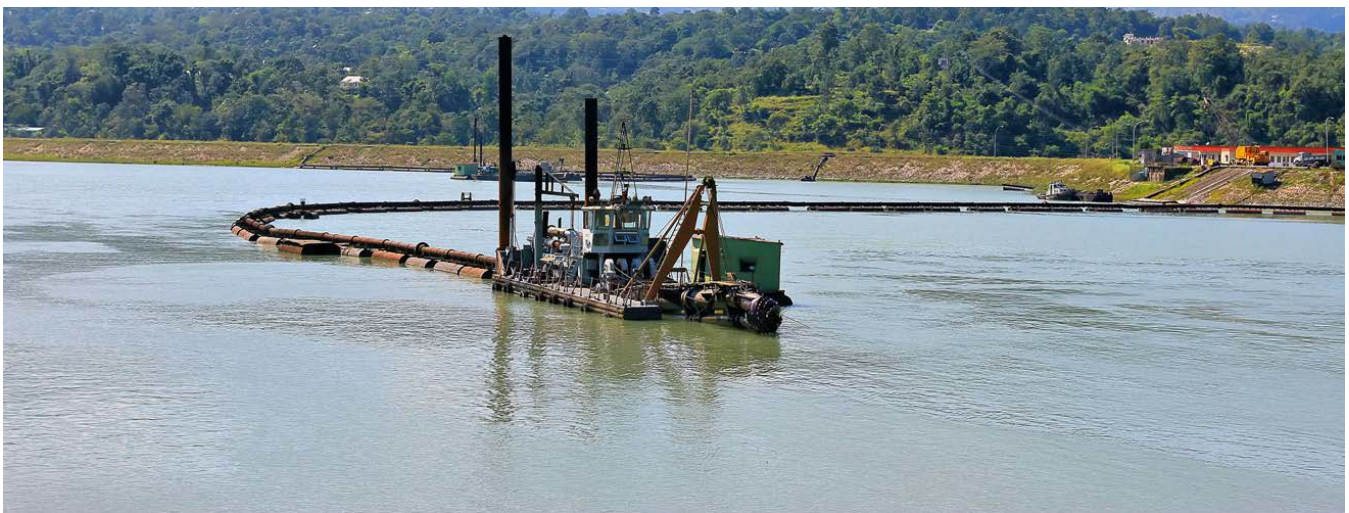
DREDGING AND EROSION:

Dredging is a deepening and straightening of a waterway, allowing water to move at a higher volume and speed. This effect increases the farther downstream you go and your waterway increases in size.

High water speeds lead to bank and bottom scouring, increasing erosion rates in streams. While erosion is a natural process, the increased flows and destabilization of the creek-bed by dredging may actually speed the process up and lead to significant property damage.
