**Channel Restoration and Riparian  
Reforestation Along Wilson Creek:  
A Demonstration Site**

**Section 319(h) Nonpoint Source Project Final Report**

**Submitted by:  
Bernheim Arboretum and Research Forest**

**October 2007**

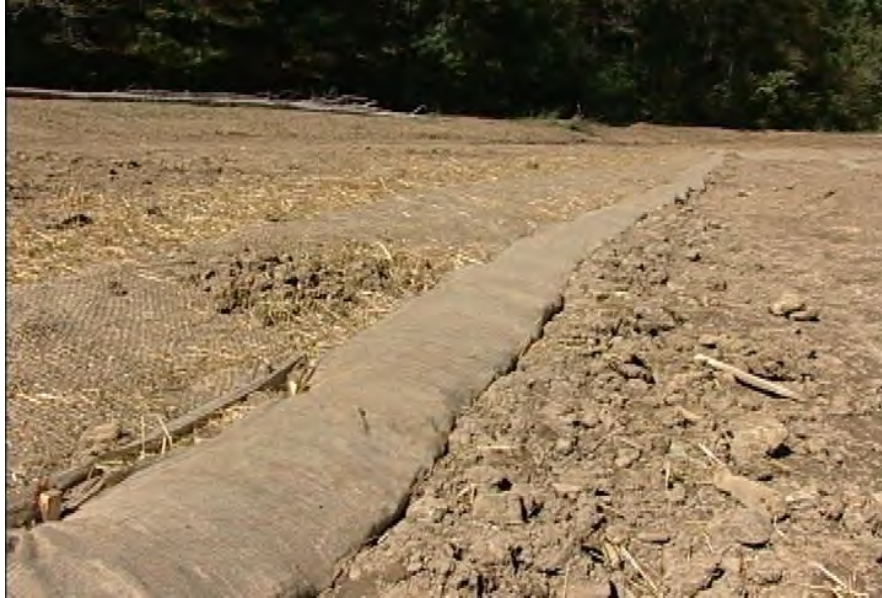
**Figure 2:** Newly constructed riffle in stream restoration before introduction of flow to the channel. Anti-Wash Geojute™, burlap wrap, and stream channel are pictured from left to right

center. The coverage of fabric along riffles varied from six to seven feet wide, depending on the overlap between the burlap and jute mesh.

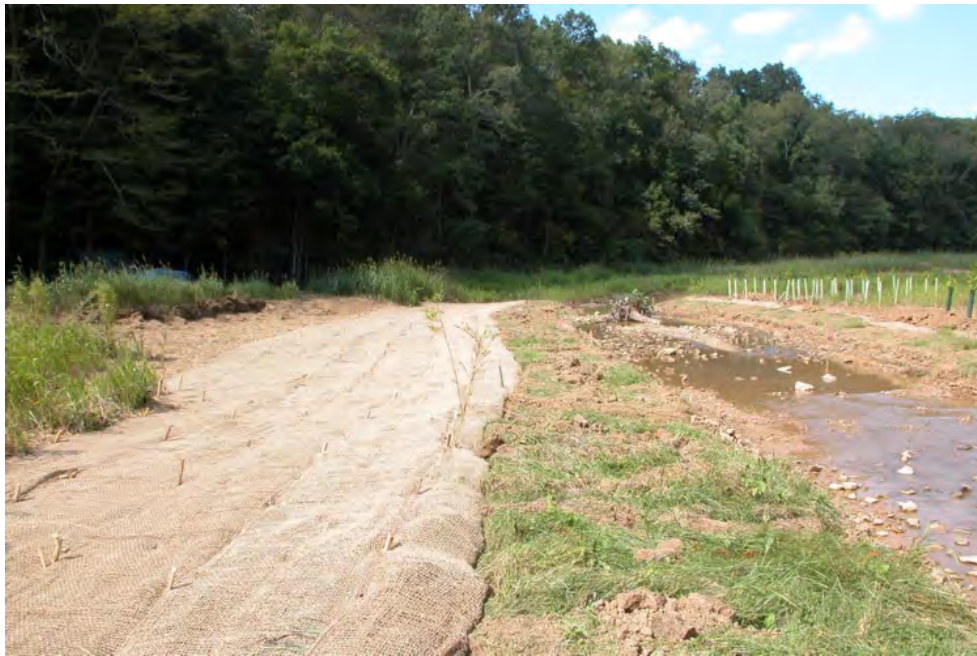
**Figure 3** Sod mats adjacent to stream directly following installation. Erosion mesh is tied into the sod and covers much of the floodplain

Additionally, the burlap soil wrap was abandoned due to its ineffectiveness; vegetation did not penetrate the burlap well, especially after the scouring produced in an out-of-bank flow. Instead we placed large pieces of sod (4' X 8') along the toe of the stream bank (Figure 3). These pieces of sod were eight to ten inches thick and provided an instant mass of soil, roots, and foliage in the most vulnerable areas of stream bank. The sod layer provided a much greater level of protection (sod is eight feet wide in every riffle) and appears to be very stable in comparison to the methods of 2003.

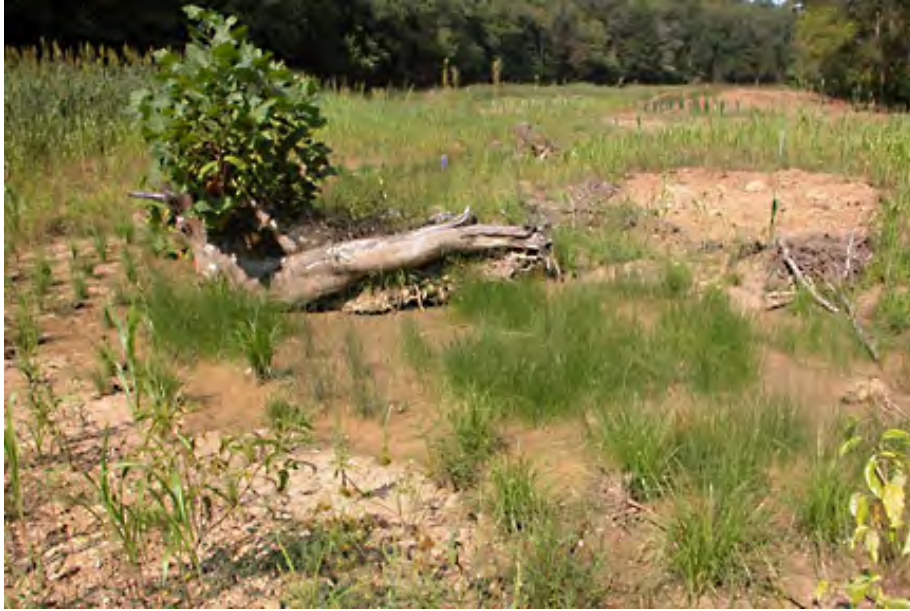
**Figure 4** Rushes and sedges have become established by 2004

In April an additional 500 sycamores and 500 swamp white oaks were planted along the riffle areas of the stream. Also, 1140 wetland plugs representing 76 plugs of the same 15 species were added to the prior years' plantings (Figure 4).

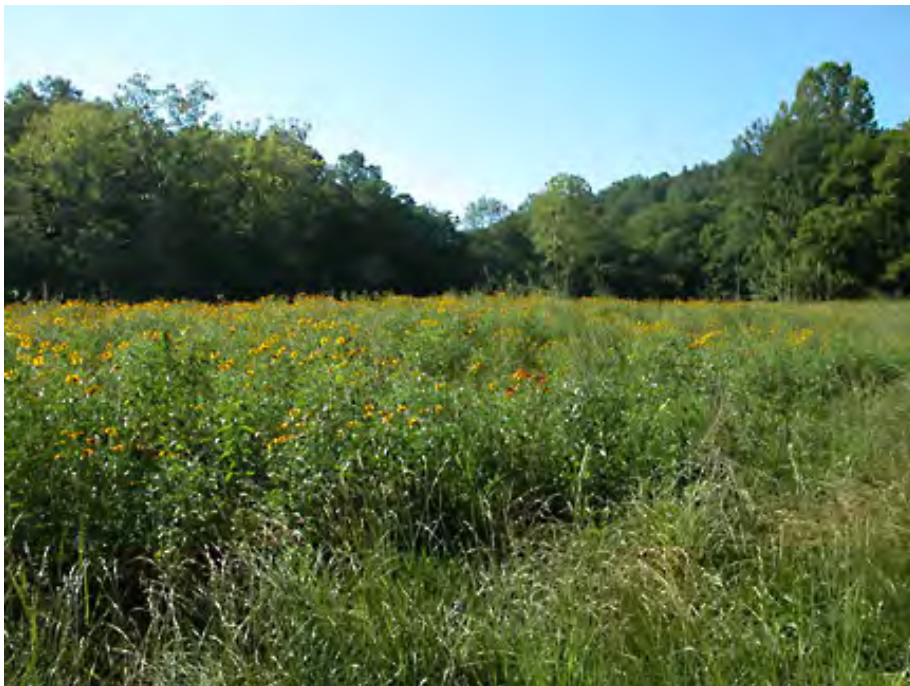
**Figure 5** By June of 2005 upland species were becoming fully established and no further cover crops were needed.

In 2005 the native upland grassland plantings were filling in well and no additional cover crop was needed (Figure 5). Late summer some repair was also made to the imbedded logs that had been washed out of the stream bank during heavy rain.

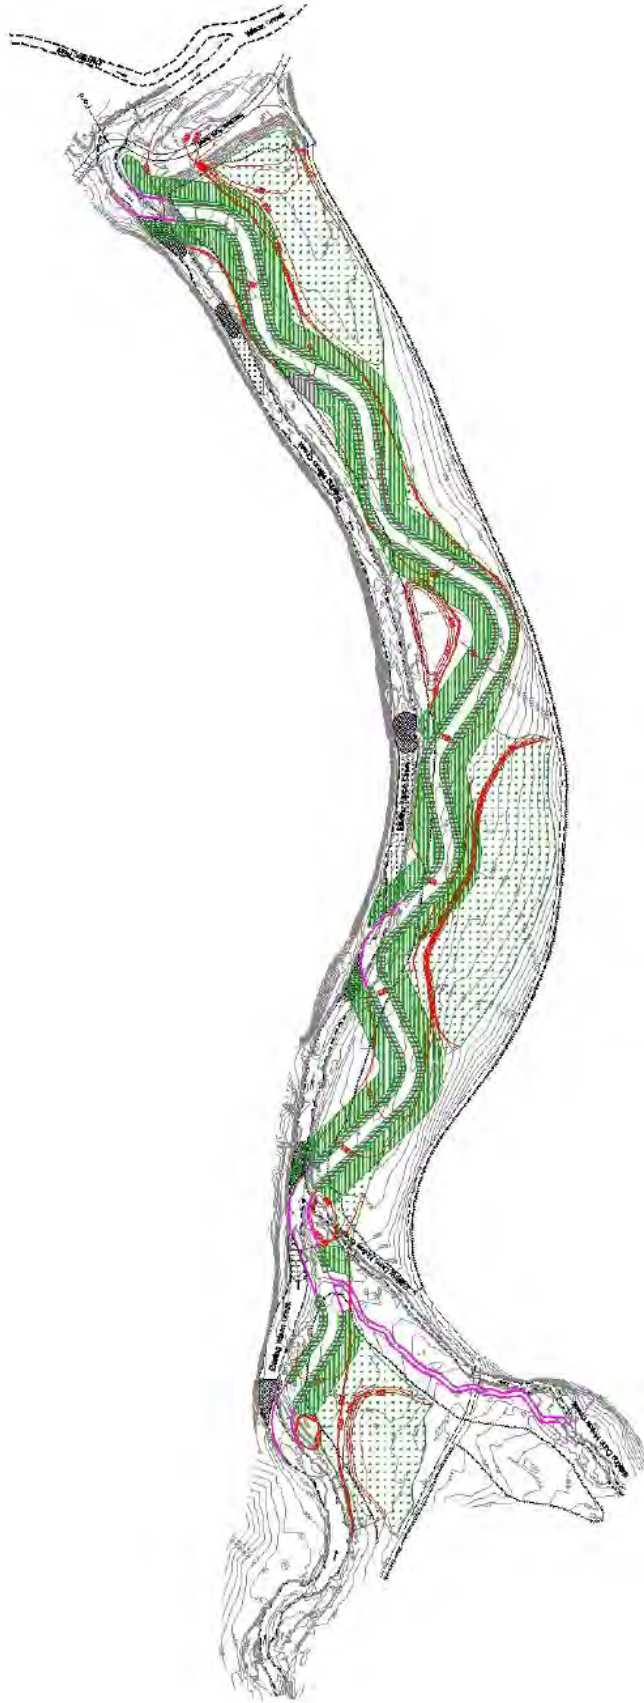
Figure 1 Wilson Creek design layout.

Transition from the un-entrenched C4 stream within the restoration to the F4 channel downstream of the restoration was accomplished by extending the floodplain excavation past the downstream limit of the restoration reach. Floodplain excavation would extend downstream of the country road crossing to a reach immediately upstream

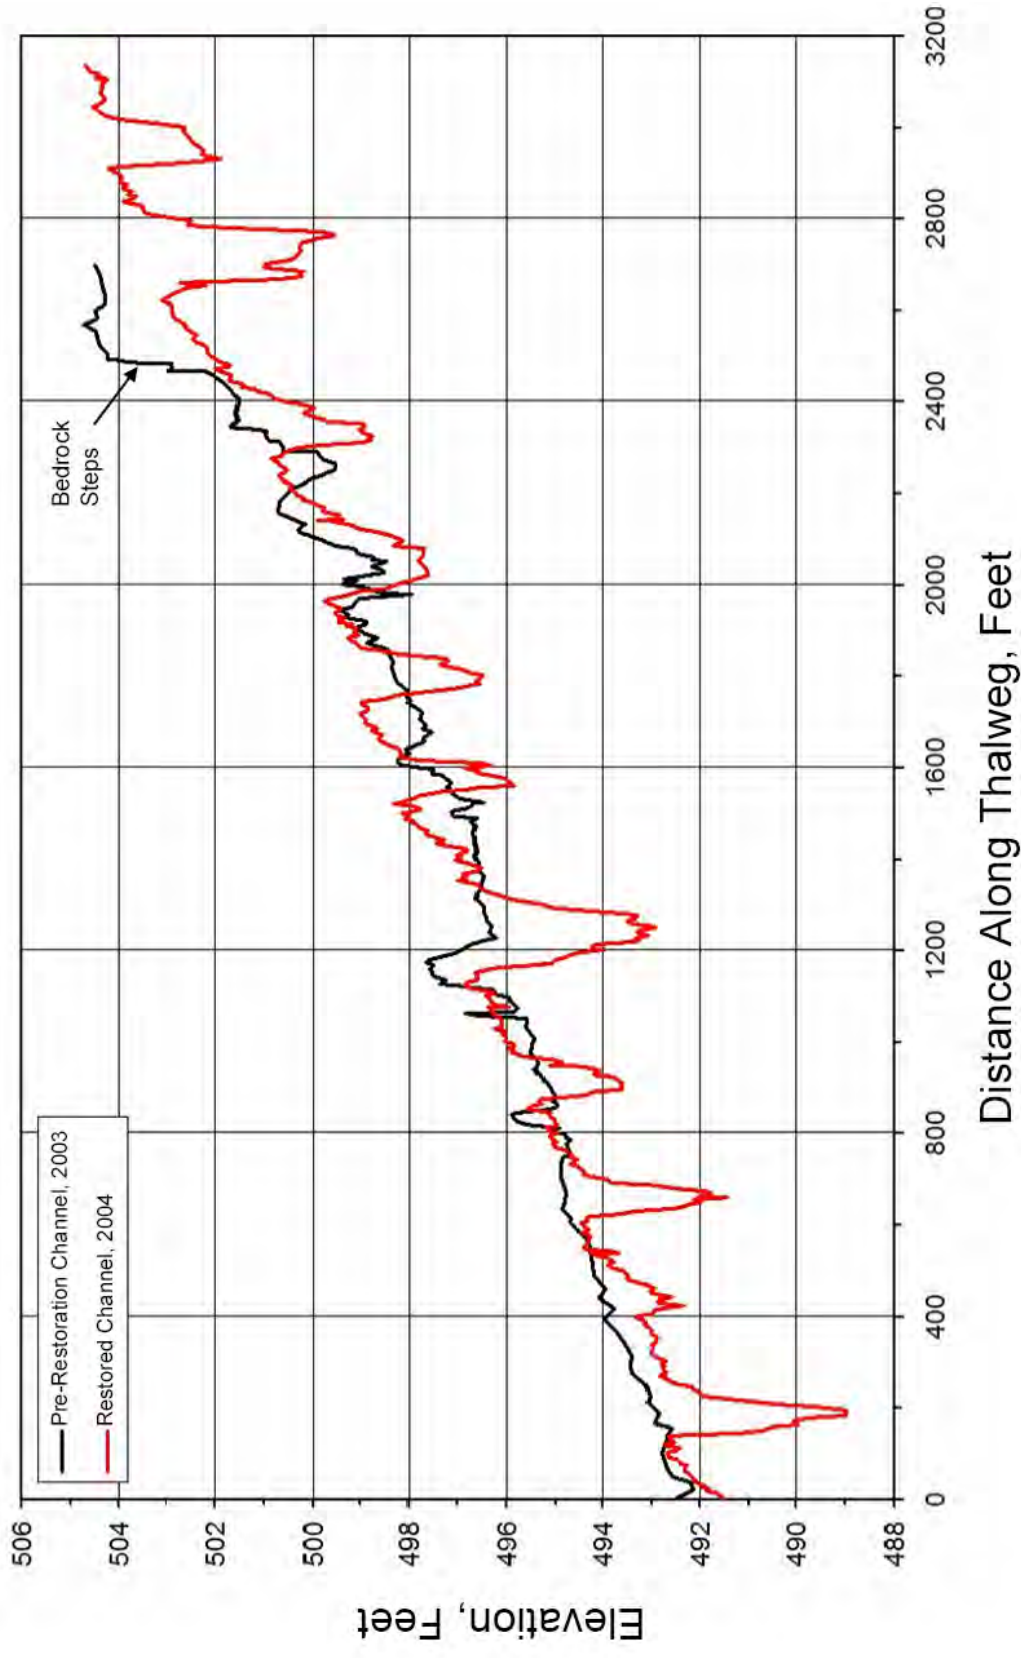
**Figure 2** Comparison of the pre-restoration channel thalweg obtained in spring 2003 and the restored channel thalweg surveyed in March 2004.

The channel planform and profile had been designed to maintain deep low-flow pool-riffle habitat and to increase groundwater levels. The restored channel thalweg shown in Figure 2 indicates that, for approximately the same location along the valley axis, the restored channel pools are deeper than those of the pre-restoration channel, with the exception of those pools that were constructed within the pre-restoration channel. Although pools for both channels are limited by shale bedrock, the bedrock elevation in the valley is non-uniform; a limited number of test pits indicated that the bedrock surface elevation tends to be higher along the valley hillsides and lower in the lowest elevation.

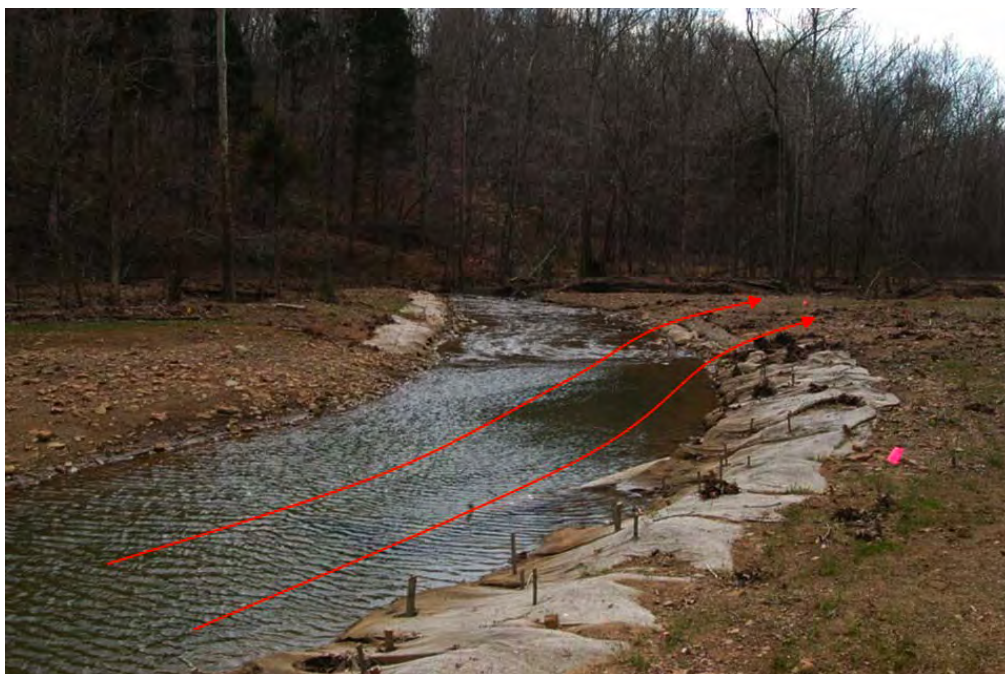
**Figure 3** Flood flow overtops banks as it leaves the bend of the restored channel prior to sod placement. Note the erosion control matting is still in place at the toe of the bank downstream of the bend. Ruts have formed in the unvegetated floodplain and on the top of the bank near the flow indication arrows.

Observations made during and immediately after flood events indicated that as flow transferred from the channel into the floodplain, it accelerated as it passed over the top of the banks. As a consequence of the bank-overtopping flow and the lack of established bank vegetation, bank erosion occurred at many locations along the riffles, as shown in Figure 3. Erosion was most severe over the upper third of the banks of riffles, where flows overtopped the stream banks, and on the floodplain surface, where the flow

dispersed into the floodplain after overtopping the stream banks. After several floods, rills formed and concentrated flow leaving the channel. Erosion was initiated from the top of the bank, gradually forming rills that lowered the bank elevation, allowing progressively concentrated flow to exit the channel. This concentrated flow formed several small channels in the floodplain during subsequent flow events. The lack of established vegetation on the floodplain surface and the absence of flow resistance and erosion protection of floodplain soil resulted in an excessive loss of floodplain surface material. Evaluation of this erosion process and pattern indicated the need for a change in the design of topography of the floodplain near the upper third of the riffles in order to prevent this type of erosion that could be likely to occur before bank and floodplain vegetation is established. In the summer of 2004, floodplain topography was modified and vegetation was established on the stream banks in the regions of the channel most susceptible to rapid bank erosion (Parola et al. 2005). The modification that most affected the post-restoration channel's profile and planform was placement of sod mats on the banks along riffles to rapidly establish bank vegetation. The sod placement required that construction equipment traverse sections of riffles in multiple directions, resulting in changes to the channel profile from the original as-built profile. As part of the sod placement process, survey monuments were inadvertently destroyed. New survey controls were installed, and the channel thalweg was resurveyed.

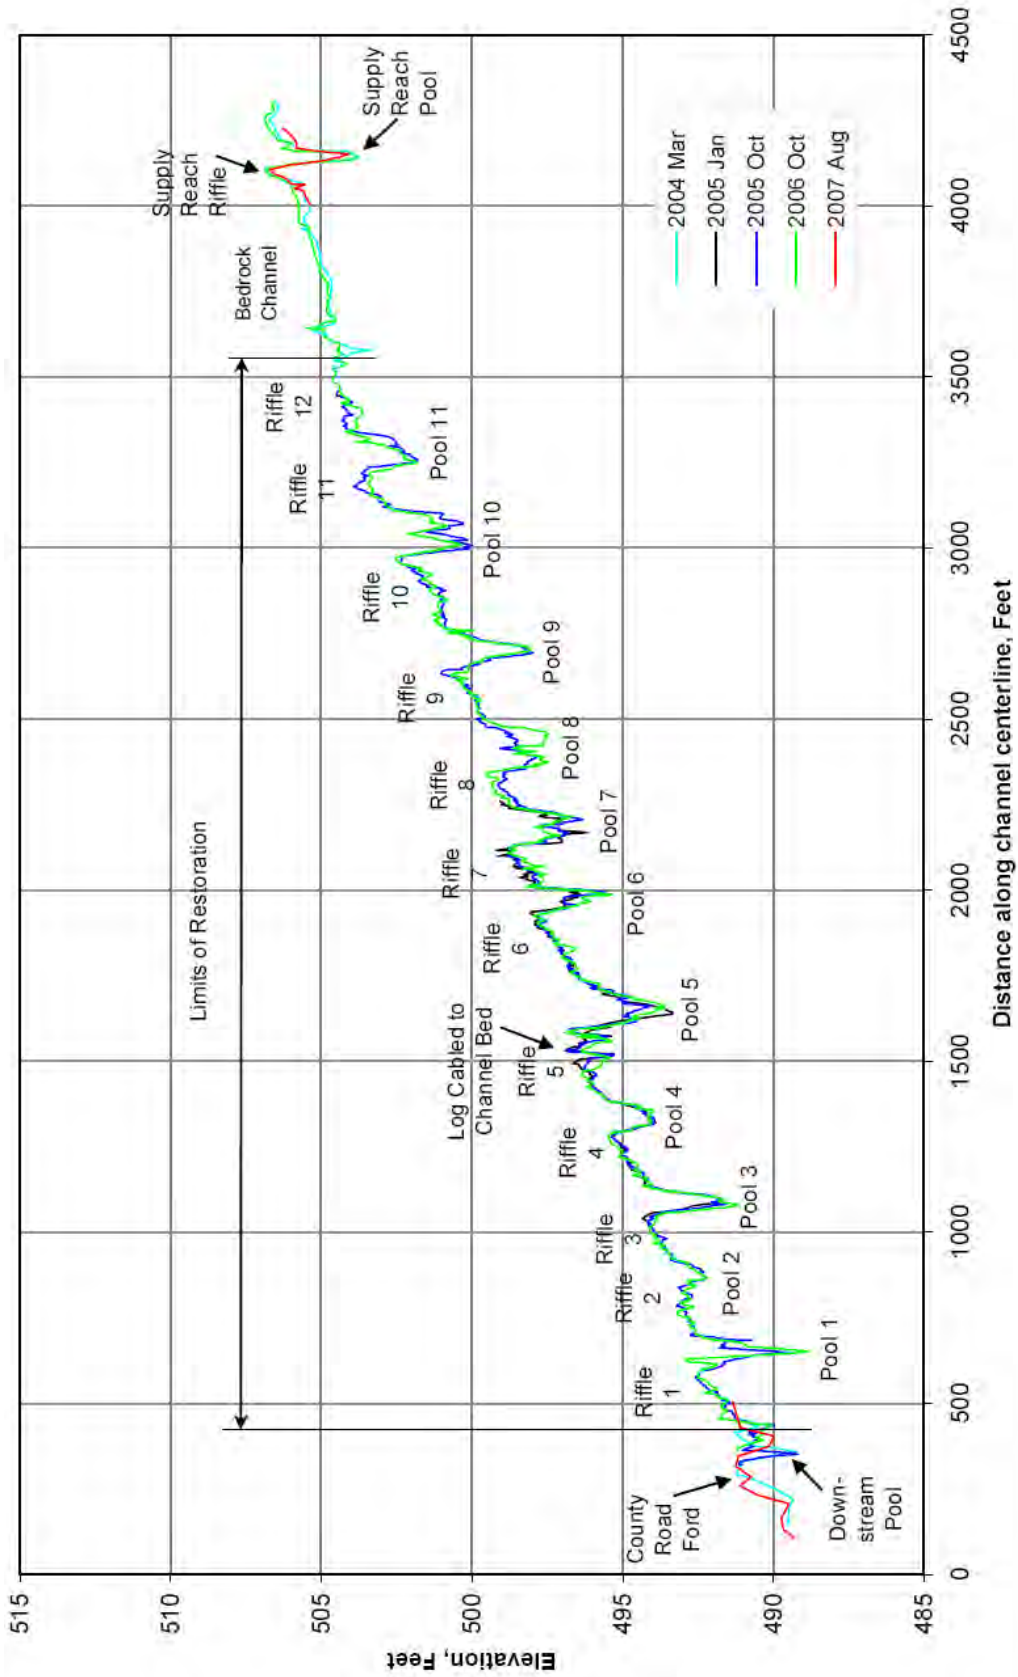
**Figure 4** Surveys of the restored channel thalweg were conducted between March 2004 and August 2007. Thalweg surveys of the entire restoration reach were conducted in October 2005 and October 2006. All of the surveyed thalweg elevation data is plotted with respect to distance along the channel centerline.

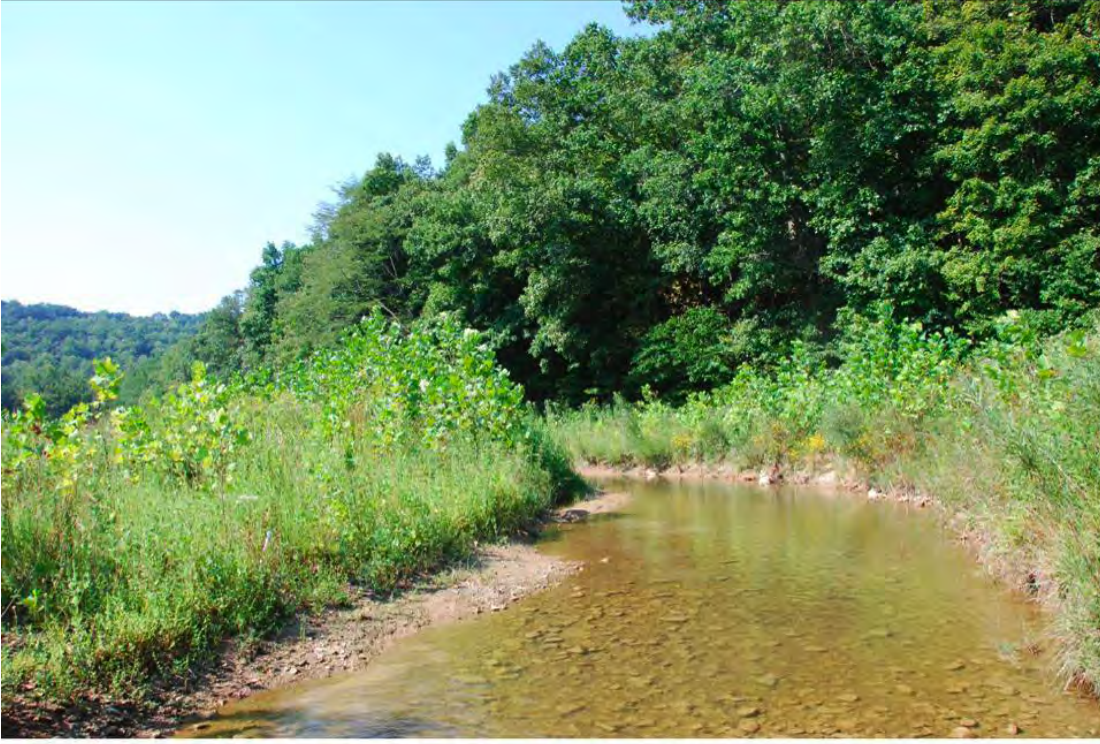
**Figure 5** Restored floodplain and channel looking downstream at Pool 5 during the low-flow period of August 2007. Note the small difference in elevation between the left floodplain and the water surface of the pool maintained primarily by groundwater.

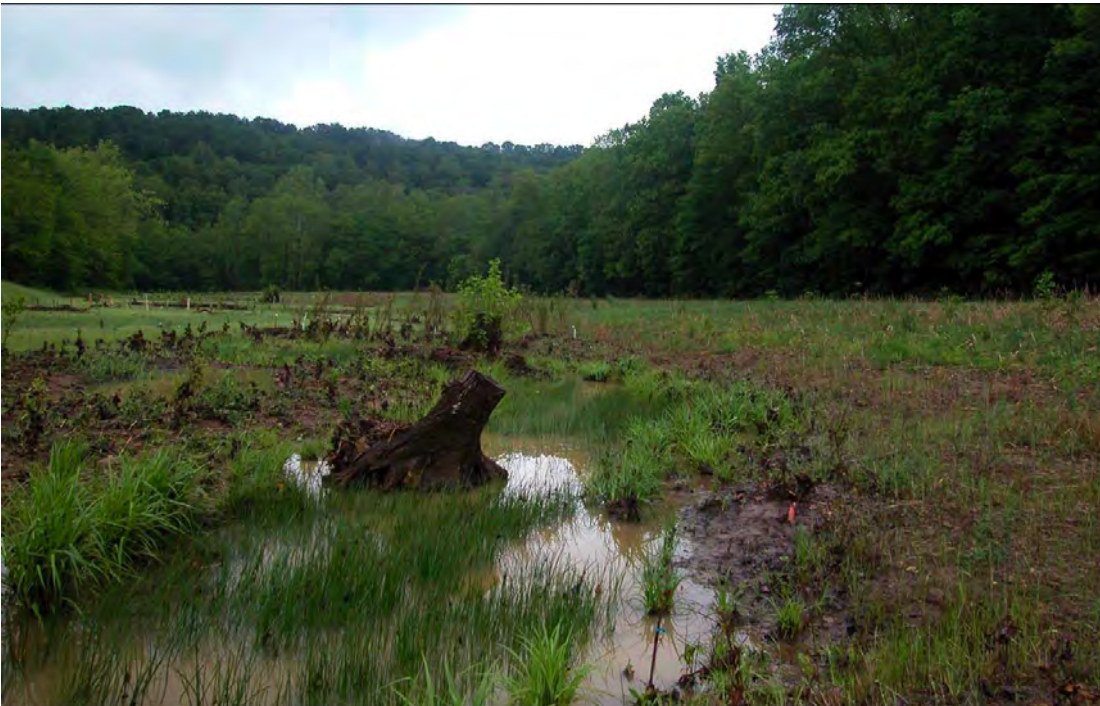
**Figure 6** Excavated linear floodplain depression developing into a wetland. The photograph shows leaves caught on floodplain vegetation. Wetland vegetation and leaf pack are in the depression.

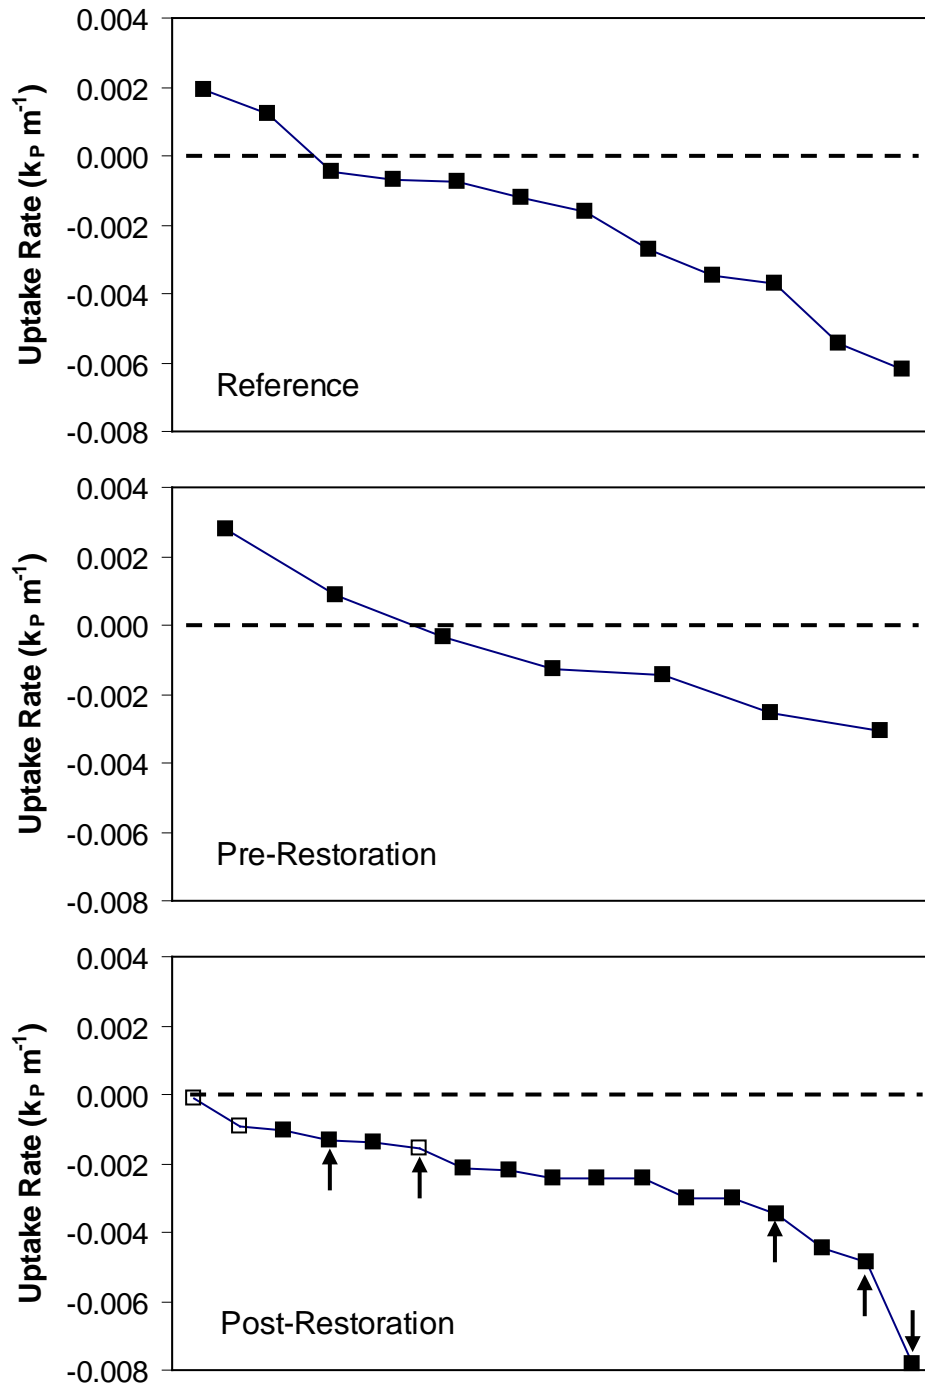
Figure 6. Nitrogen uptake rate coefficients for the reference (Harts Run), channelized (Wilson Creek, pre-restoration) and naturalized (Wilson Creek, post-restoration) sites. Solid symbols denote coefficients that are significantly different from zero. Arrows in lower panel denote a sub-reach of the naturalized channel that was connected to a backwater area formed by remnants of the old channel (note difference in y-axis scale).

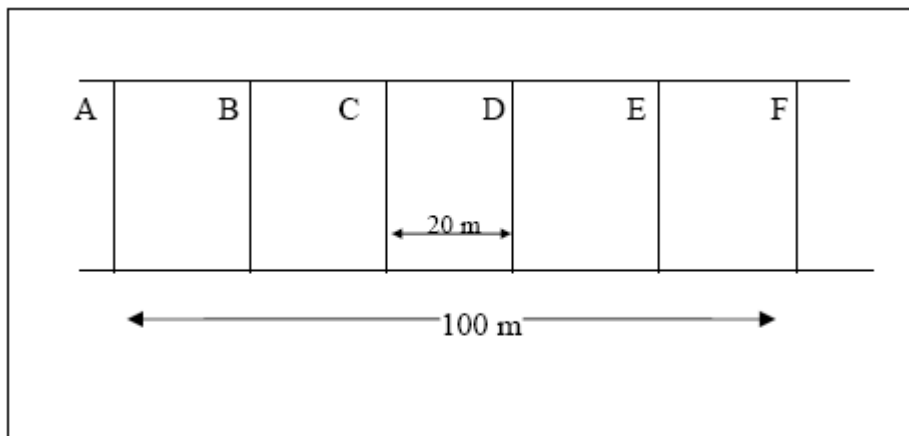
Figure 3. Example sample reach with 20 m transects.

Within each 100 m reach sampling “blocks” were established (n=5). “Blocks” represented the area between transects. Within each “block”, one seine haul was performed in a downstream fashion (Figure 3). A total of five seine hauls were performed, one in each 20 m “block”, at each reach. All easily identified fish were identified and measured (mm) in the field and released, all others were preserved in 10% formaldehyde and returned to the laboratory for identification (species). Fish were assessed with the Kentucky Index of Biotic Integrity (KIBI) (Compton et al. 2003) (Table 2). Macroinvertebrates were collected semi-quantitatively by compositing four 0.25 m kicknet samples (KDOW 2002). A sub-sample of 300 organisms was processed in the laboratory. All macroinvertebrates were identified to lowest possible level (genus) and assessed with the Kentucky Macroinvertebrate Bioassessment index (MBI) (Pond et al. 2003 and KDOW unpublished data) (Table 2). Algae were collected by natural scraping and assessed with the diatom biotic index (DBI) following KDOW (2002) (Table 2). Habitat was assessed at each site using the rapid bioassessment protocols (RBP) described in Barbour et al. (1997) and KDOW (2002) (Table 3) during biological surveys. In addition to the RBP protocols the following were collected at each transect (Figure 2): wetted width, canopy cover (using a densiometer), riparian zone (left/right bank width) and visual determination of the two dominate substrates (fines (silt, clay and sand), gravel, cobble, boulder, and bedrock). The upper and middle sites were considered headwater sites and the lower site was considered a wadeable site for the purposes of assessment with the KIBI, MBI, DBI and habitat (KDOW 2002, Compton et al. 2003 and Pond et al. 2003). All parameters were sampled at each site the same day or two consecutive days.

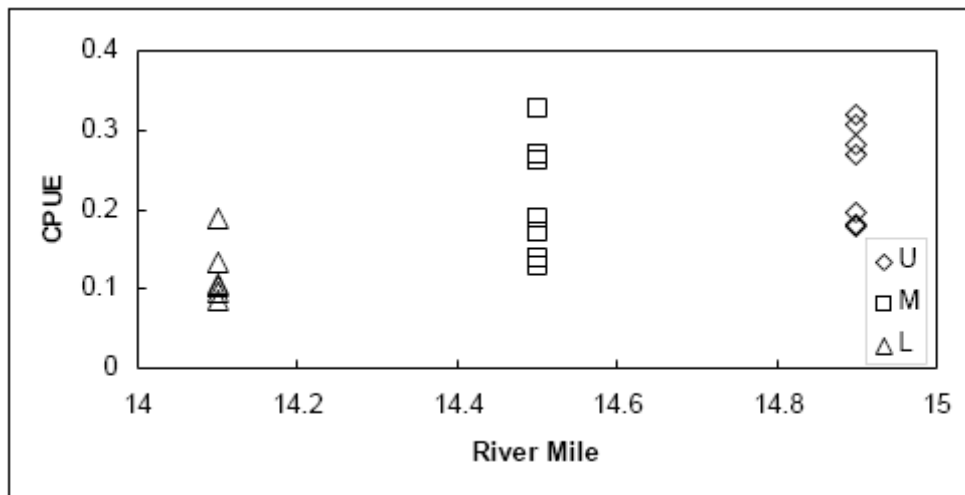
Figure 4. Catch per unit effort (CPUE fish/s) at three sampling locations (upper = U, middle = M and lower = L) in the Wilson Creek Watershed, Nelson/Bullitt Counties, Kentucky, USA.

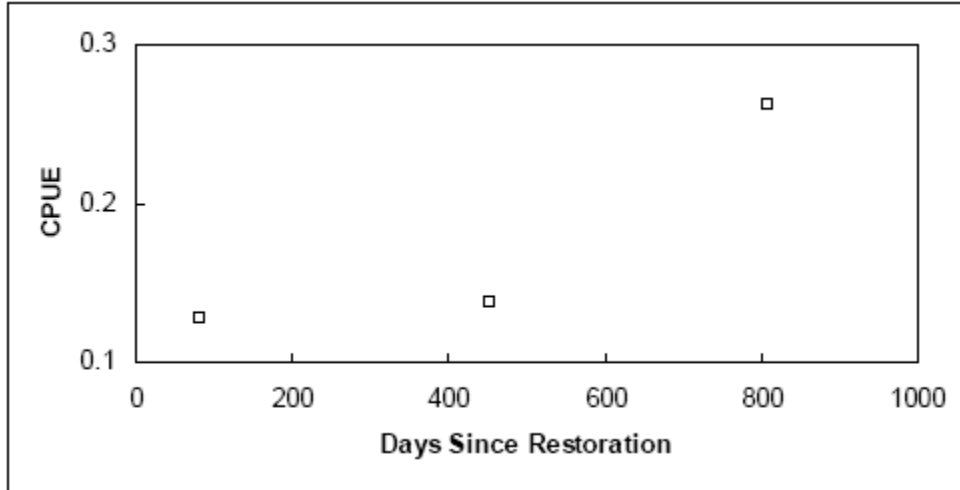
Figure 5. Spring post-BMP catch per unit effort (CPUE fish/s) at the middle sampling location in the Wilson Creek Watershed, Nelson/Bullitt Counties, Kentucky, USA.

downstream and upstream sites. An upward trend in CPUE during spring samples at the middle site was observed (Figure 5). Most sites had excellent or good KIBI scores (Table 7 and Figure 6) during all sample events except for the upstream site (July and September 2004 and March 2006) and the middle site (September 2004 and 2006) which received fair KIBI scores. The fair KIBI scores for the upstream site (July and September 2004) and middle site (September 2004) samples were probably related to seasonal effects of sampling headwater streams during the summer and fall (Compton et al 2003). The middle and upstream sites scored excellent and good (respectively) during the spring (2005) sampling event. The middle and upstream sites KIBI score of fair during the spring of 2006 were likely the result of drought conditions that dried the stream during the summer of 2005. KIBI scores were similar for the restored and old channel immediately after construction of the new channel (spring 2004). By the spring of 2005, KIBI scores were excellent in the new channel. Drought conditions during the summer of 2005 may have limited recovery of the new channel. Bayley and Osborne (1993) reported that there was no difference in pre- and post-drought fish biomass or richness and that recovery occurred within one year in an eastern Illinois stream. The new channel in Wilson Creek is expected to return to pre-construction condition or exceed them as the spring 2005 sampling event indicates. The downstream site pre-construction and spring 2004 KIBI scores were excellent. However, all other KIBI scores have been good. Although these scores are acceptable, some stress in the fish community is evident downstream following relocation of the Wilson Creek channel upstream.

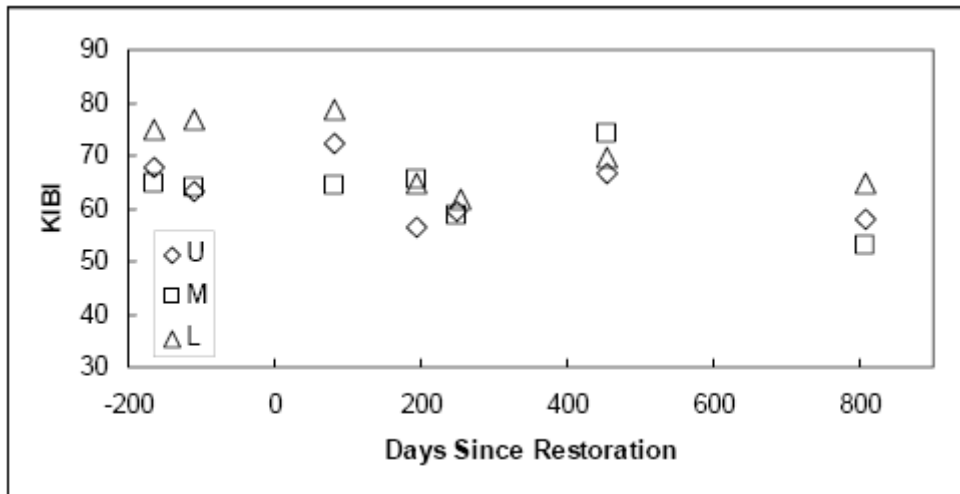
Figure 6. KIBI scores at three sampling locations (upper = U, middle = M and lower = L) in the Wilson Creek Watershed, Nelson/Bullitt Counties, Kentucky, USA.

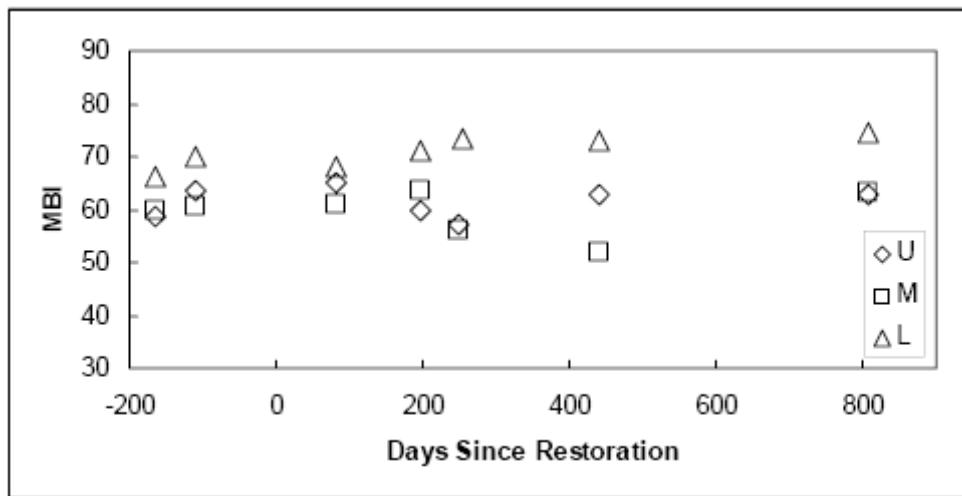
Figure 7. MBI scores at three sampling locations (upper = U, middle = M and lower = L) in the Wilson Creek Watershed, Nelson/Bullitt Counties, Kentucky, USA.

Some seasonal effects from sampling macroinvertebrates at the headwater sites is evident with the fair ratings obtained at the upstream sites during the July and September sampling events. The macroinvertebrate community is stable at the upstream site with the good ratings obtained during the spring samples events. The macroinvertebrate community at the middle is starting to improve with the two good ratings obtained in the post-construction period. The downstream site has shown the most improvement during the post-bmp period with last three of five samples rating as good. No downstream impairment has been observed in the macroinvertebrate community. The macroinvertebrate community is responding positively to the restoration.

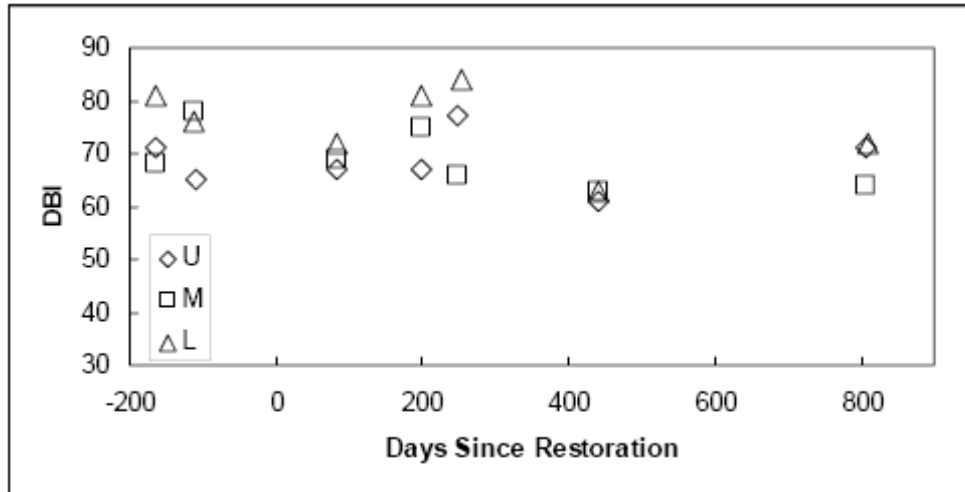
Figure 8. DBI scores at three sampling locations (upper = U, middle = M and lower = L) in the Wilson Creek Watershed, Nelson/Bullitt Counties, Kentucky, USA.

DBI scores ranged from 61 to 84 and scored excellent or good ratings at the three sampling locations in Wilson Creek (Table 10 and Figure 8). All sites, during the spring 2005 sample event, scored good ratings. These lower ratings may be related to sampling during the spring with cooler water that prevented growth of diatom communities (L. Panayotoff, pers. com.). Benthic algae should continue to improve to excellent scores as the riparian zone at the middle site matures. No downstream impairment has been detected in the benthic algae community.

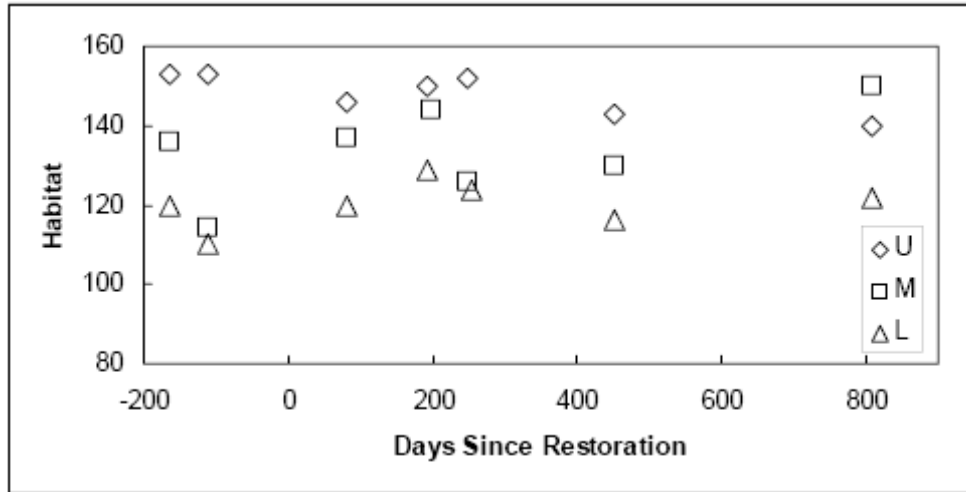
Figure 9. Habitat scores at three sampling locations (upper = U, middle = M and lower = L) in the Wilson Creek Watershed, Nelson/Bullitt Counties, Kentucky, USA.

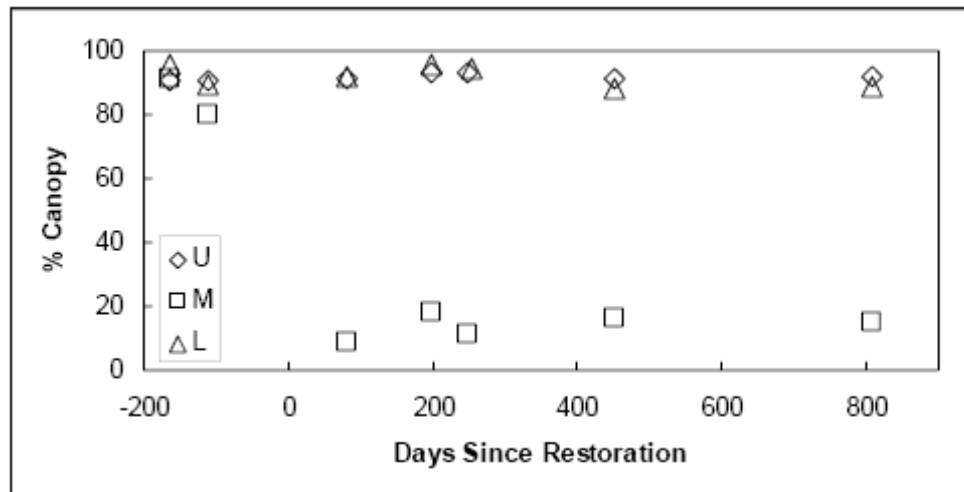
Figure 10. Percent canopy cover at three sampling locations (upper = U, middle = M and lower = L) in the Wilson Creek Watershed, Nelson/Bullitt Counties, Kentucky, USA.

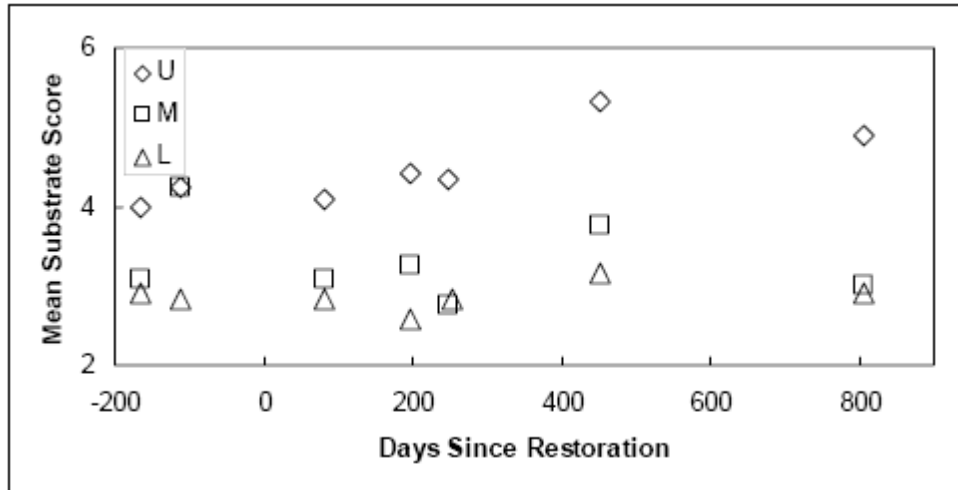
Figure 11. Mean substrate scores at three sampling locations (upper = U, middle = M and lower = L) (1=fines, 2=gravel, 3=cobble, 4=boulder and 6=bedrock) in the Wilson Creek Watershed, Nelson/Bullitt Counties, Kentucky, USA.

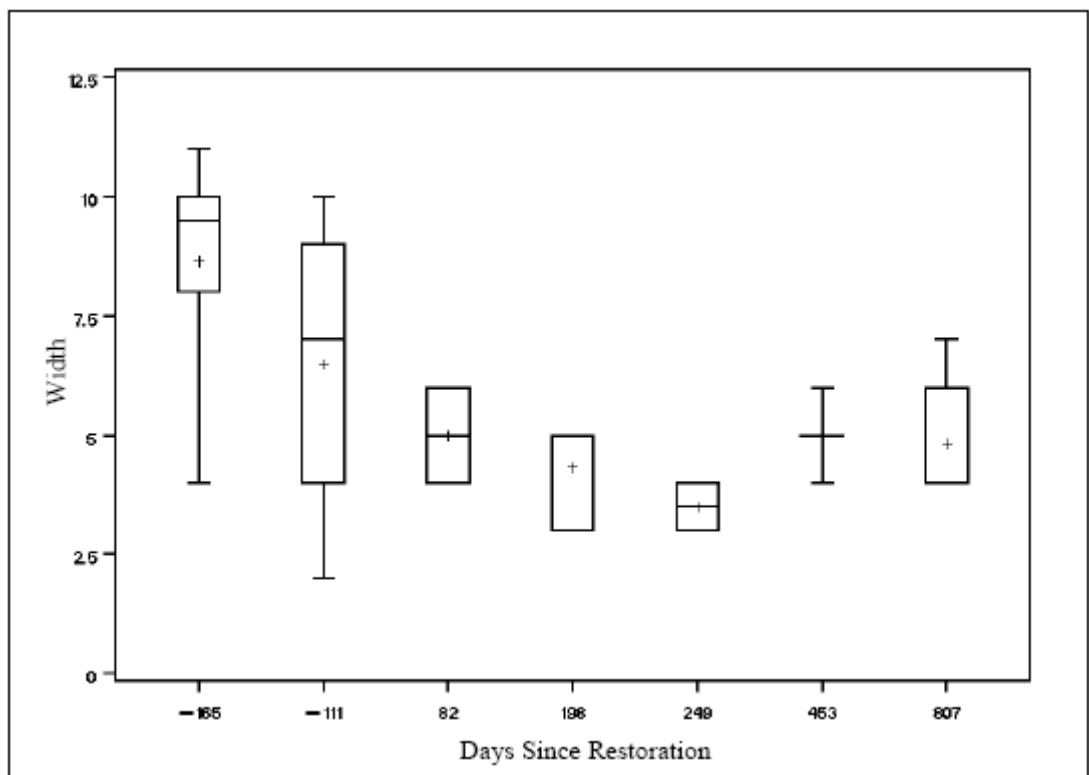
Figure 12. Mean stream width (m) at the middle sampling location in the Wilson Creek Watershed, Nelson/Bullitt Counties, Kentucky, USA.

(ANOVA  $P > 0.05$ ). No differences were detected any time at the lower site (ANOVA  $P > 0.05$ ). Mean channel width decreased during the post-construction period as compared to the July 2003 sample event (d.f. 6, 41;  $F = 5.68$ ;  $P = 0.003$ ) (Figure 12).

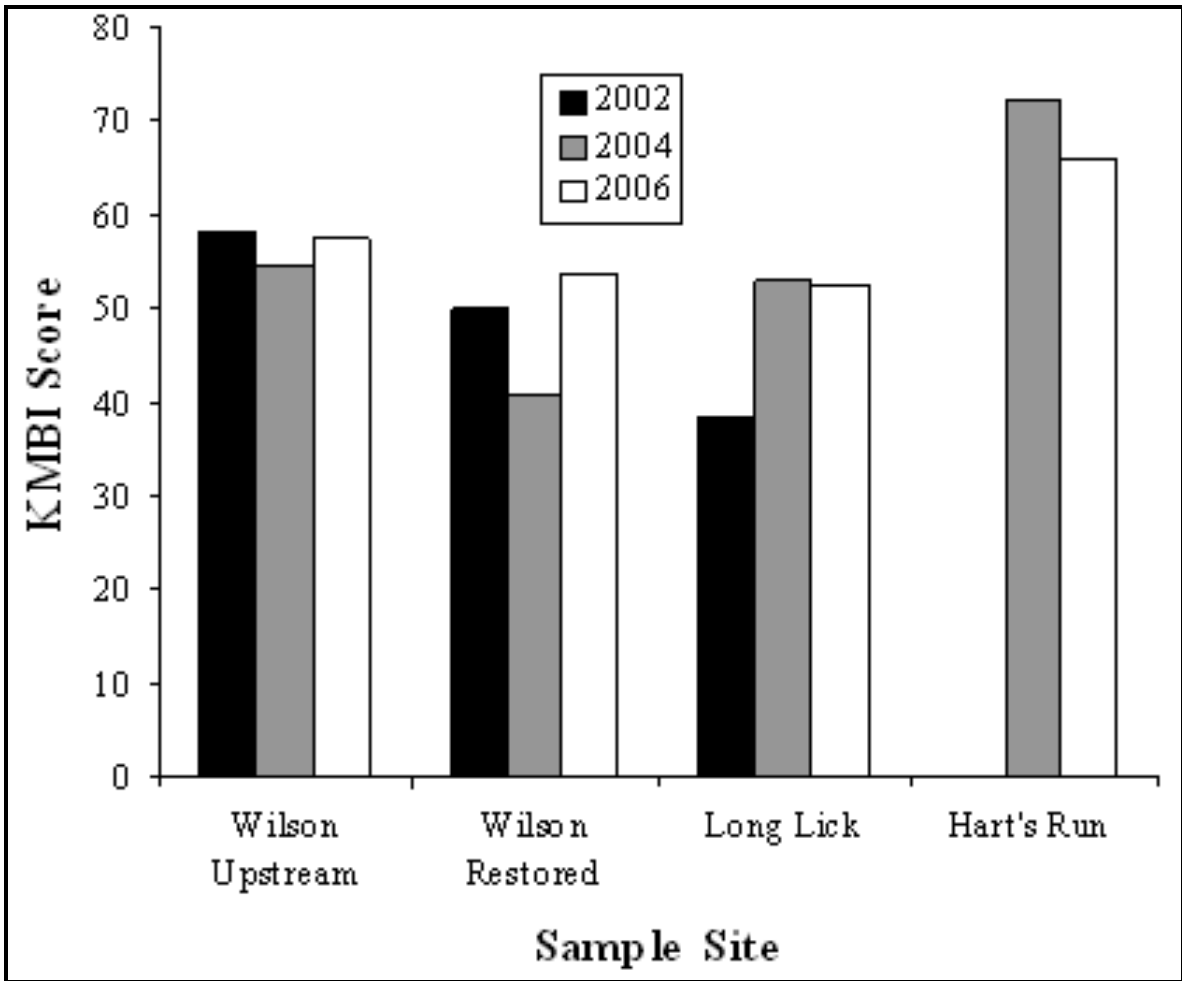
**Figure 1.** KMBI scores for the restored reach of Wilson Creek and the three reference sites

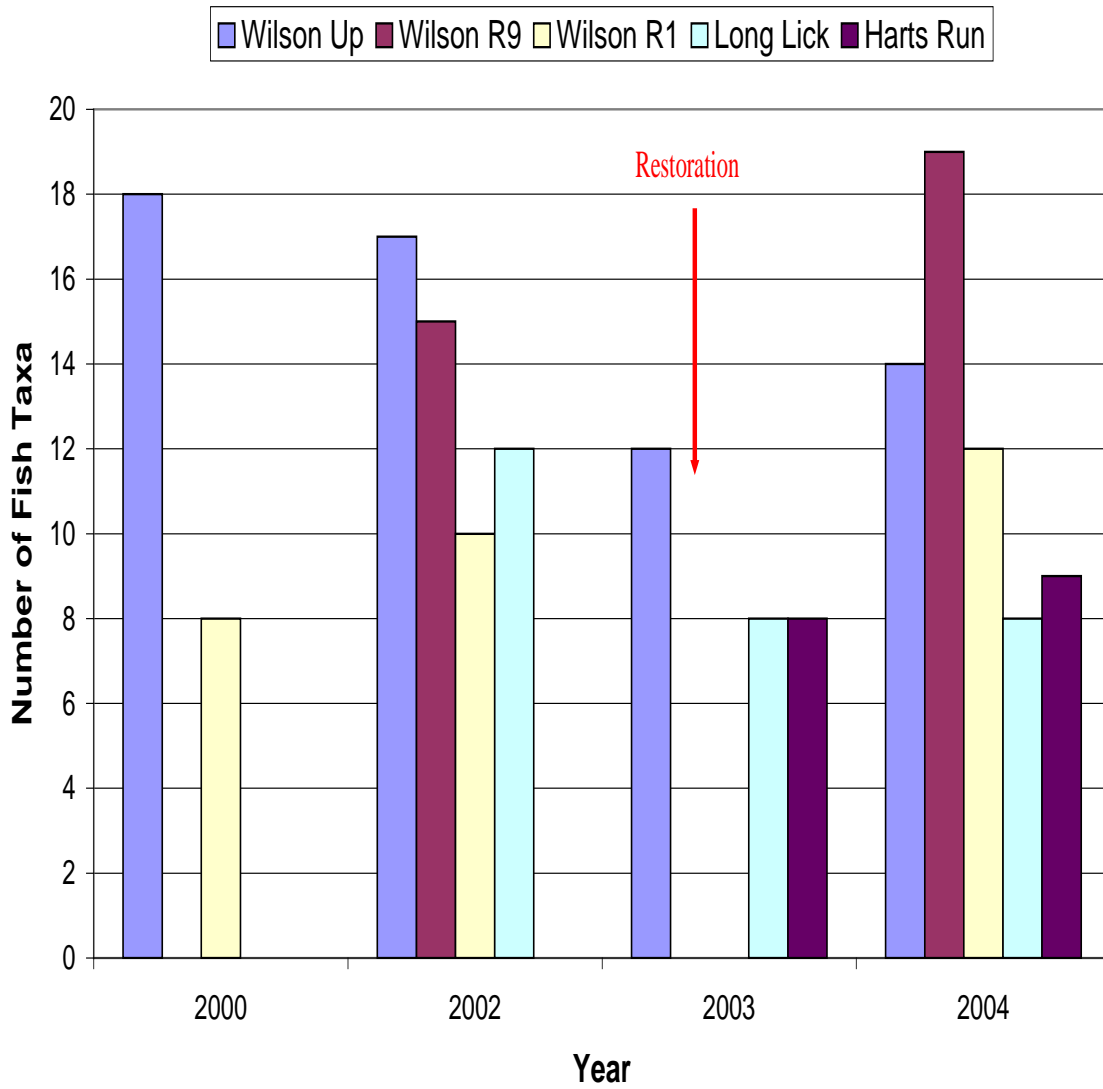
Figure 2. Fish IBI score in Wilson Creek and reference sites, pre- and post restoration.

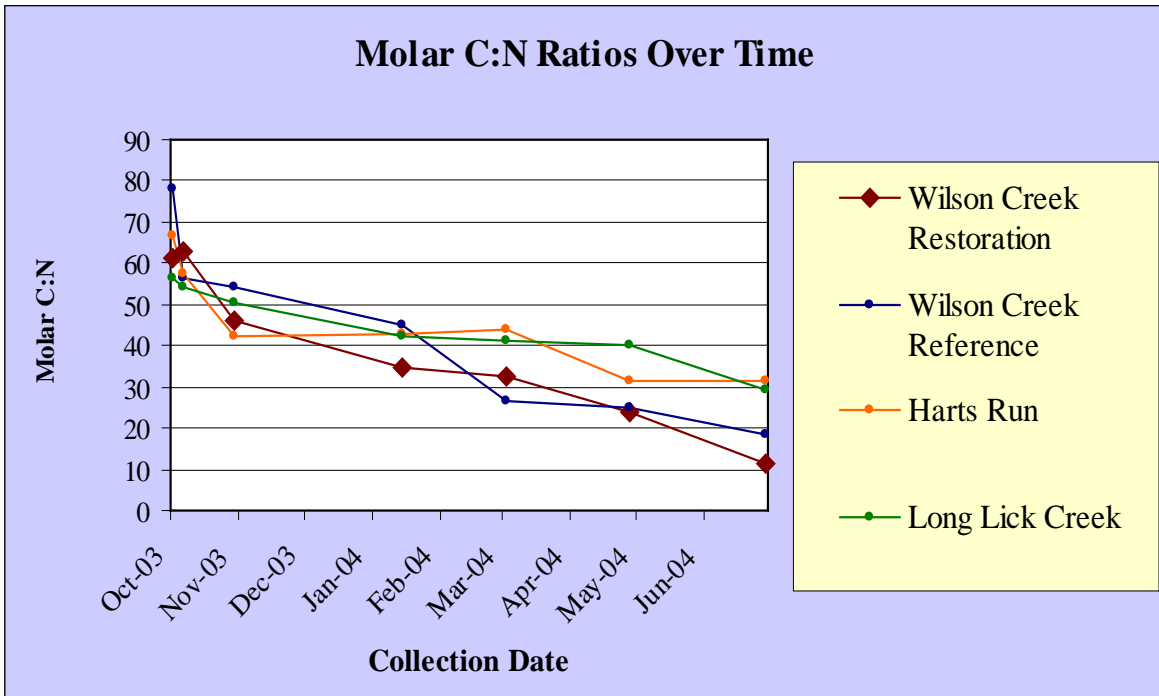
Figure 4. Molar C:N ratios of leaf litter
