**Channel Restoration and Riparian  
Reforestation Along Wilson Creek:  
A Demonstration Site**

**Section 319(h) Nonpoint Source Project Final Report**

**Submitted by:  
Bernheim Arboretum and Research Forest**

**October 2007**

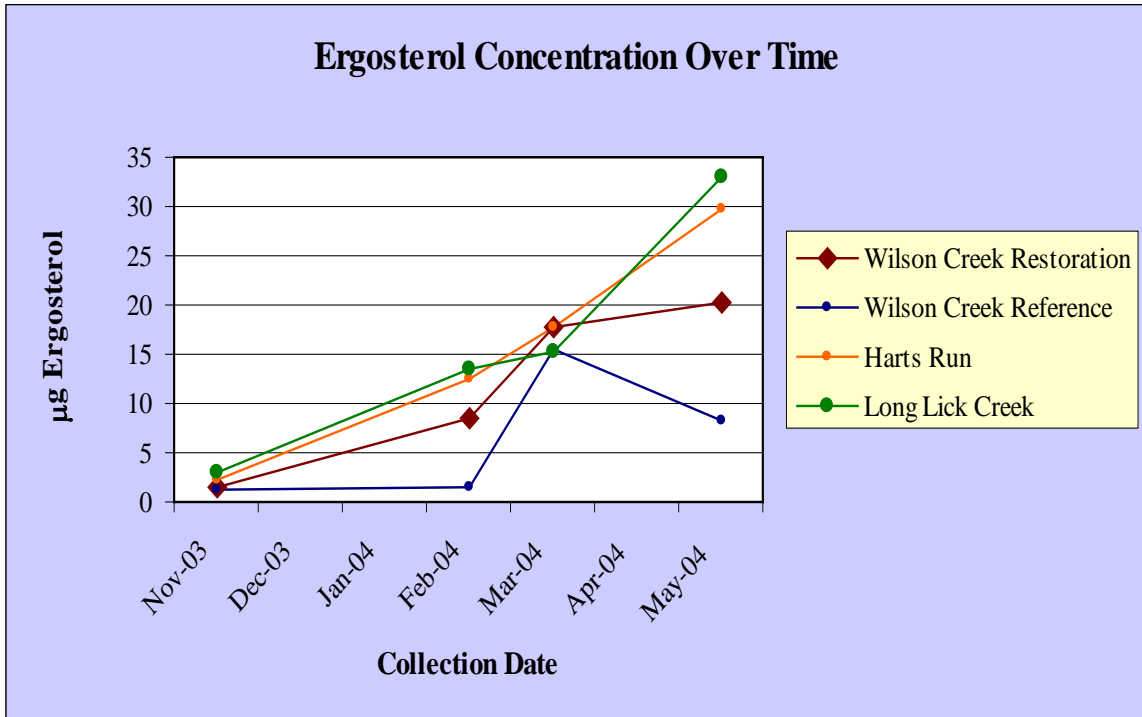
Figure 5. Ergosterol concentrations in leaf litter

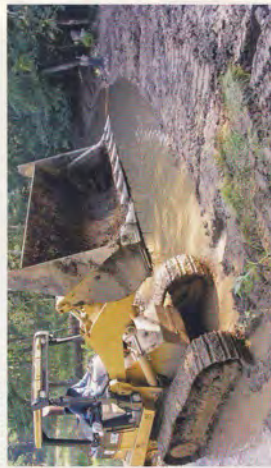
Sometime in the past 200 years, the stream channel was realigned along one side of the valley to follow a straightened course. This was most likely done to allow for farming the fertile bottomland. This change resulted in a stream channel that allowed water to cut quickly through the watershed. The faster flowing water carried away top soil and allowed fewer impurities to filter out.
