Groundwater Assessment for Nonpoint Source Pollution

Impacts and Spring Basin Delineations within

Sub-watersheds of the Salt River Basin:

Beargrass Creek and Sinking Creek

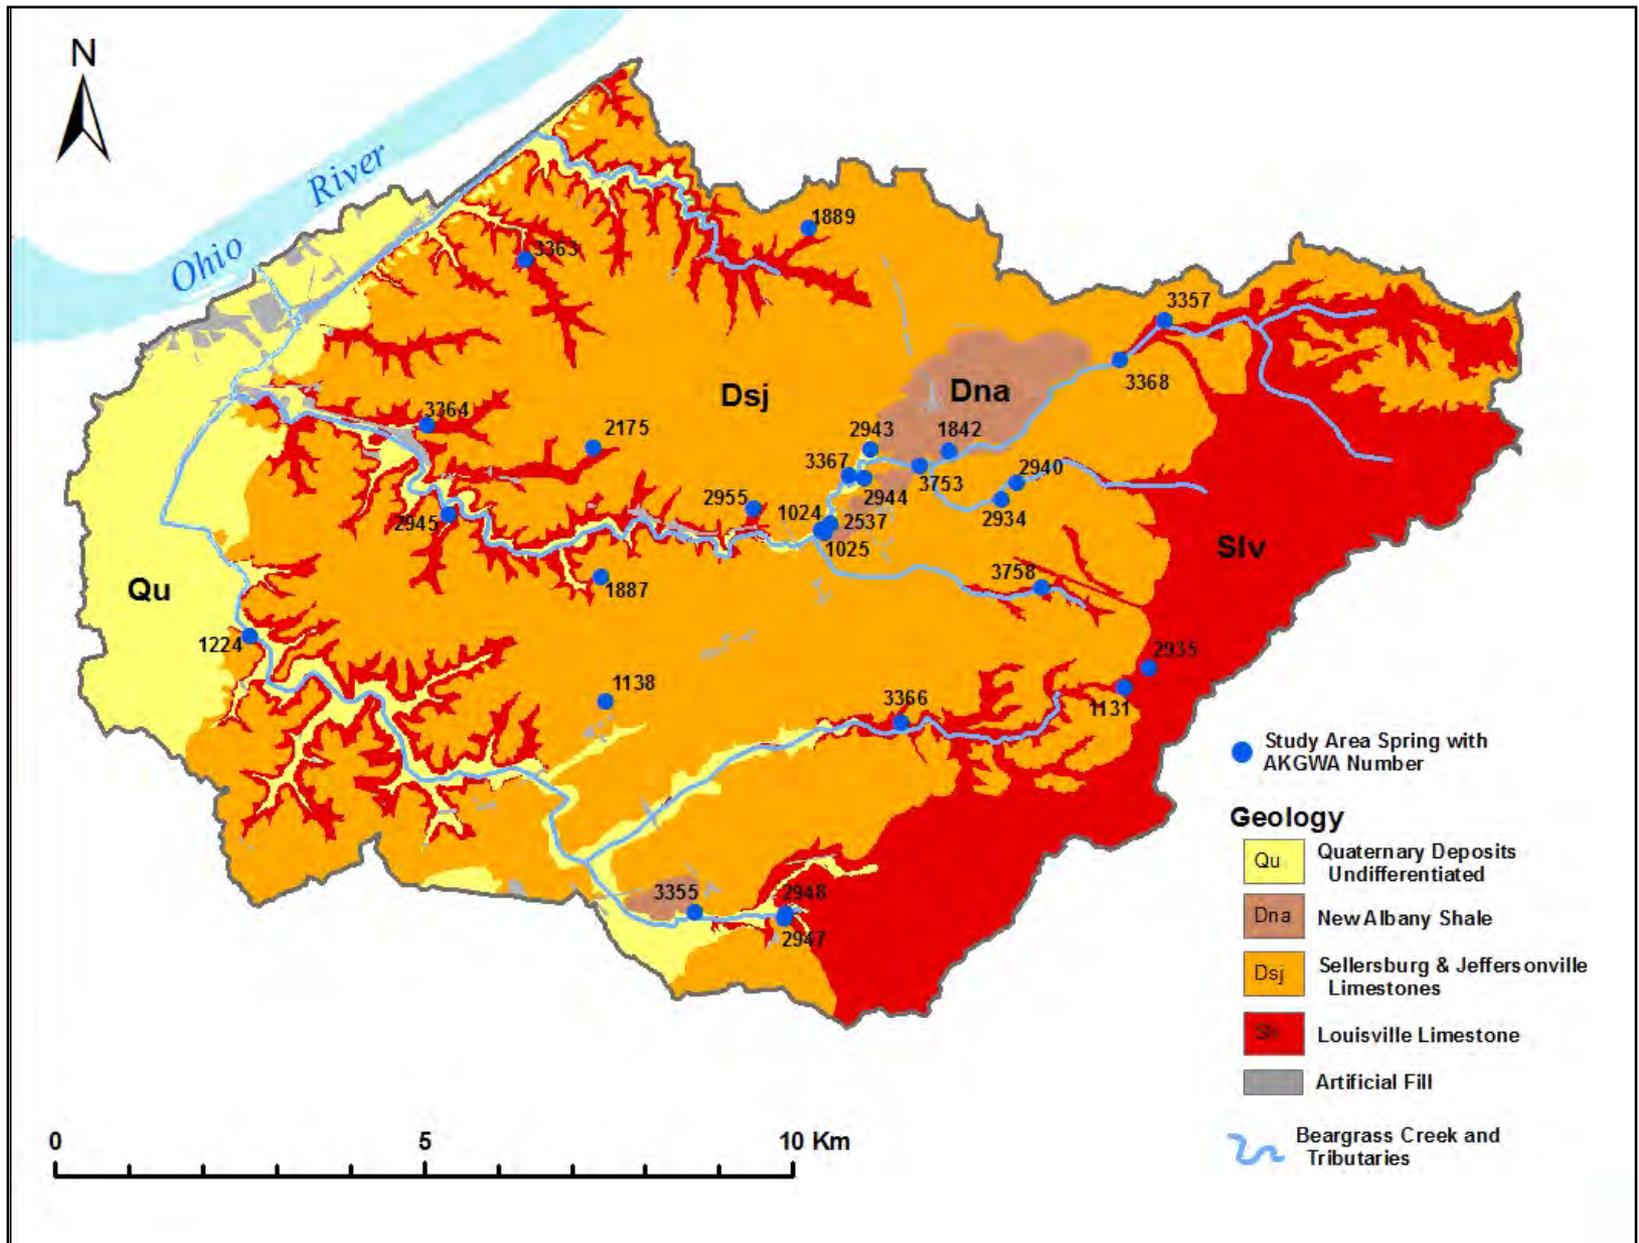
Figure 2. Beargrass Creek Watershed Geological Map with Monitored Spring Locations

found in the middle and lower reaches of each fork and along the Ohio River. Ohio River Alluvium is an especially important aquifer and is utilized for a wide variety of water sources, including public drinking water. However, groundwater resources in this aquifer were not part of this study. Lacustrine deposits are found in the lower sections of each fork. Glacial outwash is shown along and south of the Ohio River on the western margin of the watershed. Loess and eolian sand is mapped as a single unit near the west end of the watershed as a band extending from the southwest to northeast, pinching out toward the northern extent. Terrace deposits occur in one isolated area near the southernmost point of the watershed, around Standiford Field. All of these units are described as various combinations of gravel, sand, silt and clay (Kepferle, 1974a and 1974b). In Figure 2 these Quaternary Deposits are shown as Undifferentiated.

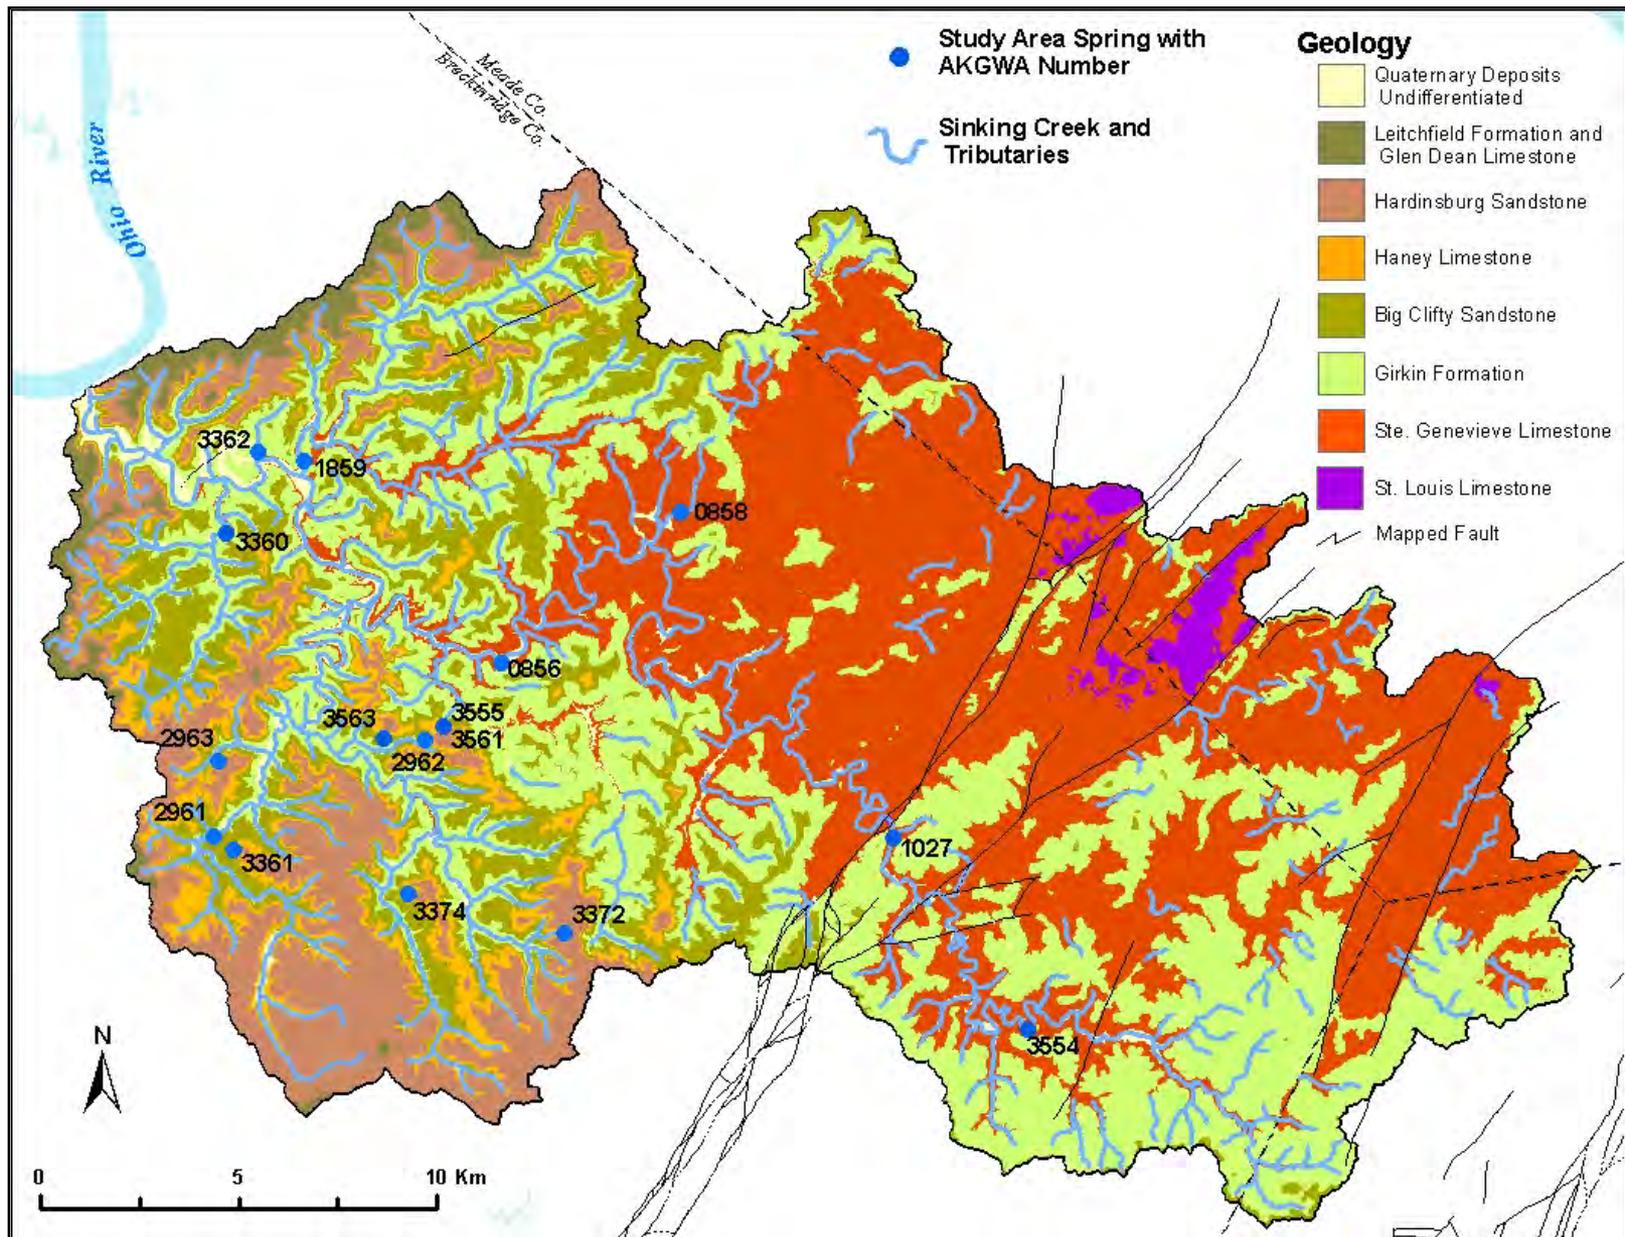
Figure 3. Sinking Creek Watershed Geological Map with Monitored Spring Locations

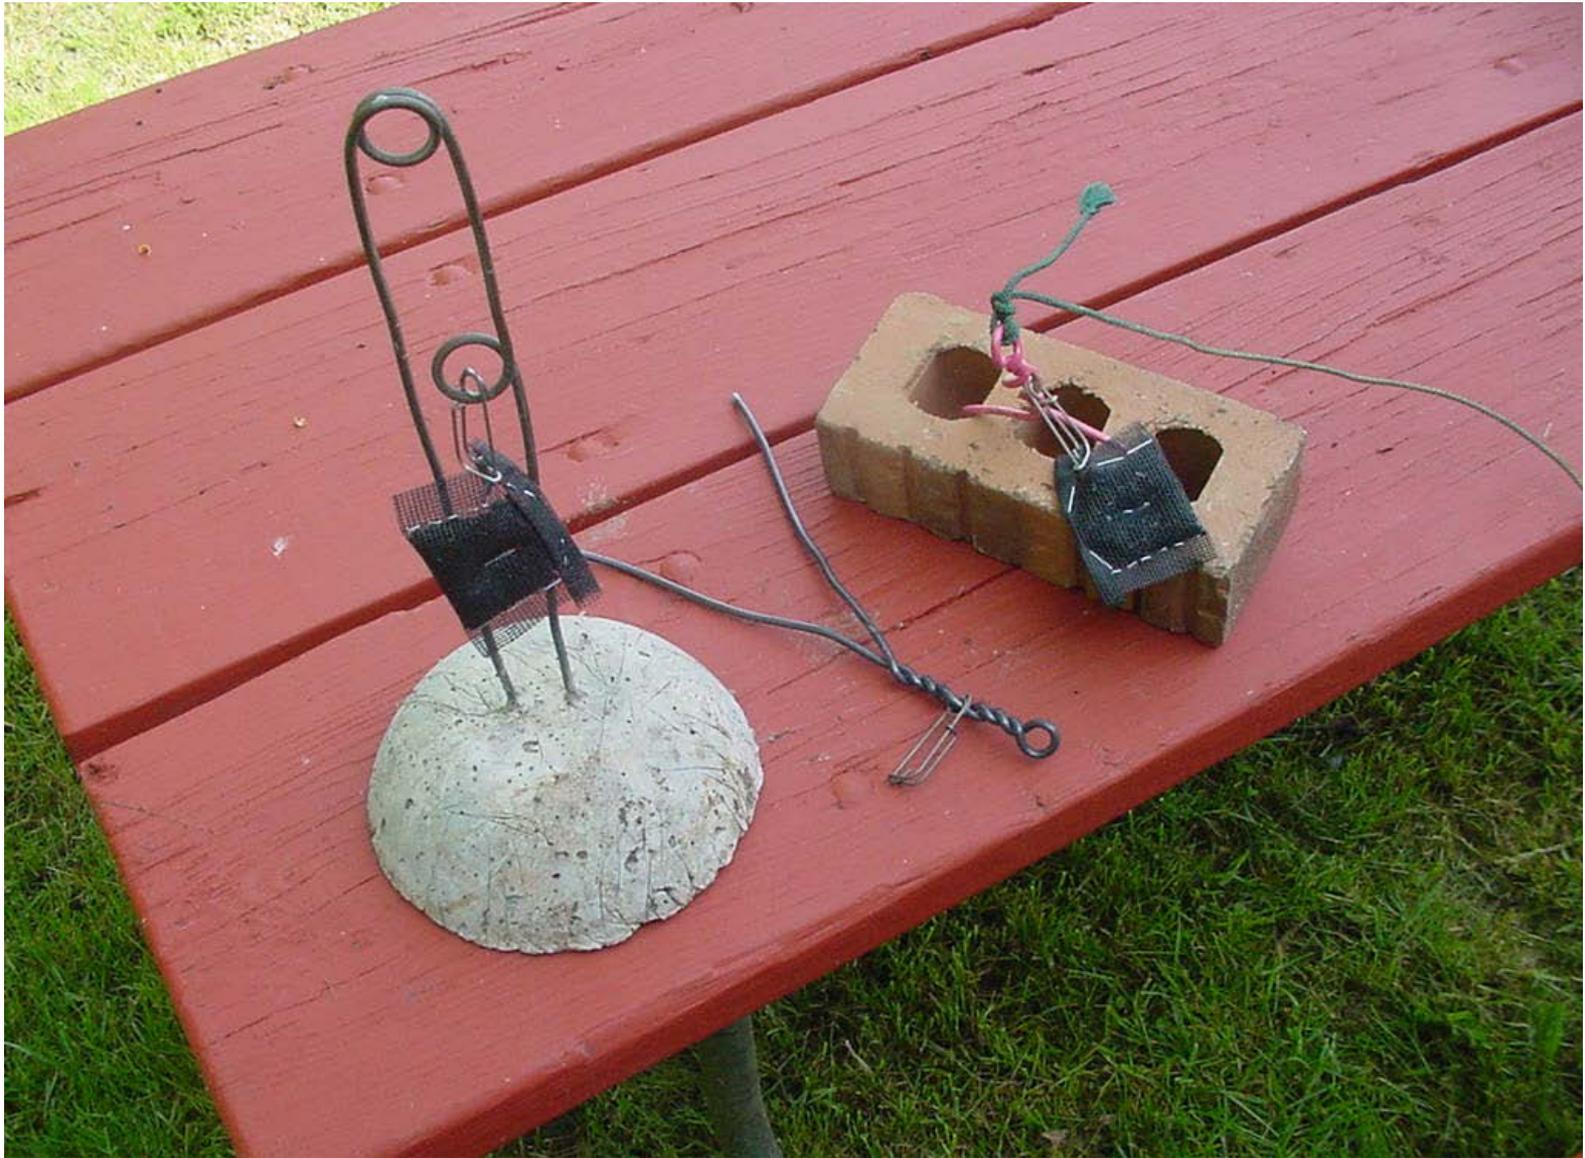
Figure 5. Activated charcoal packet attached by trot-line clip to “Quinlan Gumdrop” or brick fitted with #10 copper wire. Devices secured to retrieval point with nylon cord.

Activated carbon samplers adsorbed and accumulated the fluorescent dyes as they flowed through monitored sites. In some cases, when the dye receptor was missing, dye presence was determined by analysis of water samples. The carbon dye receptors were deployed in flowing water in springs, streams, and caves by use of a modified "gumdrop" anchor (Quinlan, 1986), or a brick fitted with a vinyl-clad copper wire and commercially available trot line clip for securing the receptors ([Figure 5](#)).

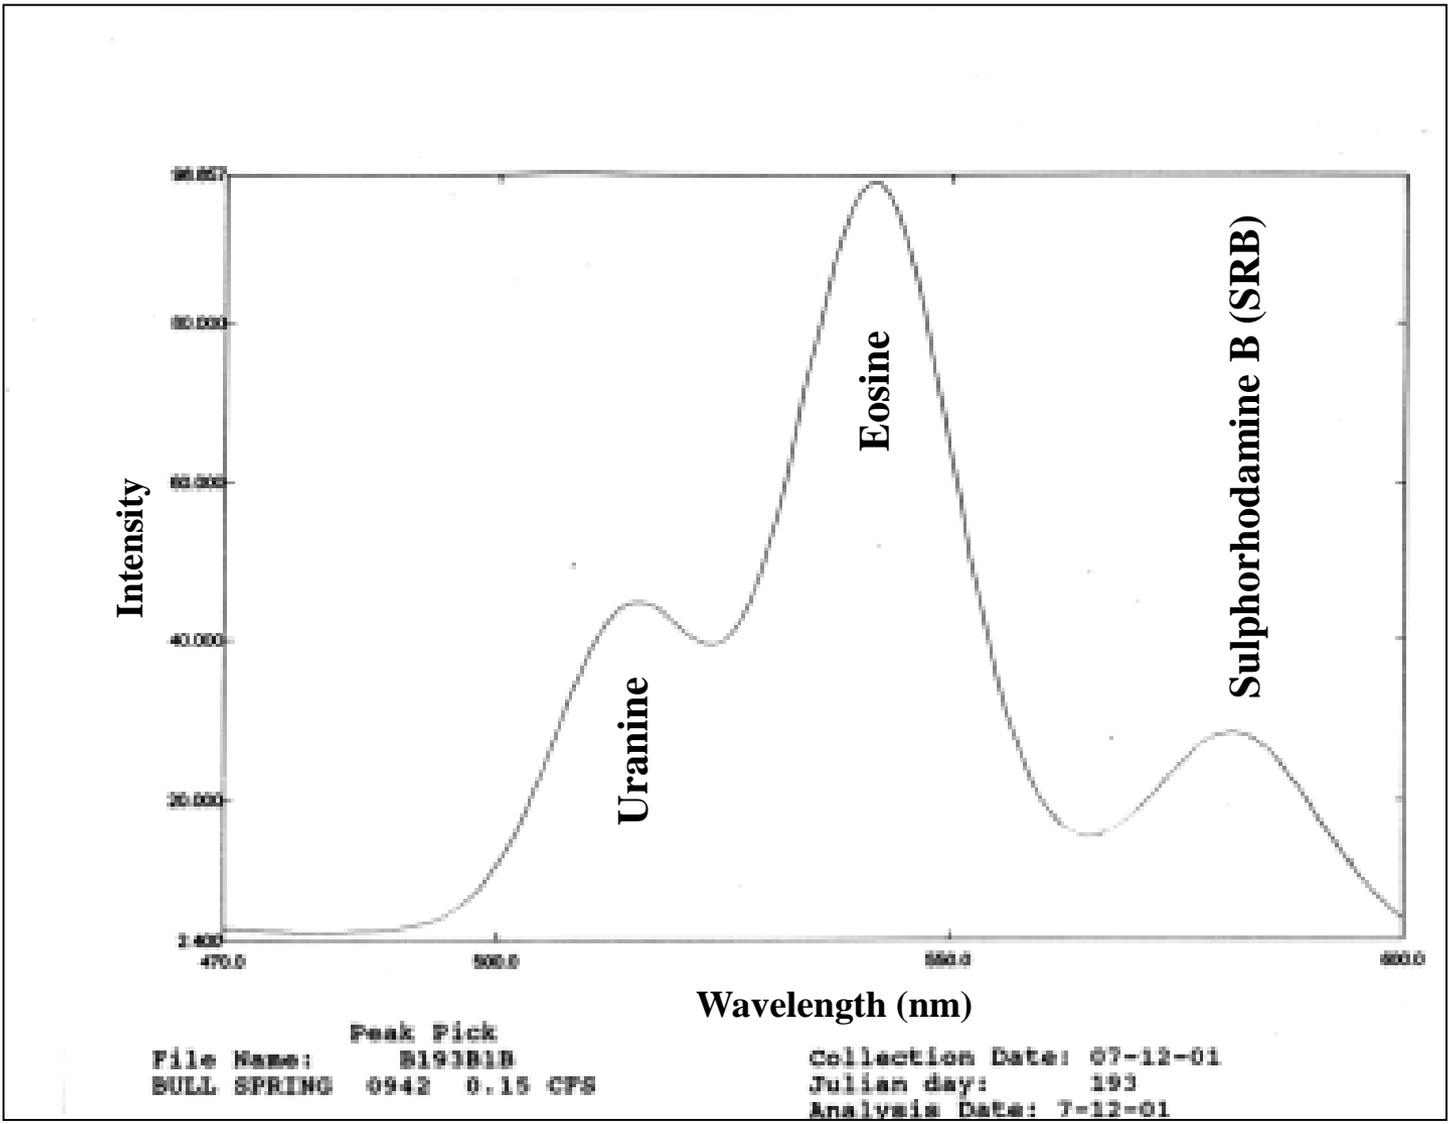
Figure 6. Typical Dye Curve on Spectrofluorophotometer

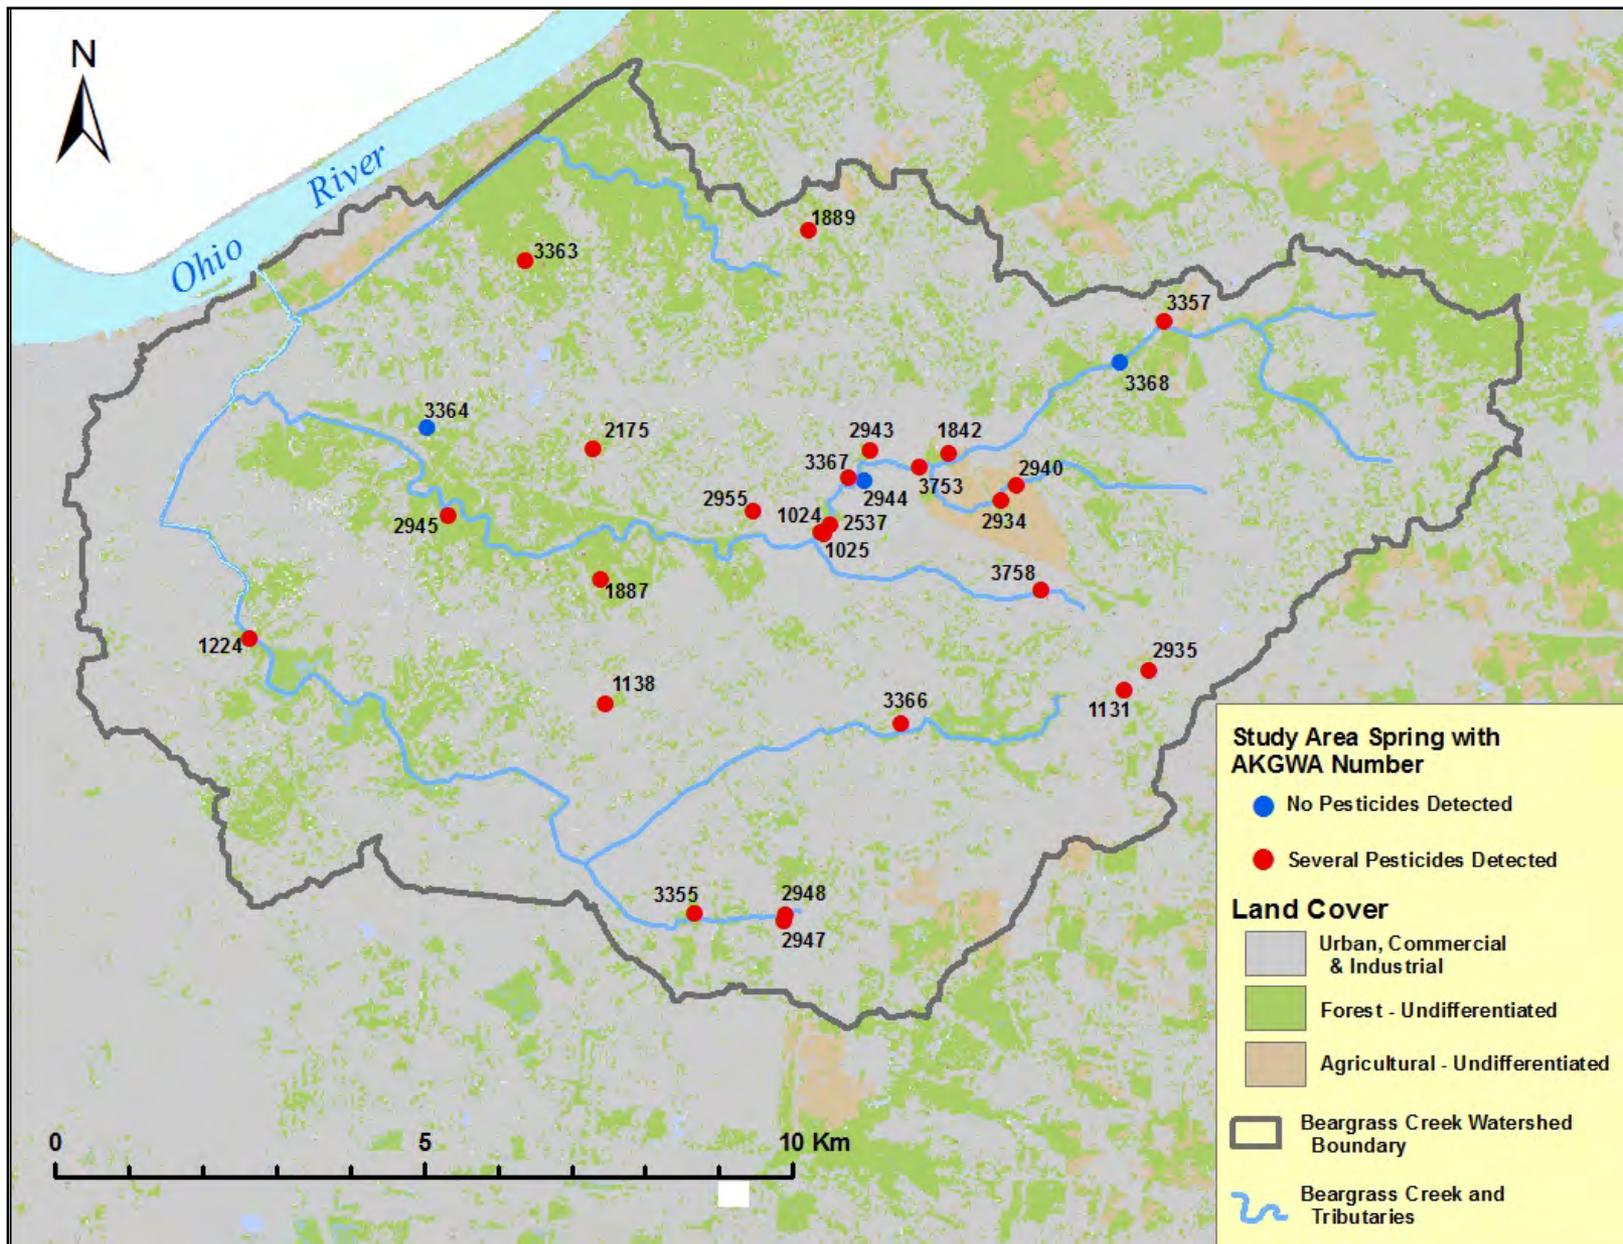
Figure 7. Pesticides Occurrences at Springs Monitored in Beargrass Creek Watershed

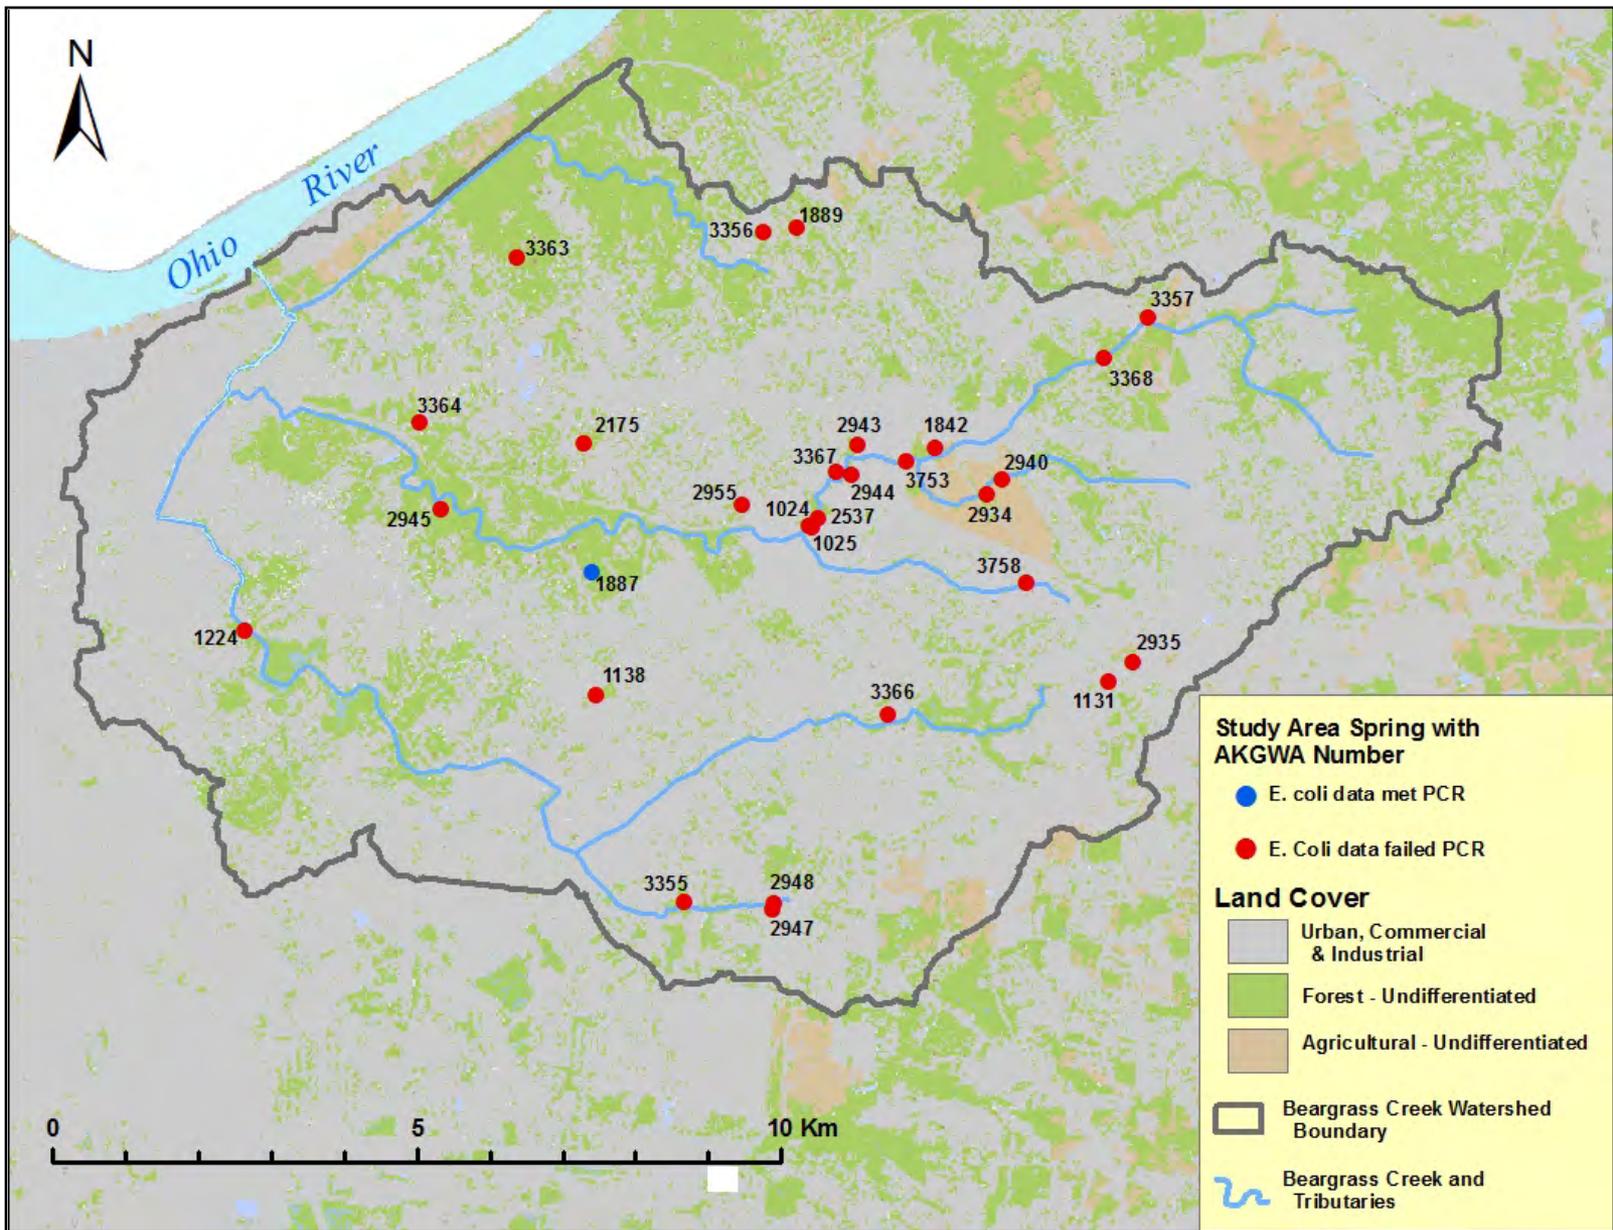
Figure 8. *E. coli* Occurrence at Springs Monitored in Beargrass Creek Watershed

Bacteria (*E. coli*). Only Breckinridge Spring met the criteria to be fully supporting for PCR based on *E. coli* results. The other 17 springs assessed were found to be impaired ([Figure 8](#)). The highest values were observed at CSO 206 Spring, with a maximum value reported as greater than 291,960 CFU/100 mL. However, many results from several springs were well over the standard of 240 CFU/100 mL.

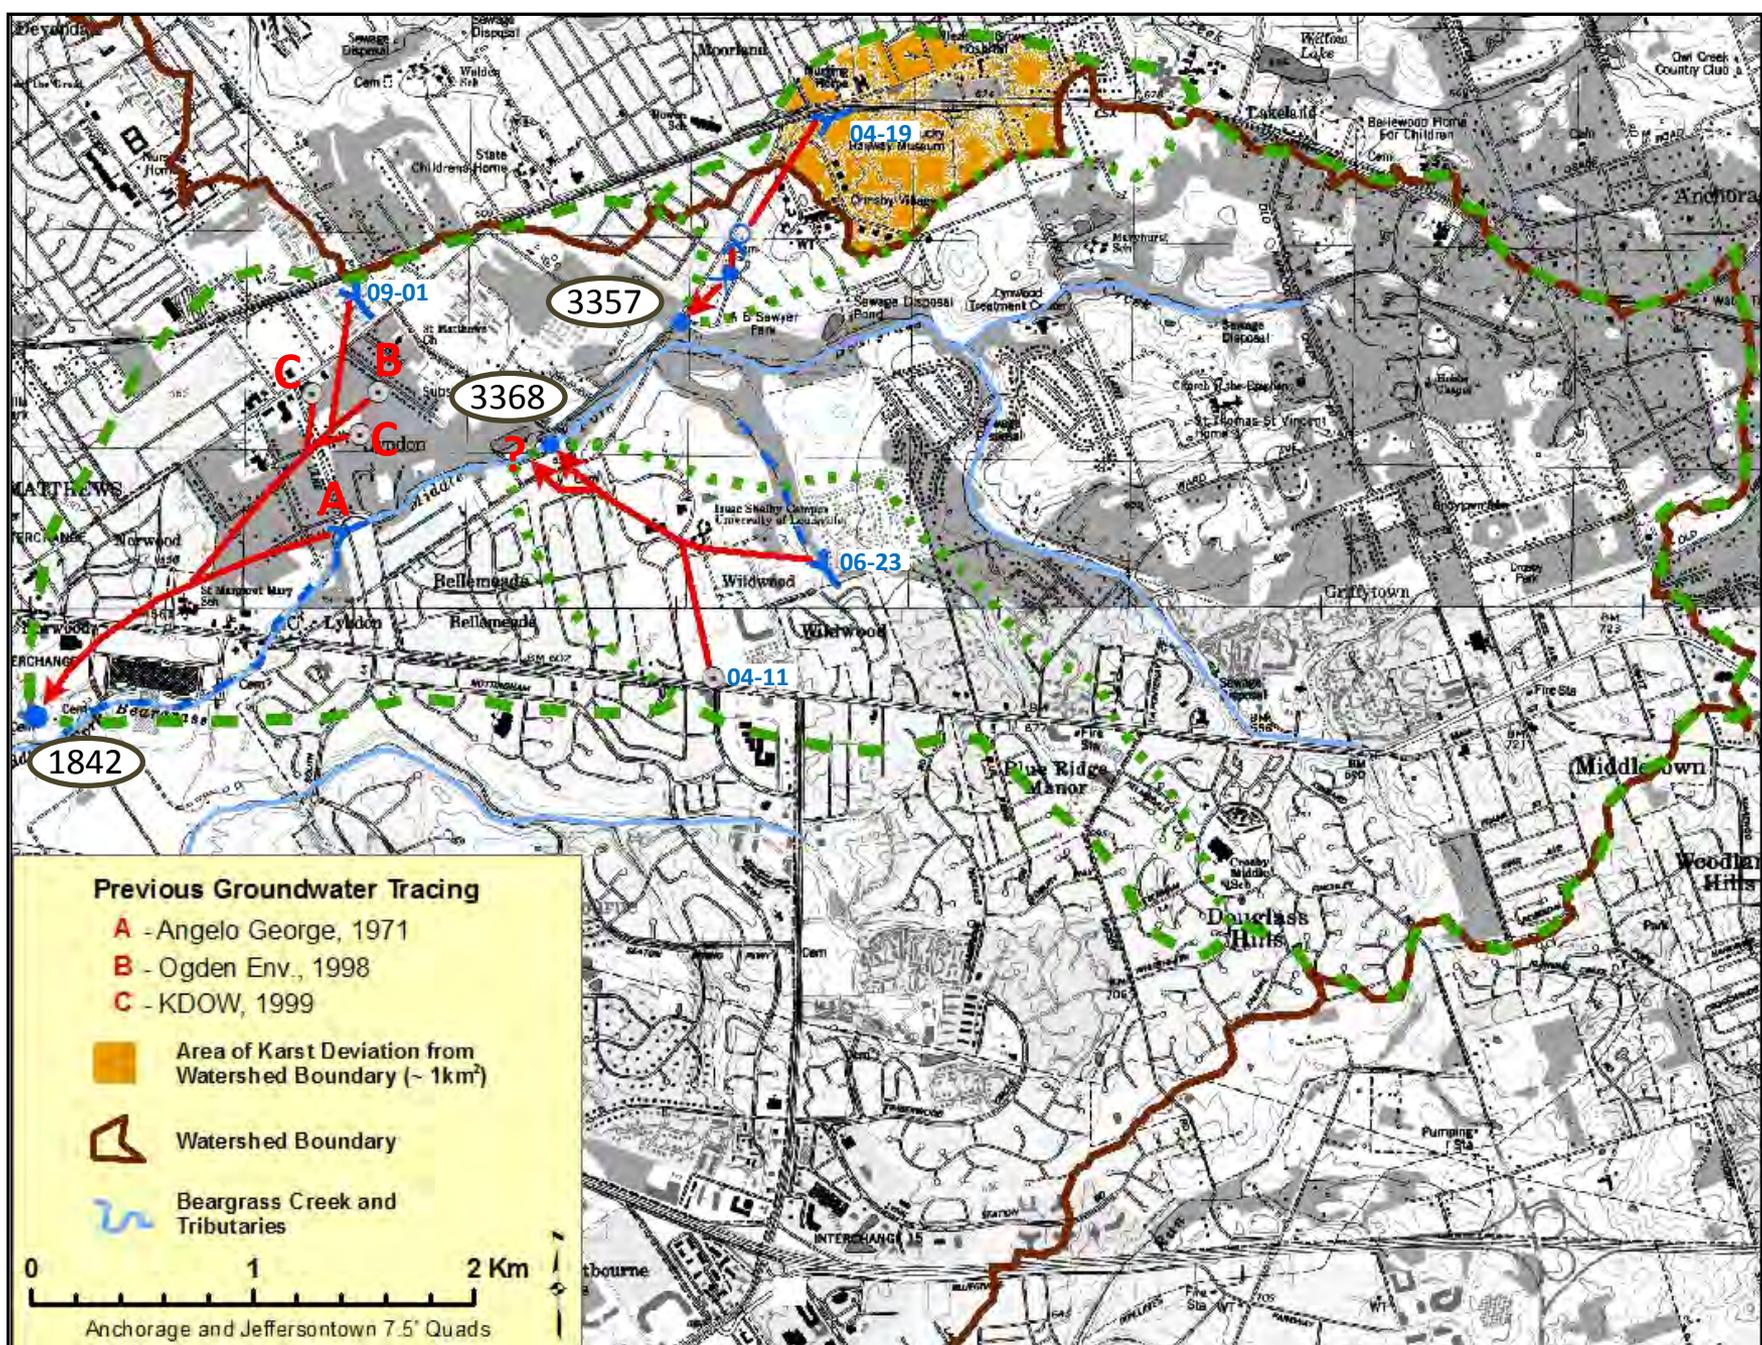
Figure 10. Tracer Data for A'Sturgis Station Sp (1842), Steinrock Sp (3368) and A.B. Sawyer Gate Sp (3357)

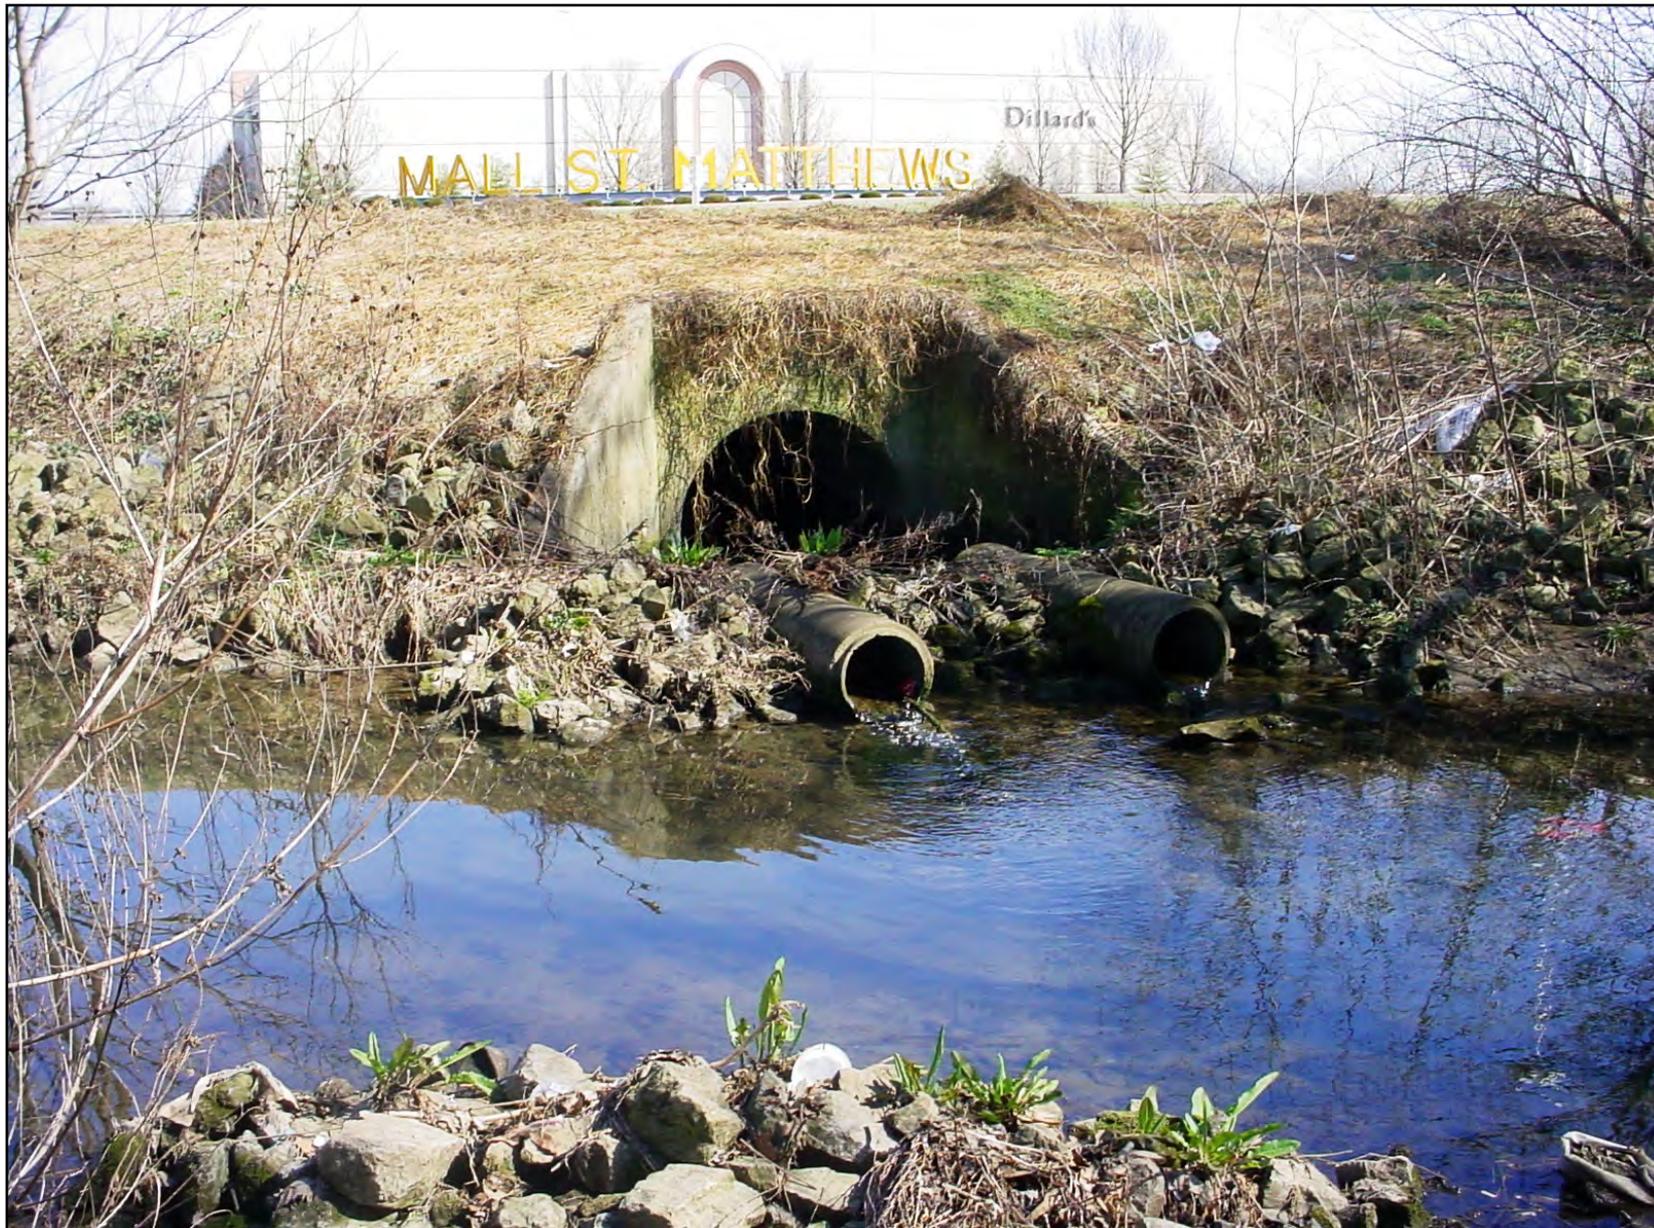
Figure 13. Bowling Blvd Spring Photograph

[N38.24583°/W85.62848°] ([Figure 13](#)). This spring is not mapped on the topographic and geologic maps. The natural spring feature may lie somewhere beneath the parking lot of the mall and should discharge from the Sellersburg and Jeffersonville Limestones (Kepferle, 1974) at an elevation of about 155 m AMSL. High flow discharge reaches about 85 L/s, however, flow ceases during very dry weather. Since the estimated basin for this spring is 4.1 km², it should exhibit significant base flow. The most likely explanation for this loss of base flow is infiltration into the sanitary sewer.

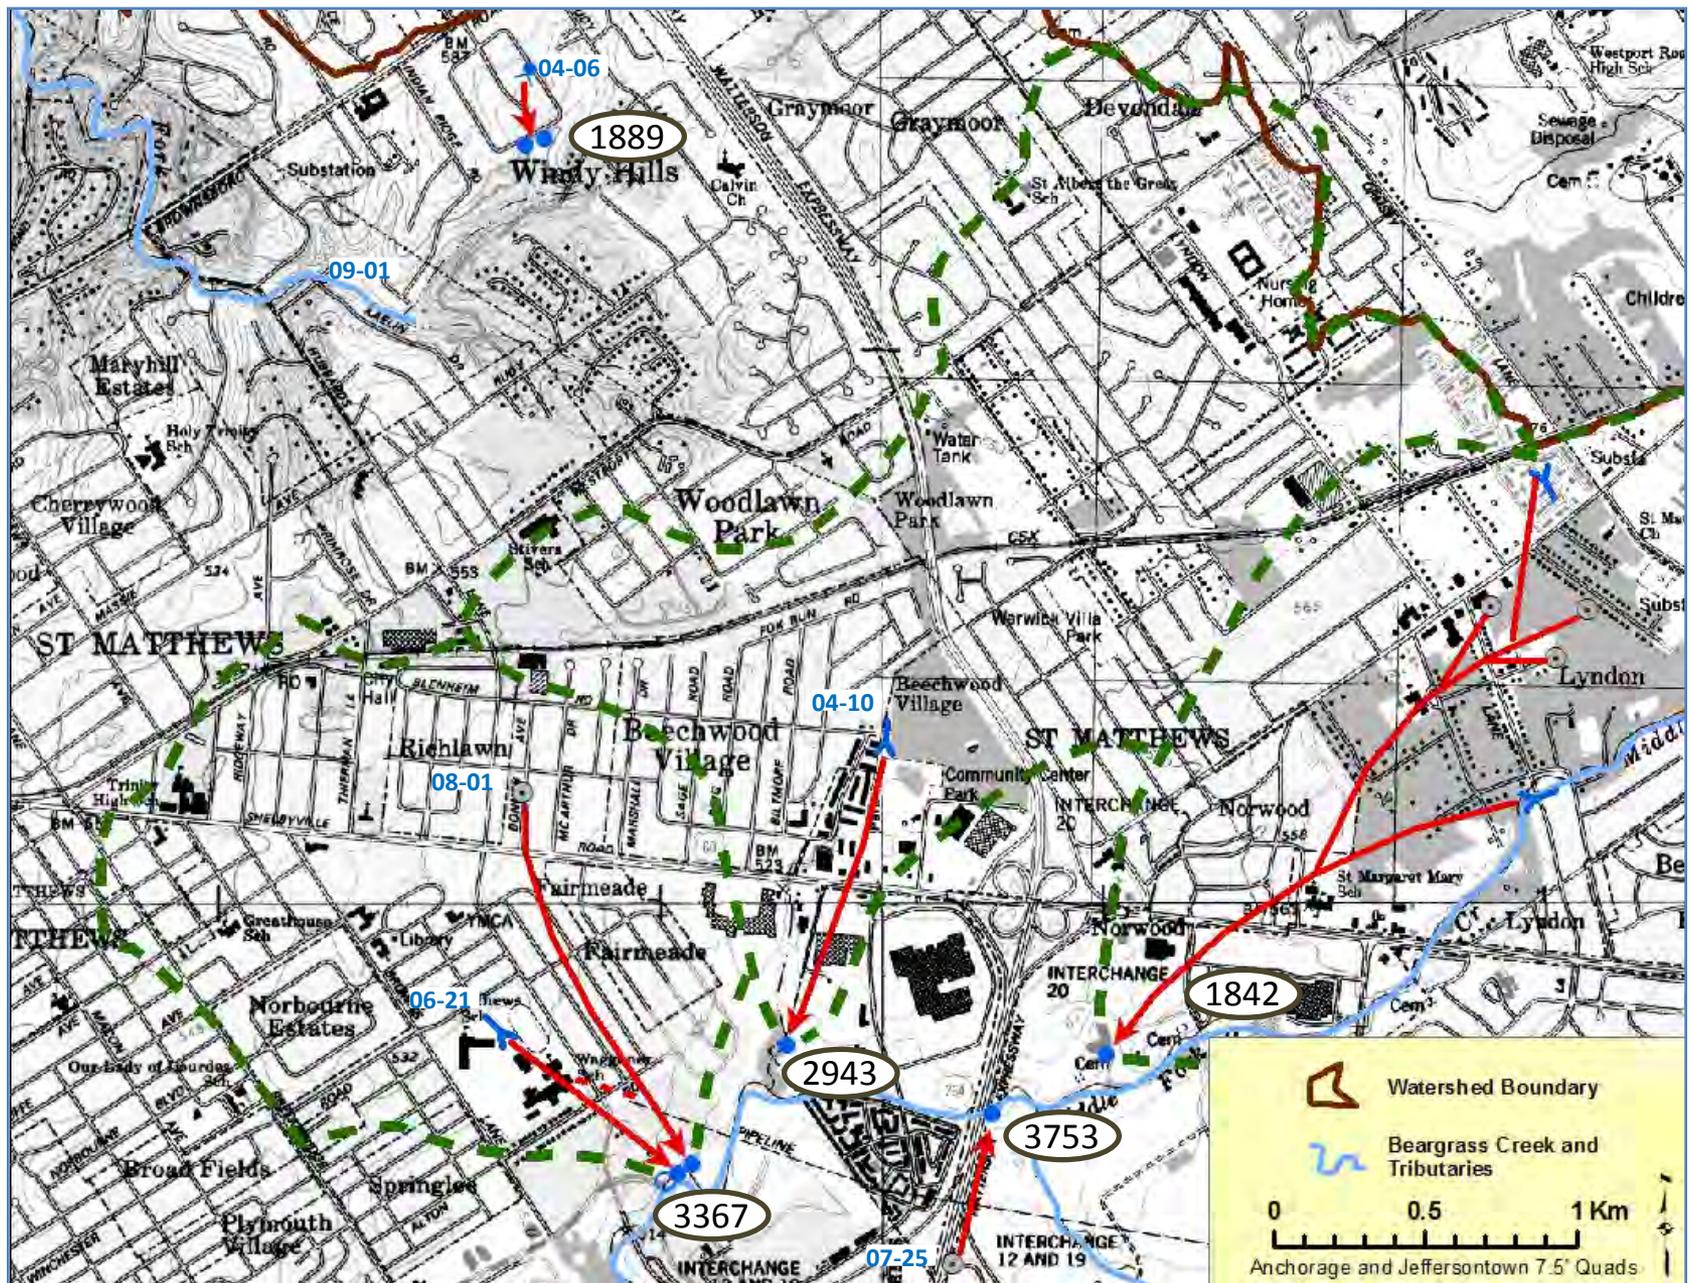
Figure 14. Tracer Data for Bowling Blvd Sp (2943), Cypress Pointe Sp (3367), Windy Hills Sp (1889) and Culvert Sp above Watterson (3753)

June 15, 2004: During low flow conditions, about 28 g of eosine were injected at **Swallet @ St. Matthews Park**, located at the east end of Blenheim Road [N38.255553°/W85.624340°]. Four sites were monitored. Within three days, Bowling Blvd. Spring, 1.14 km to the south-southwest, was very positive for eosine, while the three other sites were negative. Eleven days later Bowling Blvd. Spring was again very positive for eosine, while the other sites were likewise negative. The storm drain at Stonehenge showed an inconclusive trace of eosine, however, the dye injection site along the losing stream in St. Matthews Park at Beachwood Village would overflow through the storm drain. Any residual dye from the injection site could thus have been transported through the storm drain. Thirty-six days later Bowling Blvd. was inconclusive for eosine and the test was ended. Results are presented on the map in [Figure 14](#).

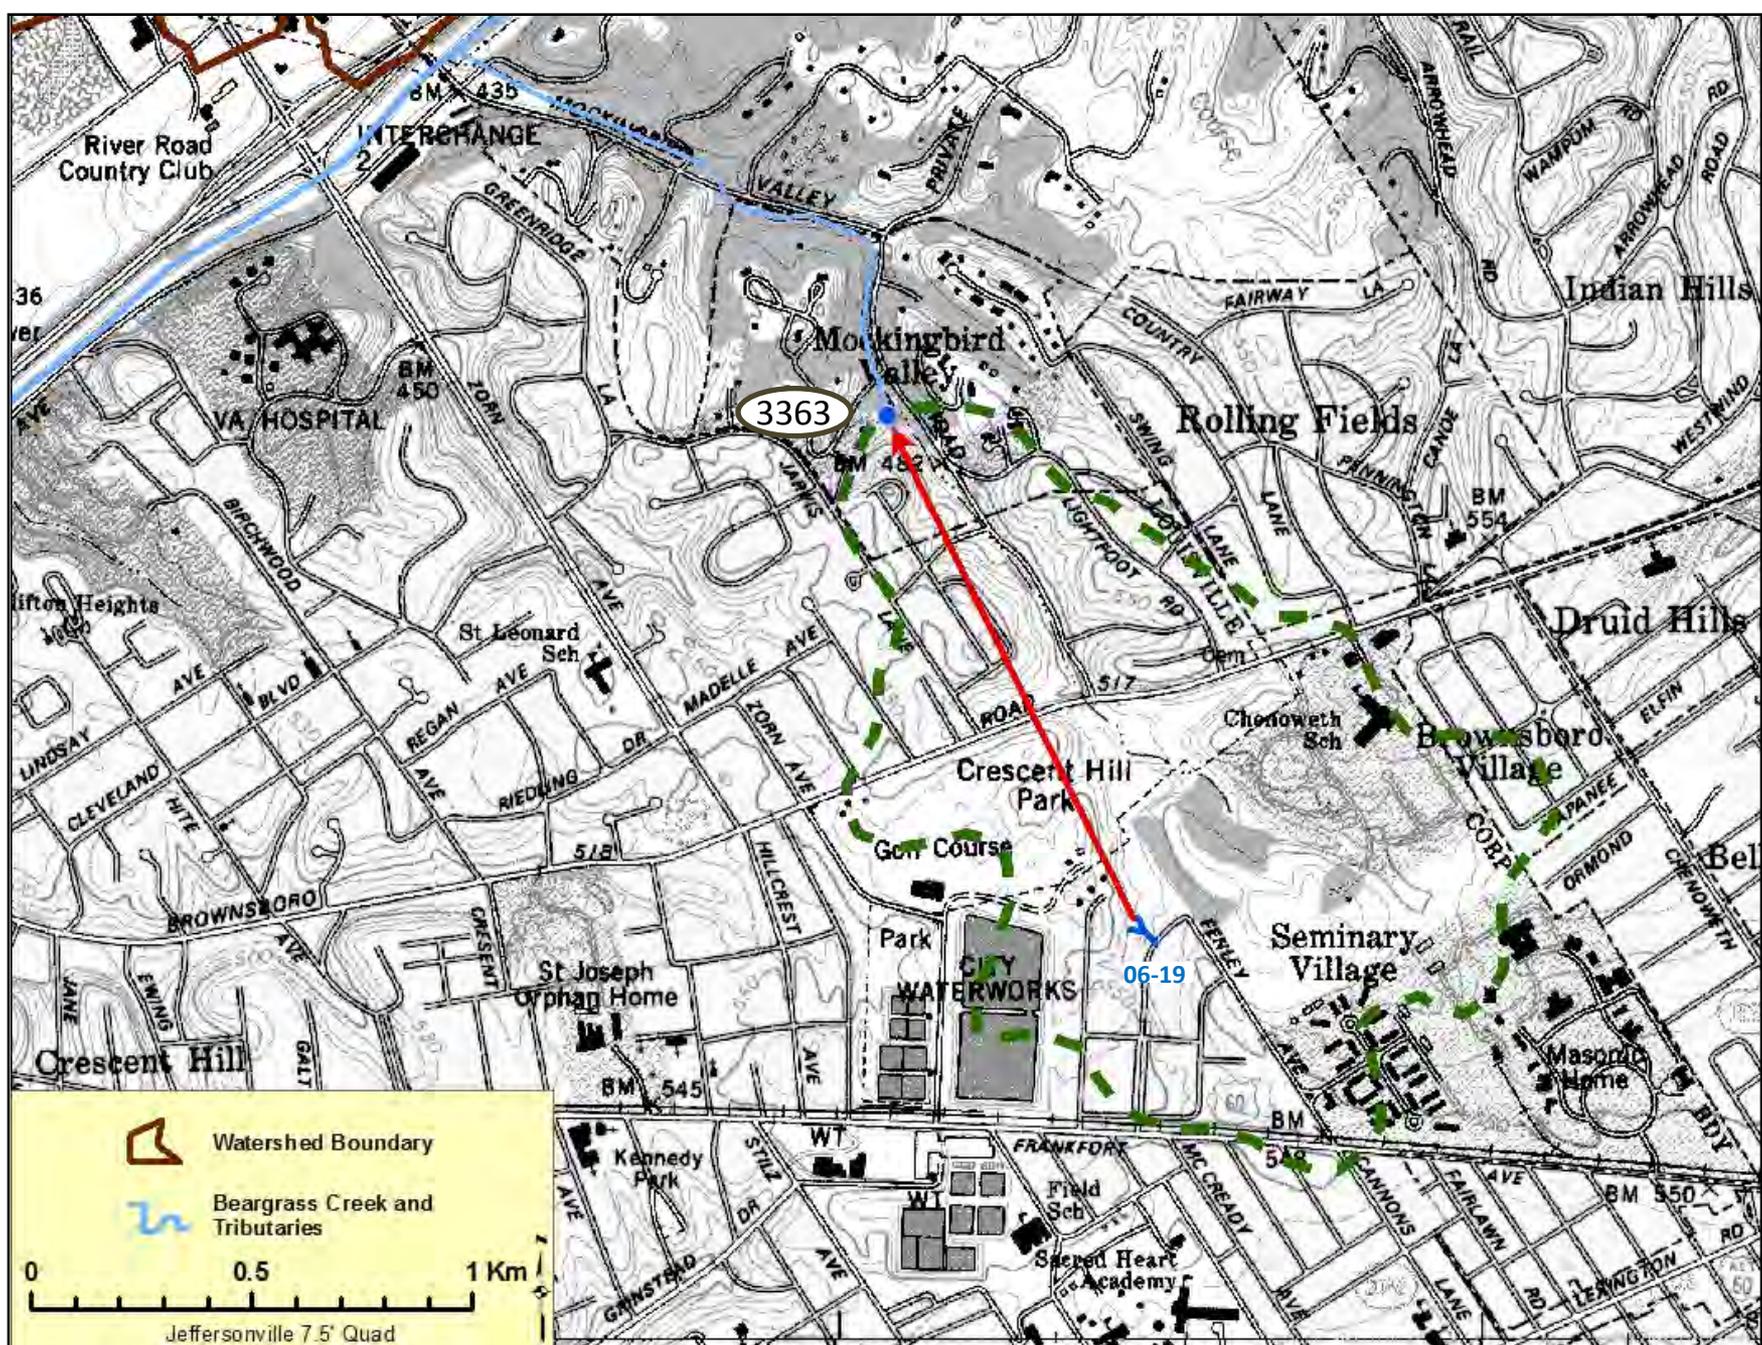
Figure 17. Tracer Data for Mockingbird Valley Sp (3363)
