Groundwater Assessment for Nonpoint Source Pollution

Impacts and Spring Basin Delineations within

Sub-watersheds of the Salt River Basin:

Beargrass Creek and Sinking Creek

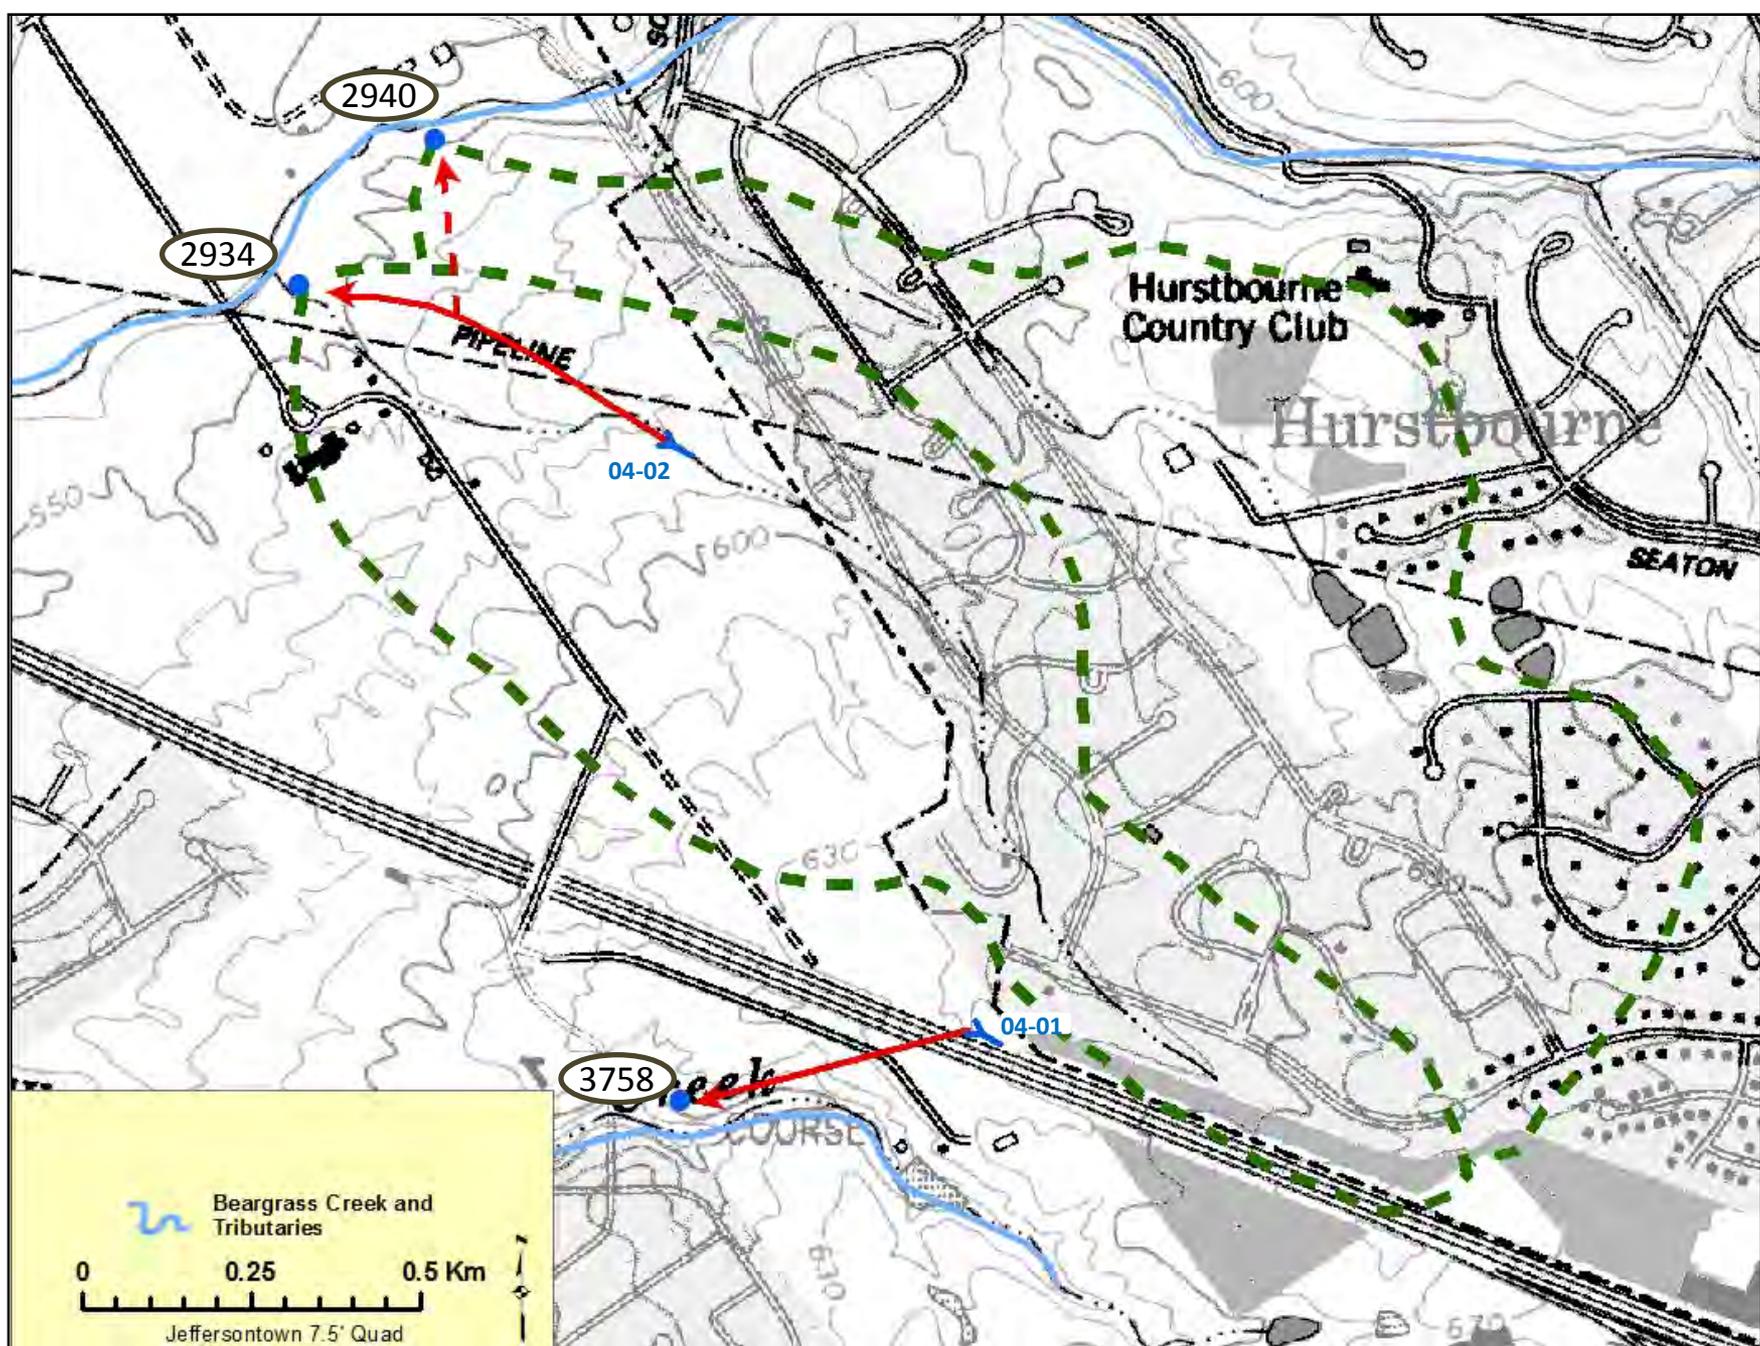
Figure 20. Tracer Data for Oxmoor Sp (2934), Upper Oxmoor Sp (2940) and Hole 10 Sp (3758)

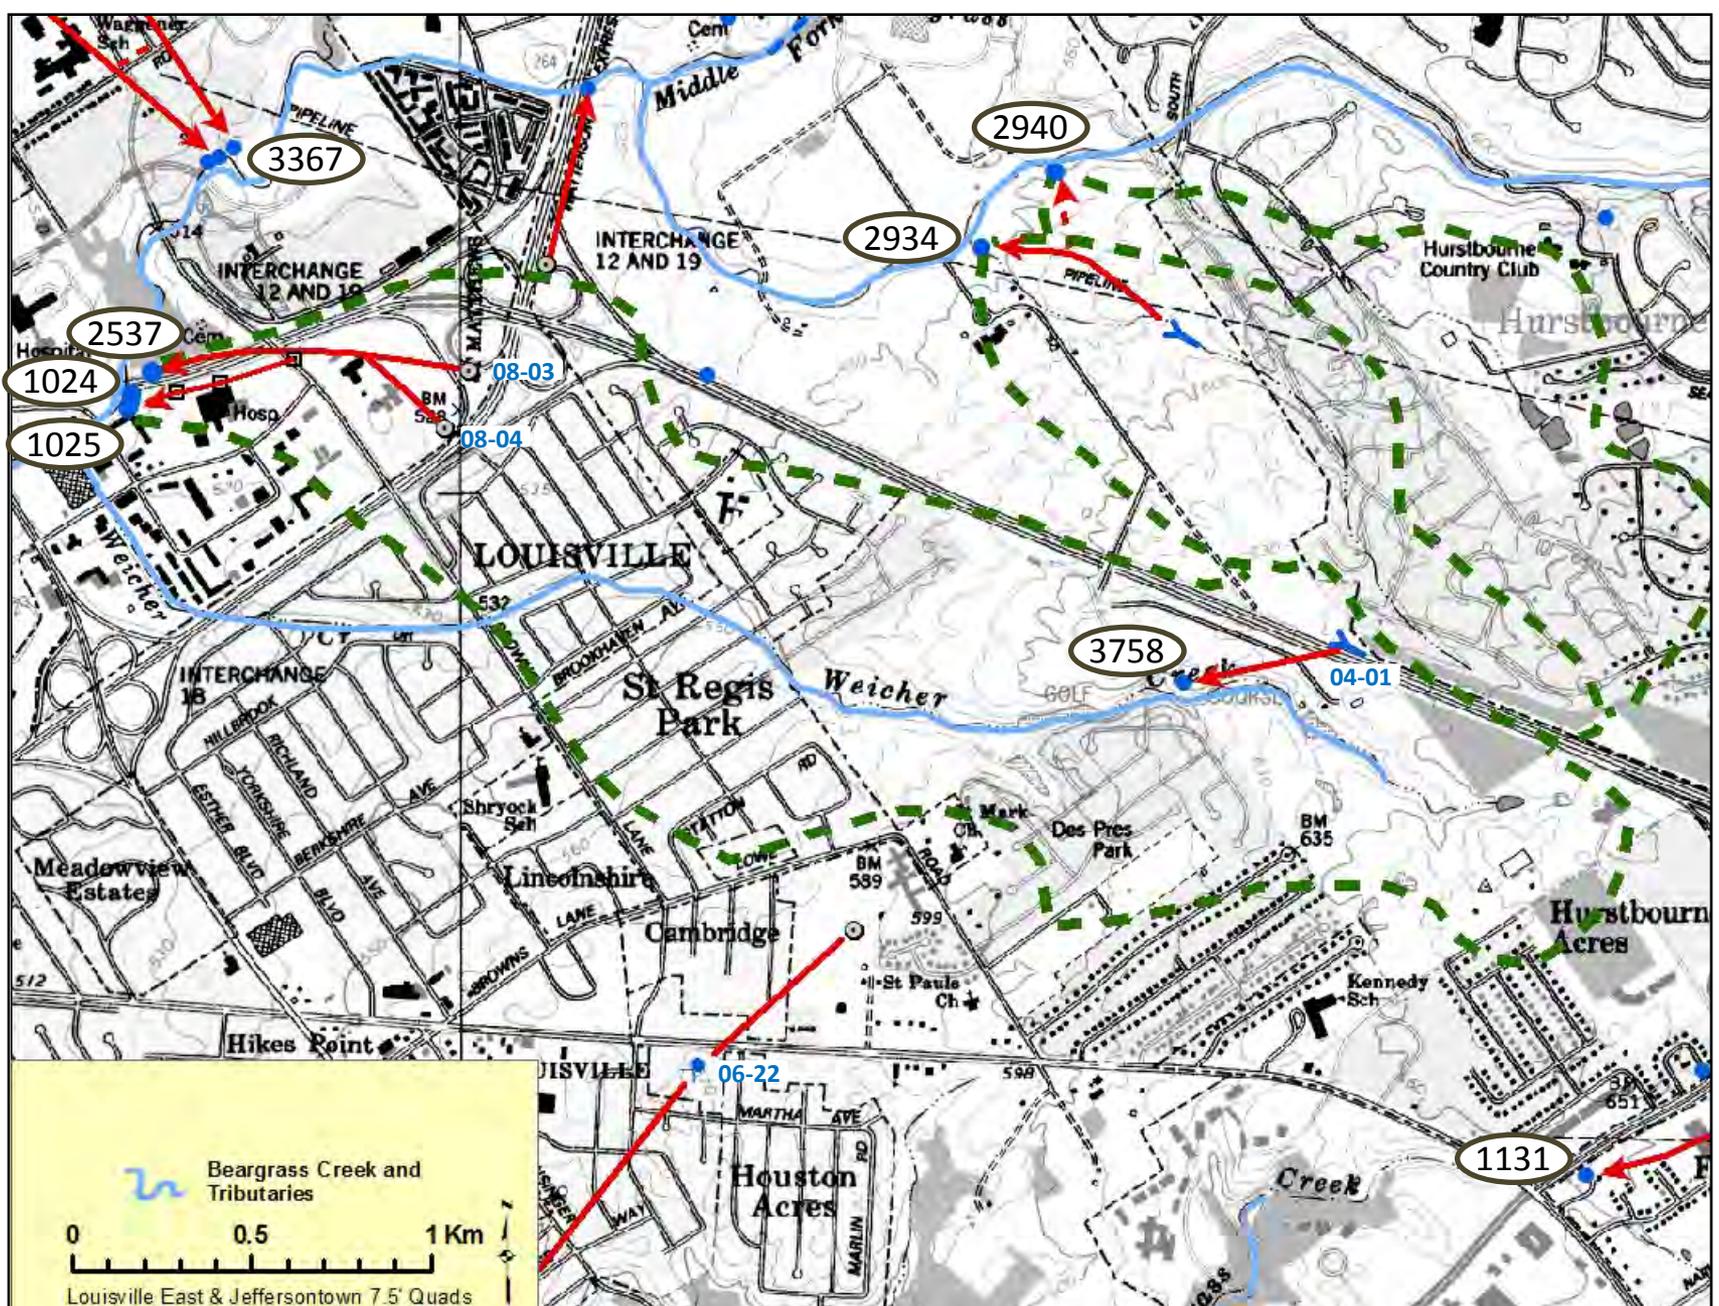
Figure 23. Tracer Data for Low Dutch Station Sp (2537), Brown Cem. Culvert Sp (1024) and Weicher Cr. Diversion Culvert Sp (1025)

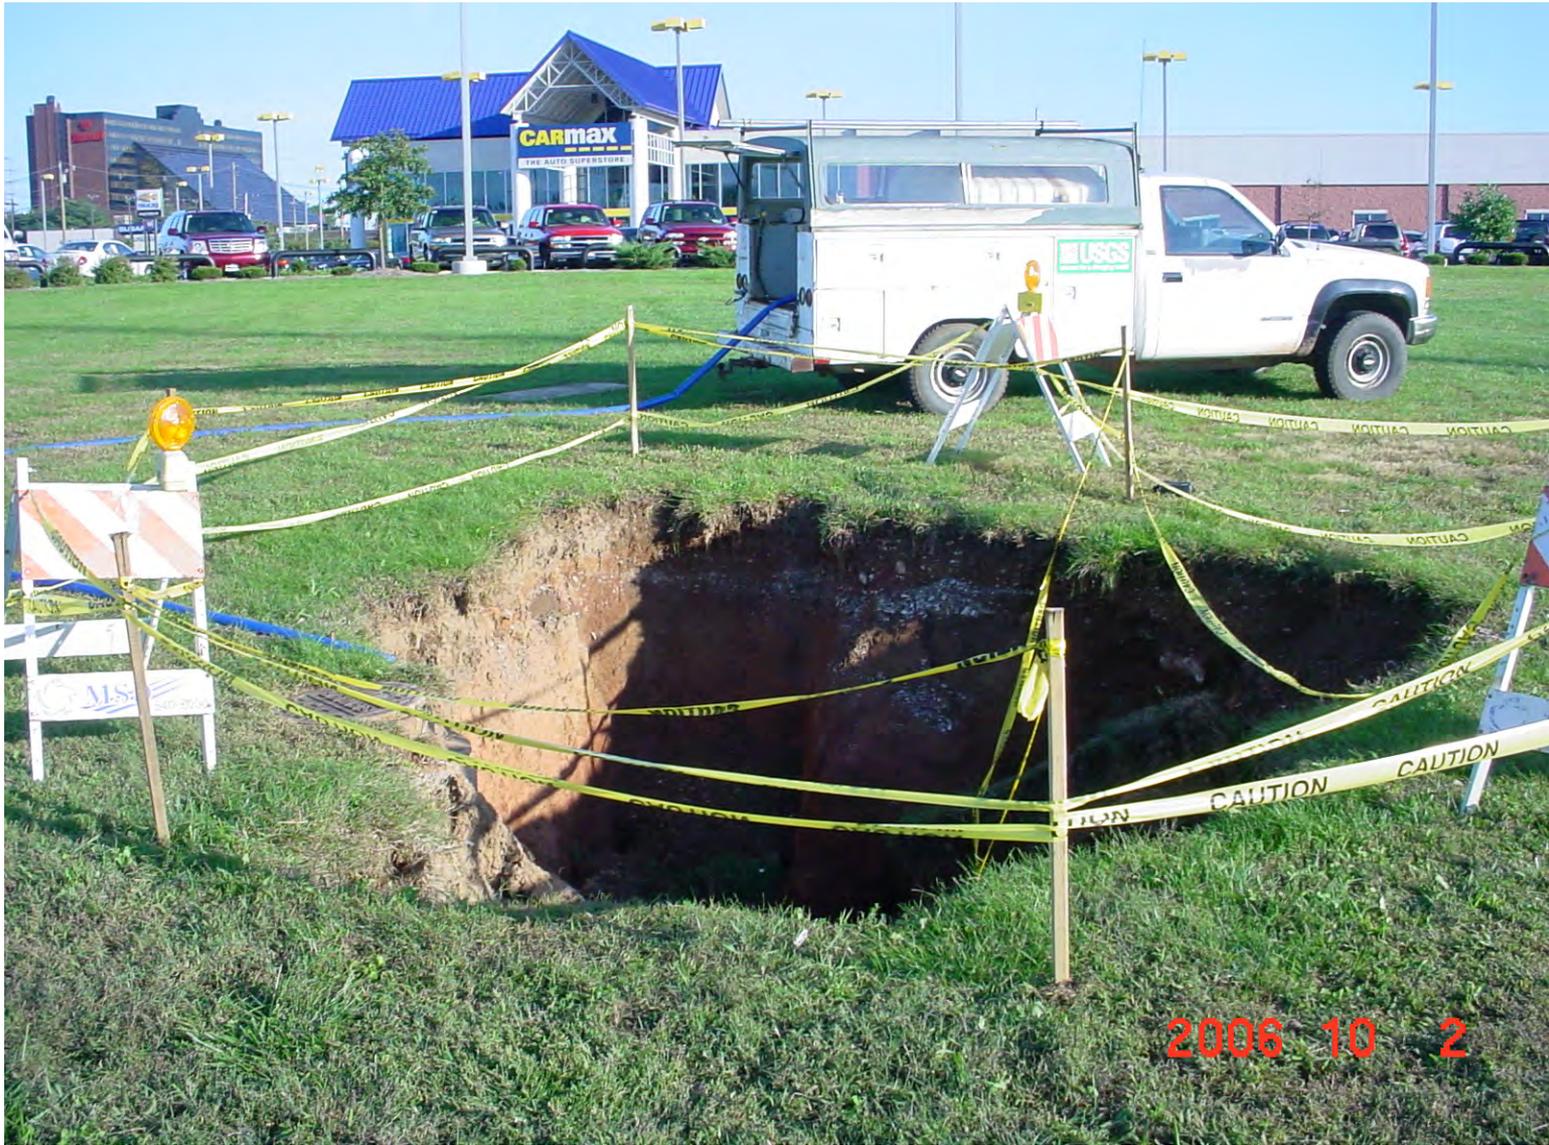
Figure 25b. CarMax Sinkhole Collapse Photograph

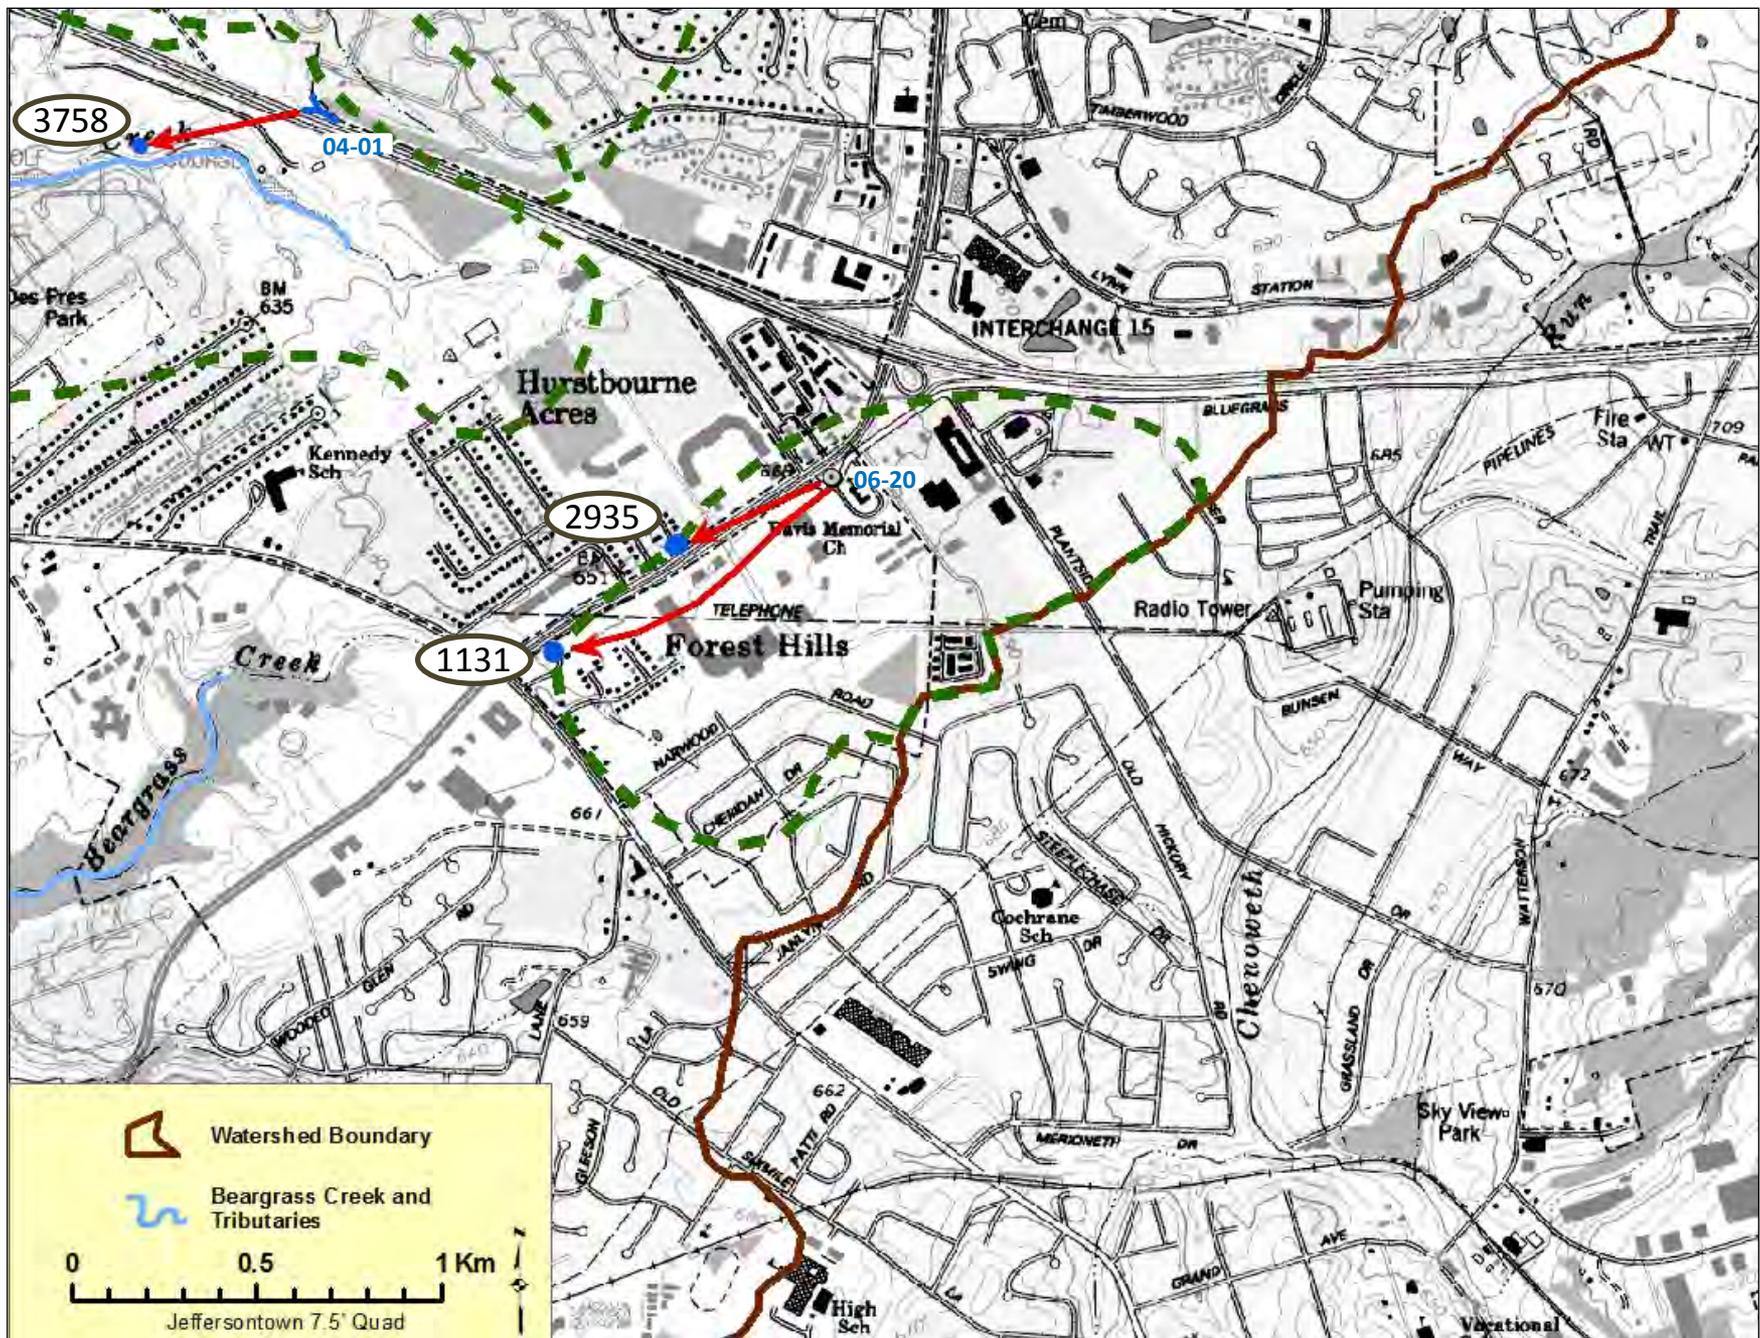
Figure 26. Tracer Data for Nunnlea Sp (2935) and Zenderhouse Sp (1131)

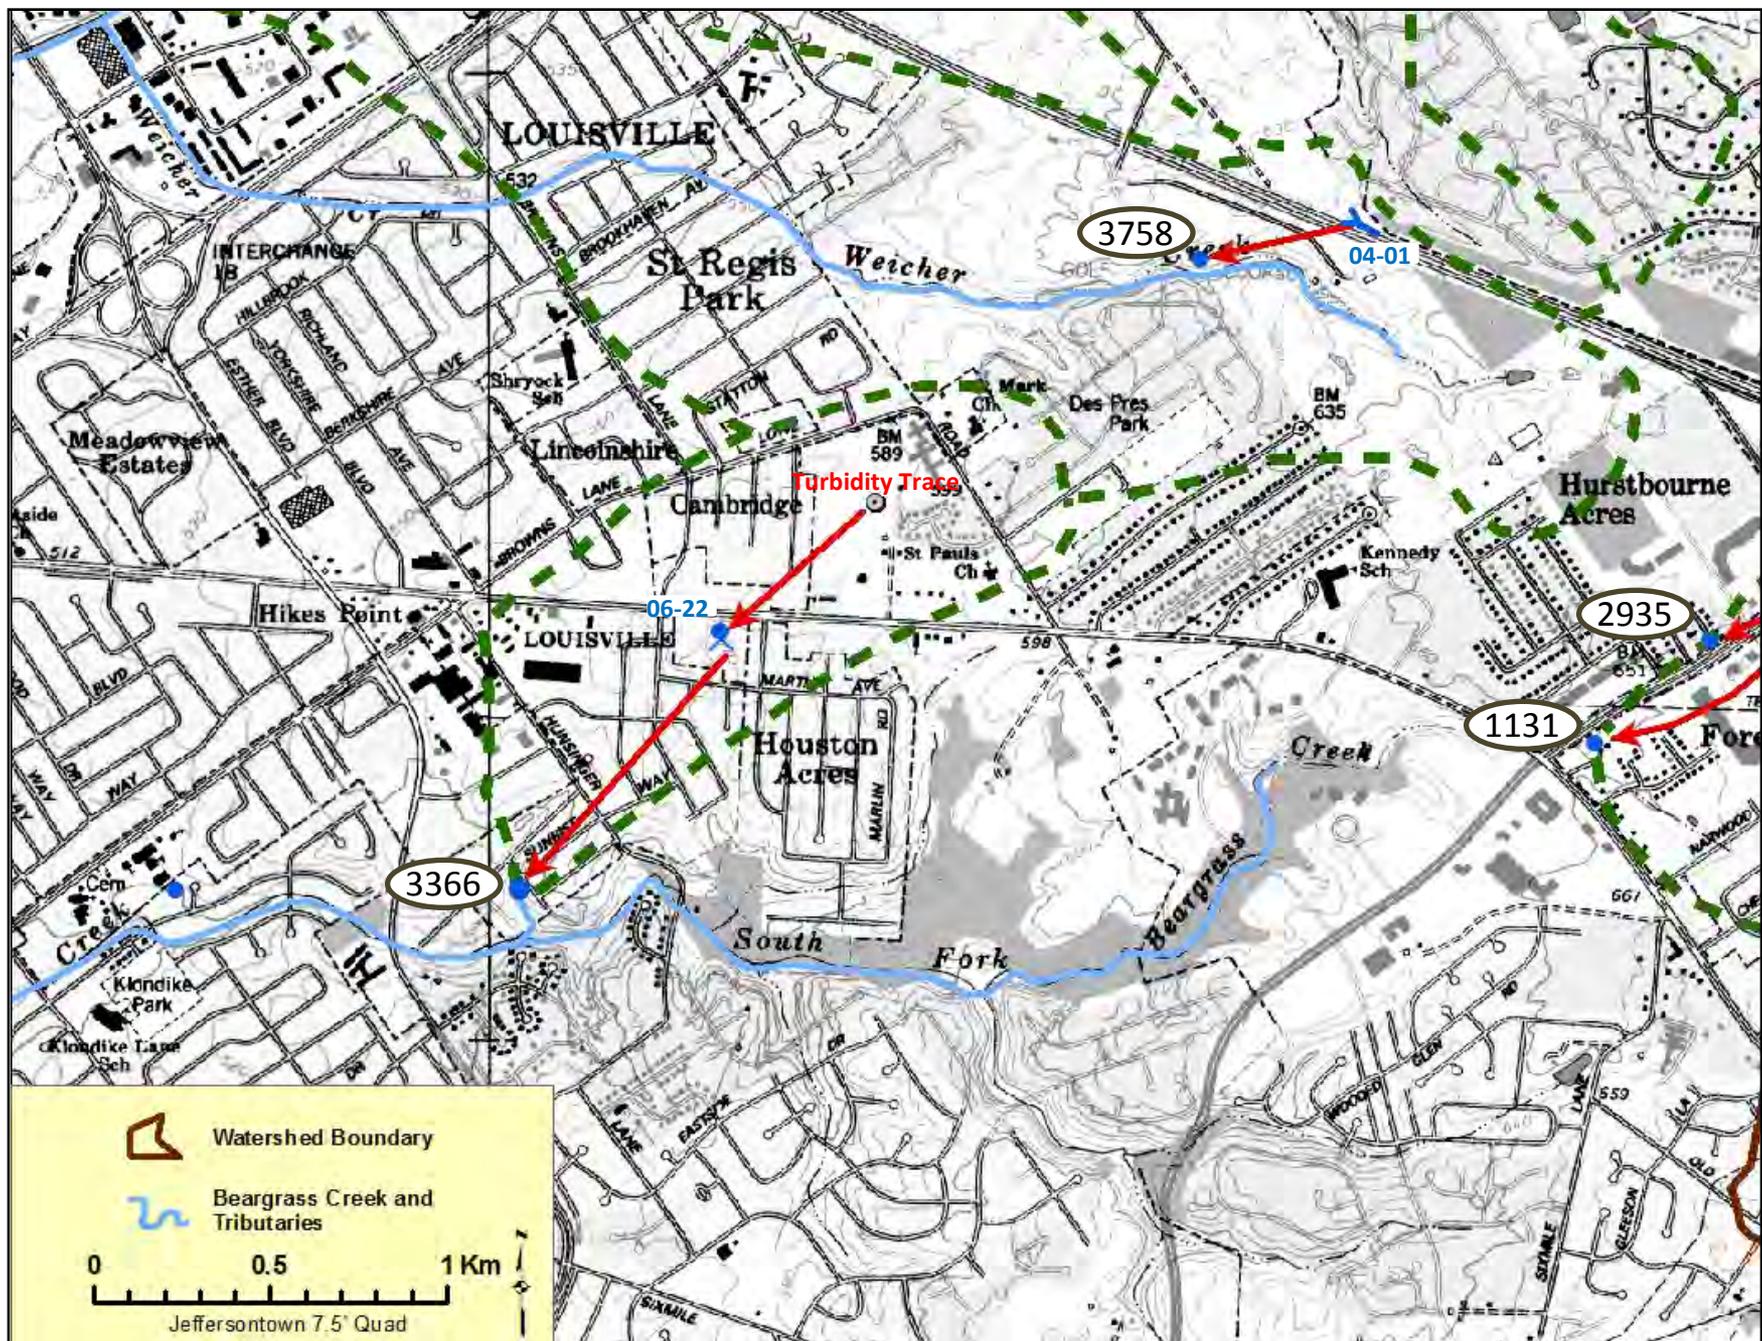
Figure 28. Tracer Data for Ray Sp (3366)

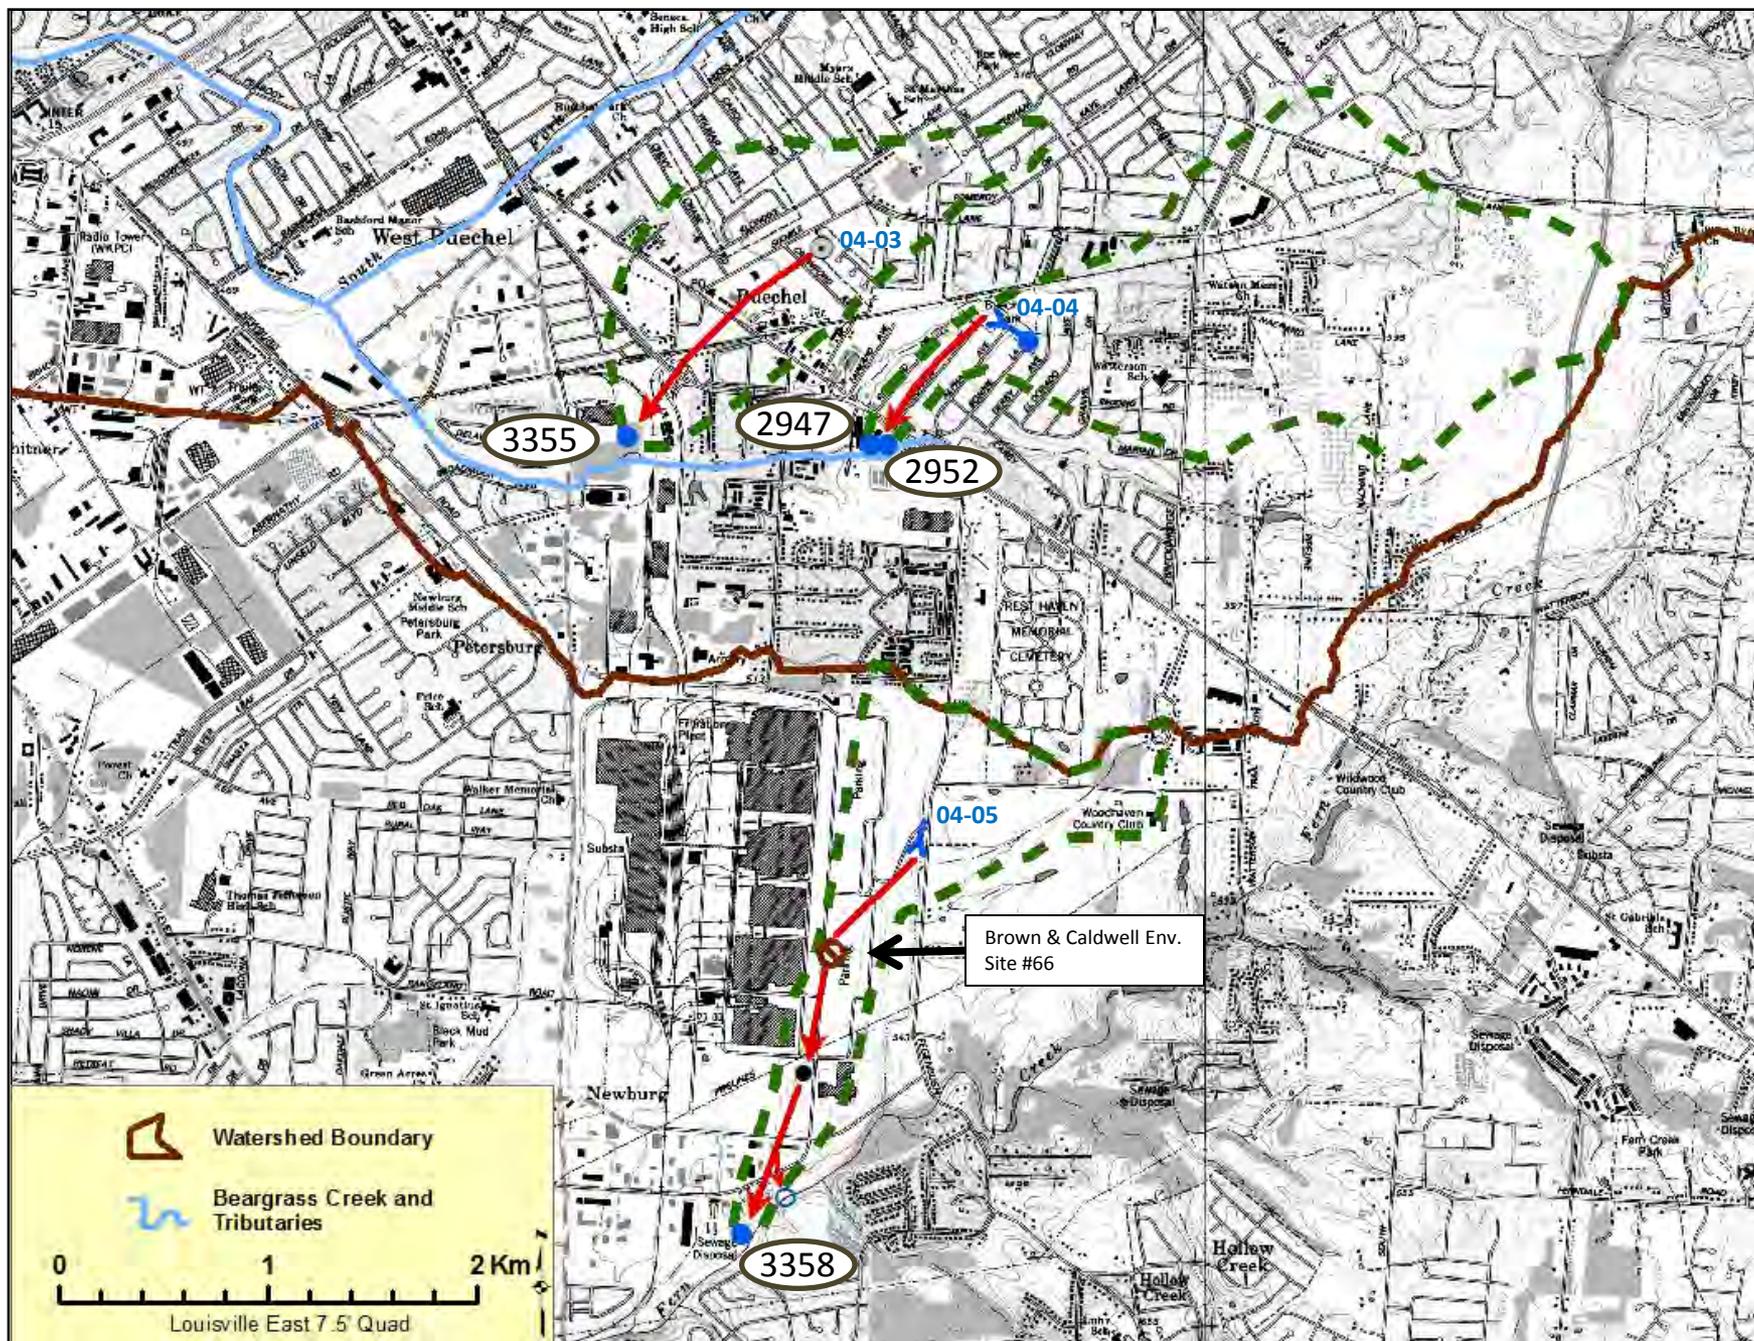
Figure 31. Tracer Data for Buechel Sp (3355), Culvert/Confluence Springs (2947/2952) and Culvert Sp @ Genfab (3358)

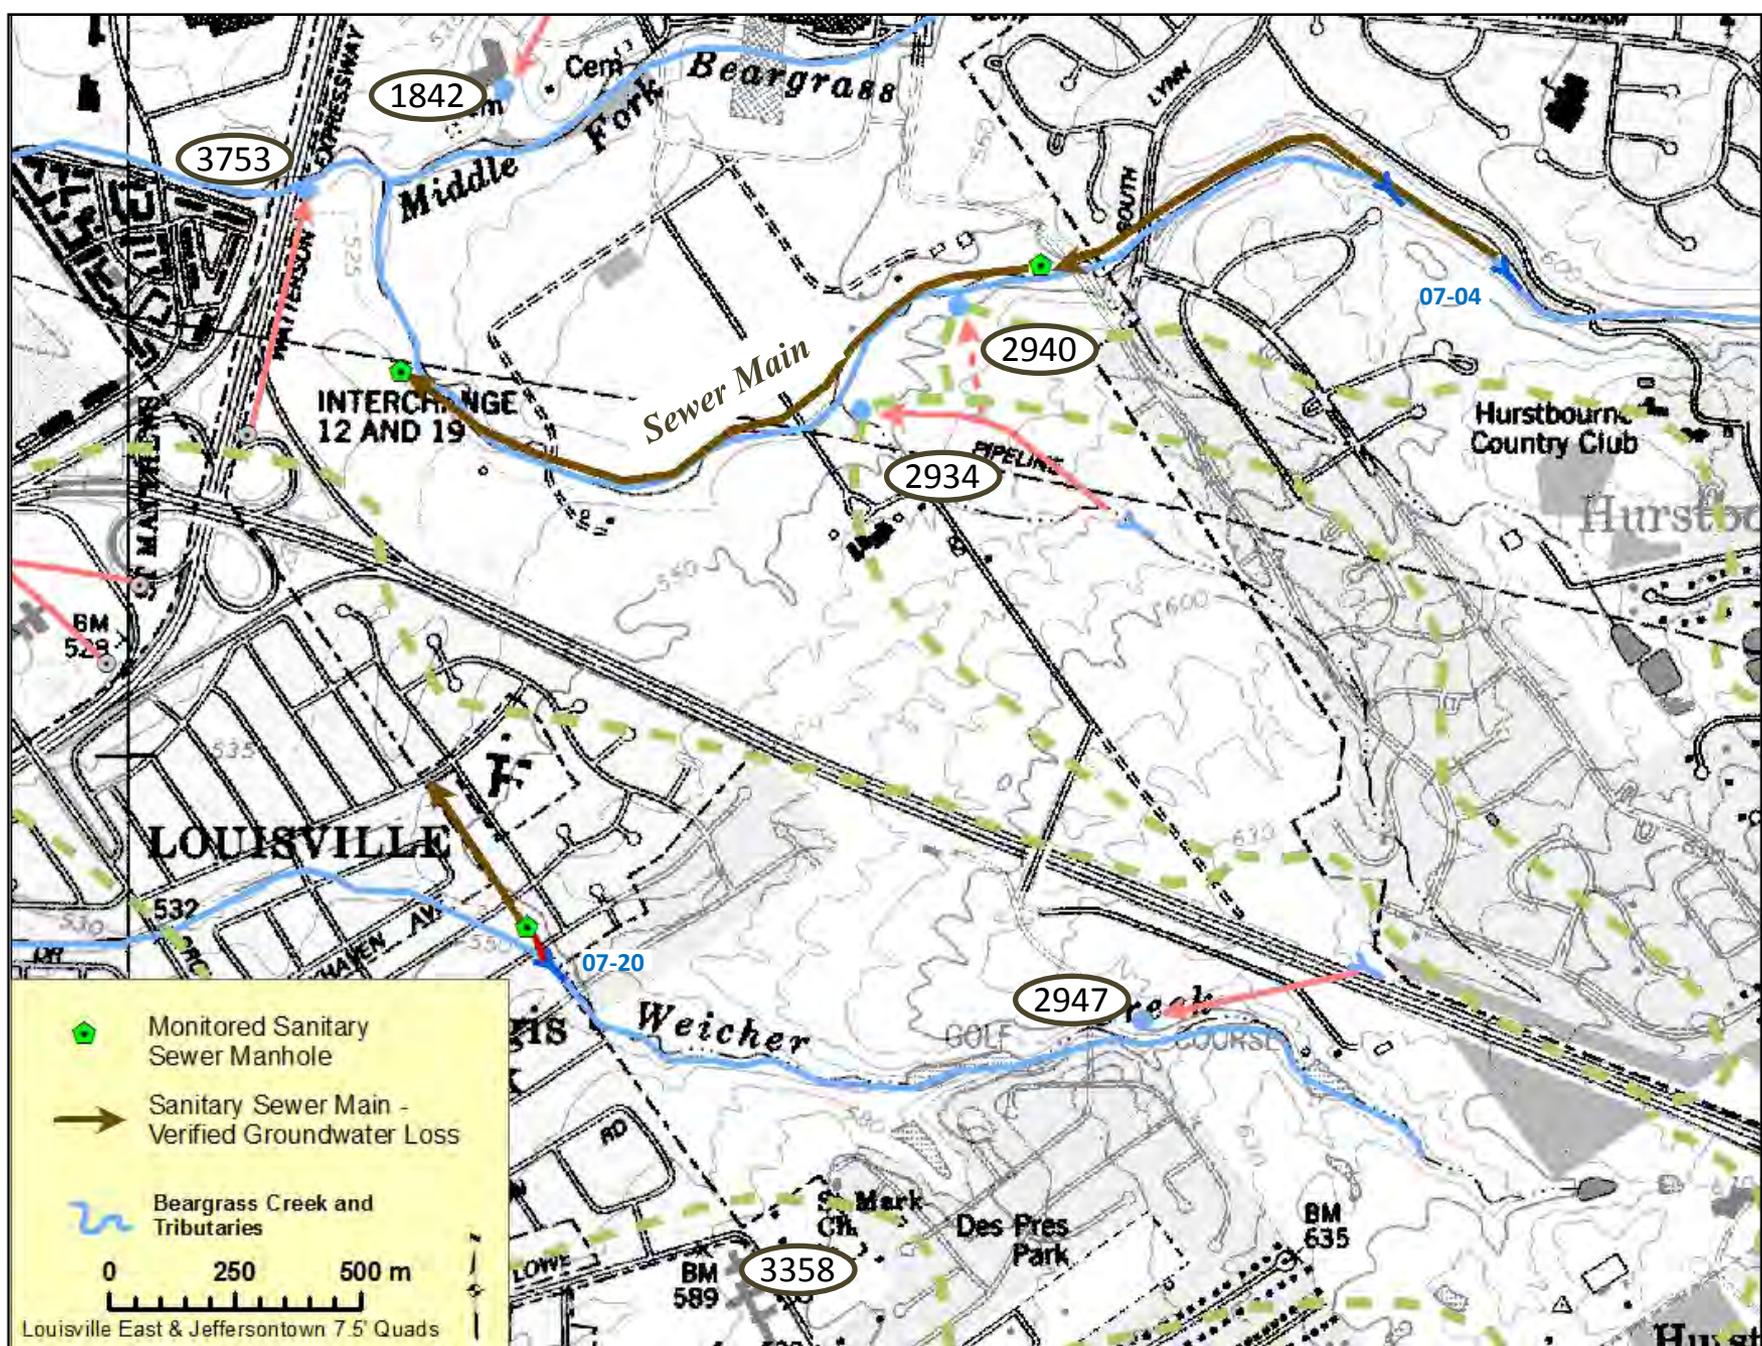
Figure 34. Tracer Data for Injections Recovered in Sanitary Sewers from Hurstbourne Trib and Dannywood Dr

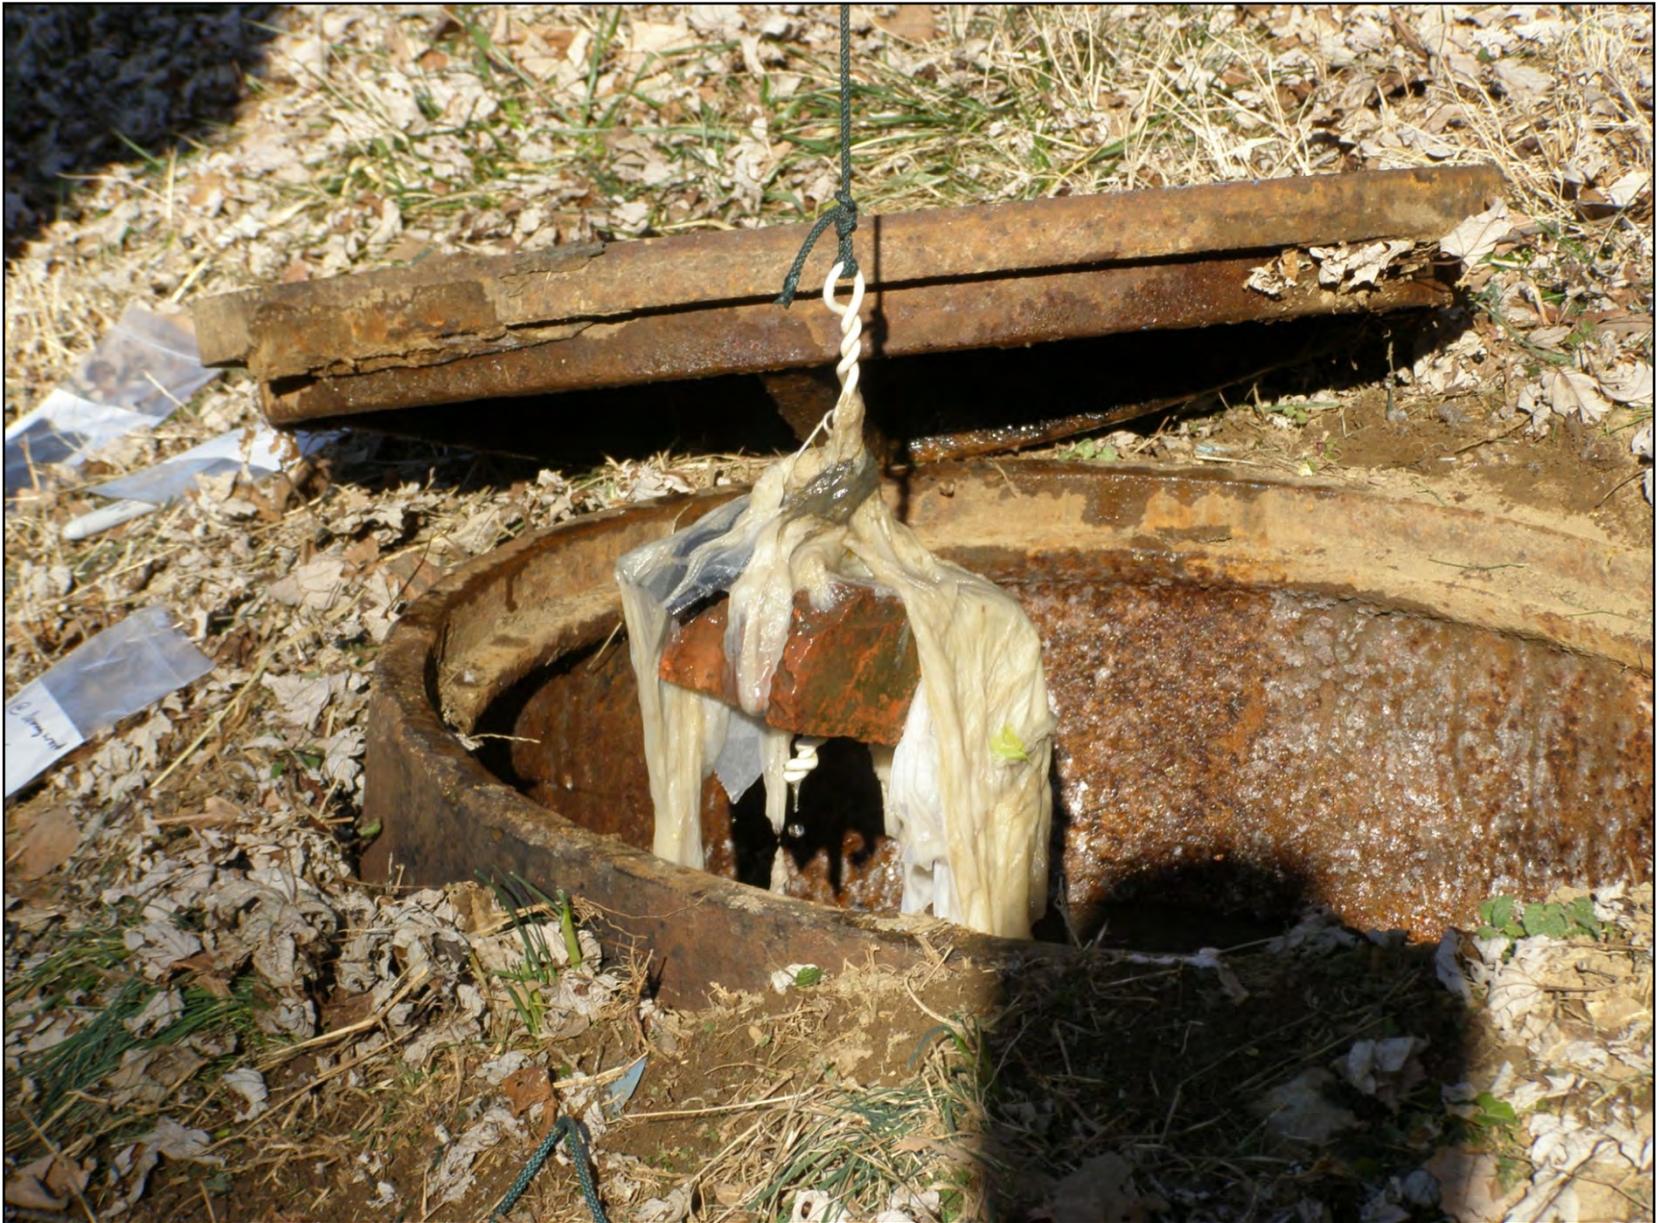
Figure 35a. Inconsistent Dye Monitoring in Sanitary Sewer with Dye-Receptor Submerged on Brick Anchor following 1 hour of deployment and covered with sewer solids

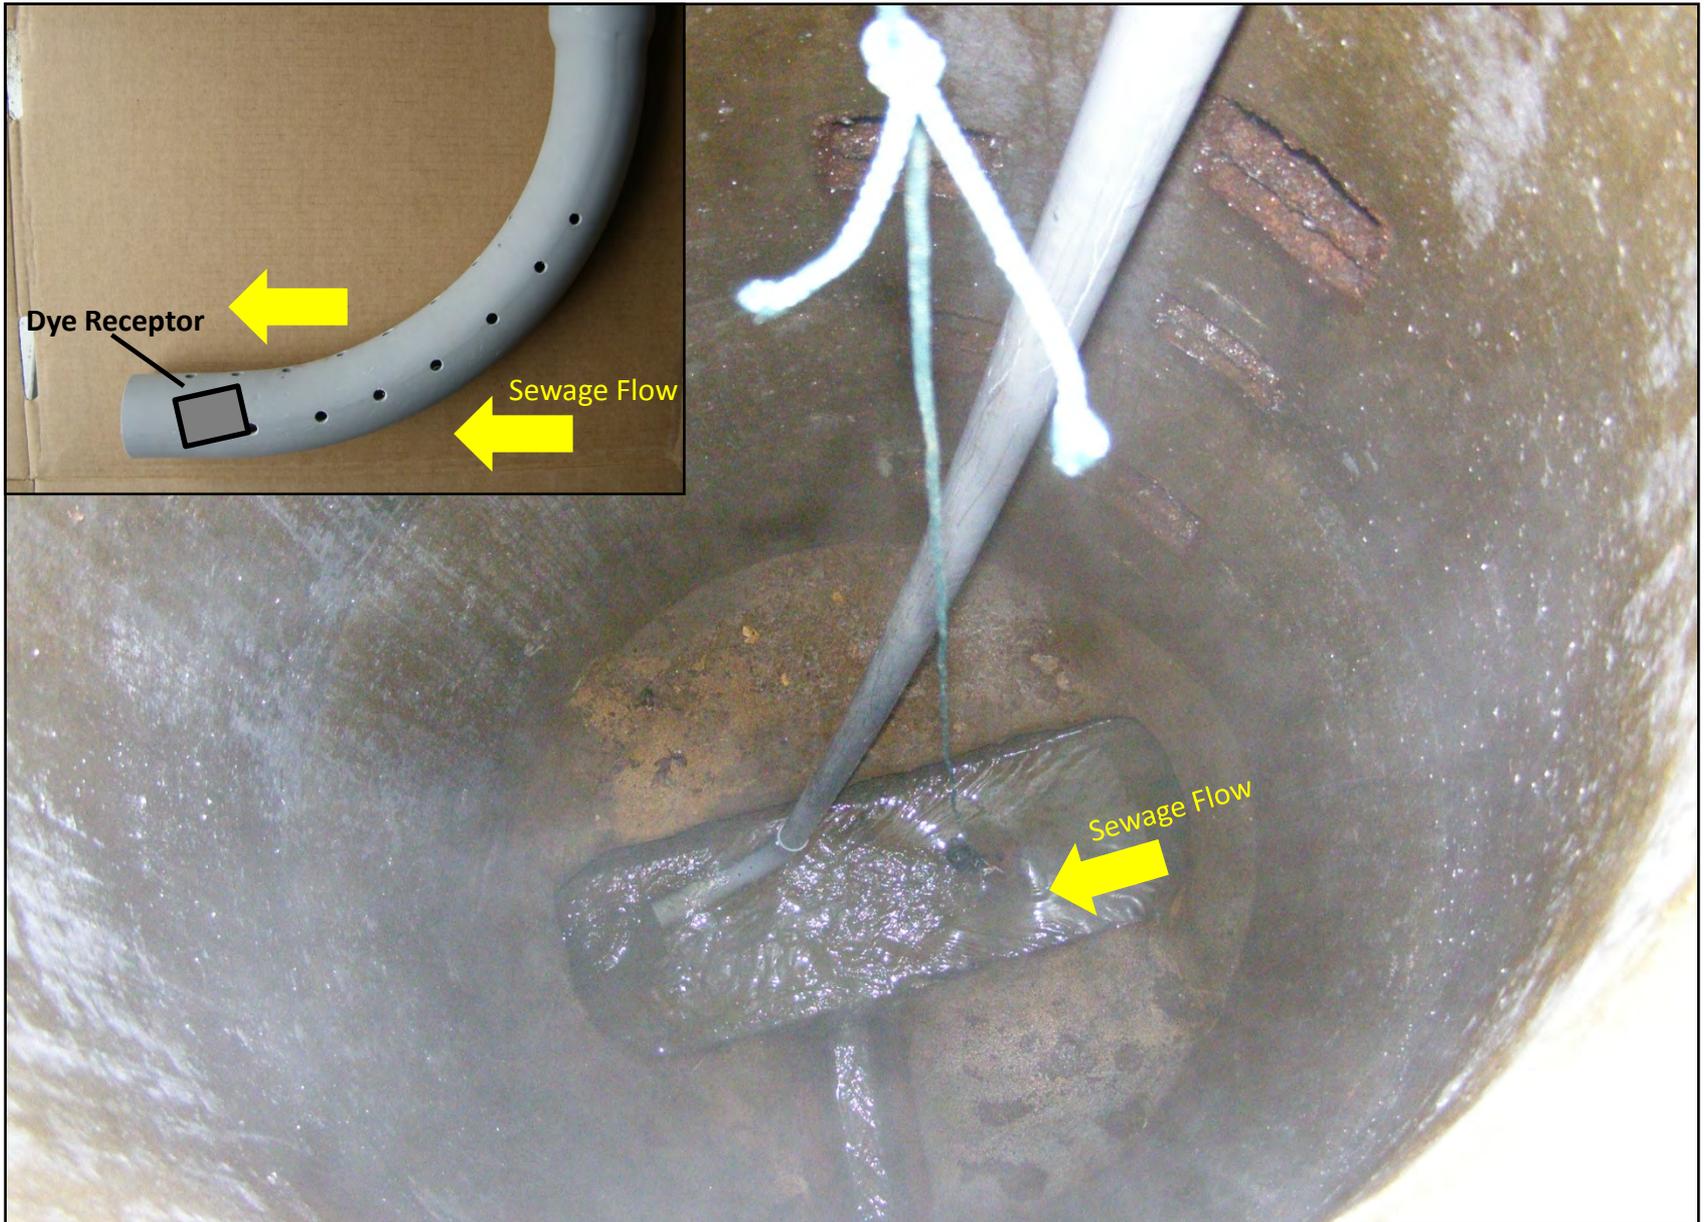
Figure 35b. Dye Monitoring in Sanitary Sewer Main along Weicher Creek with perforated sweep-90° PVC allowed for more consistent tracer recovery by shielding dye receptor from sewer solids

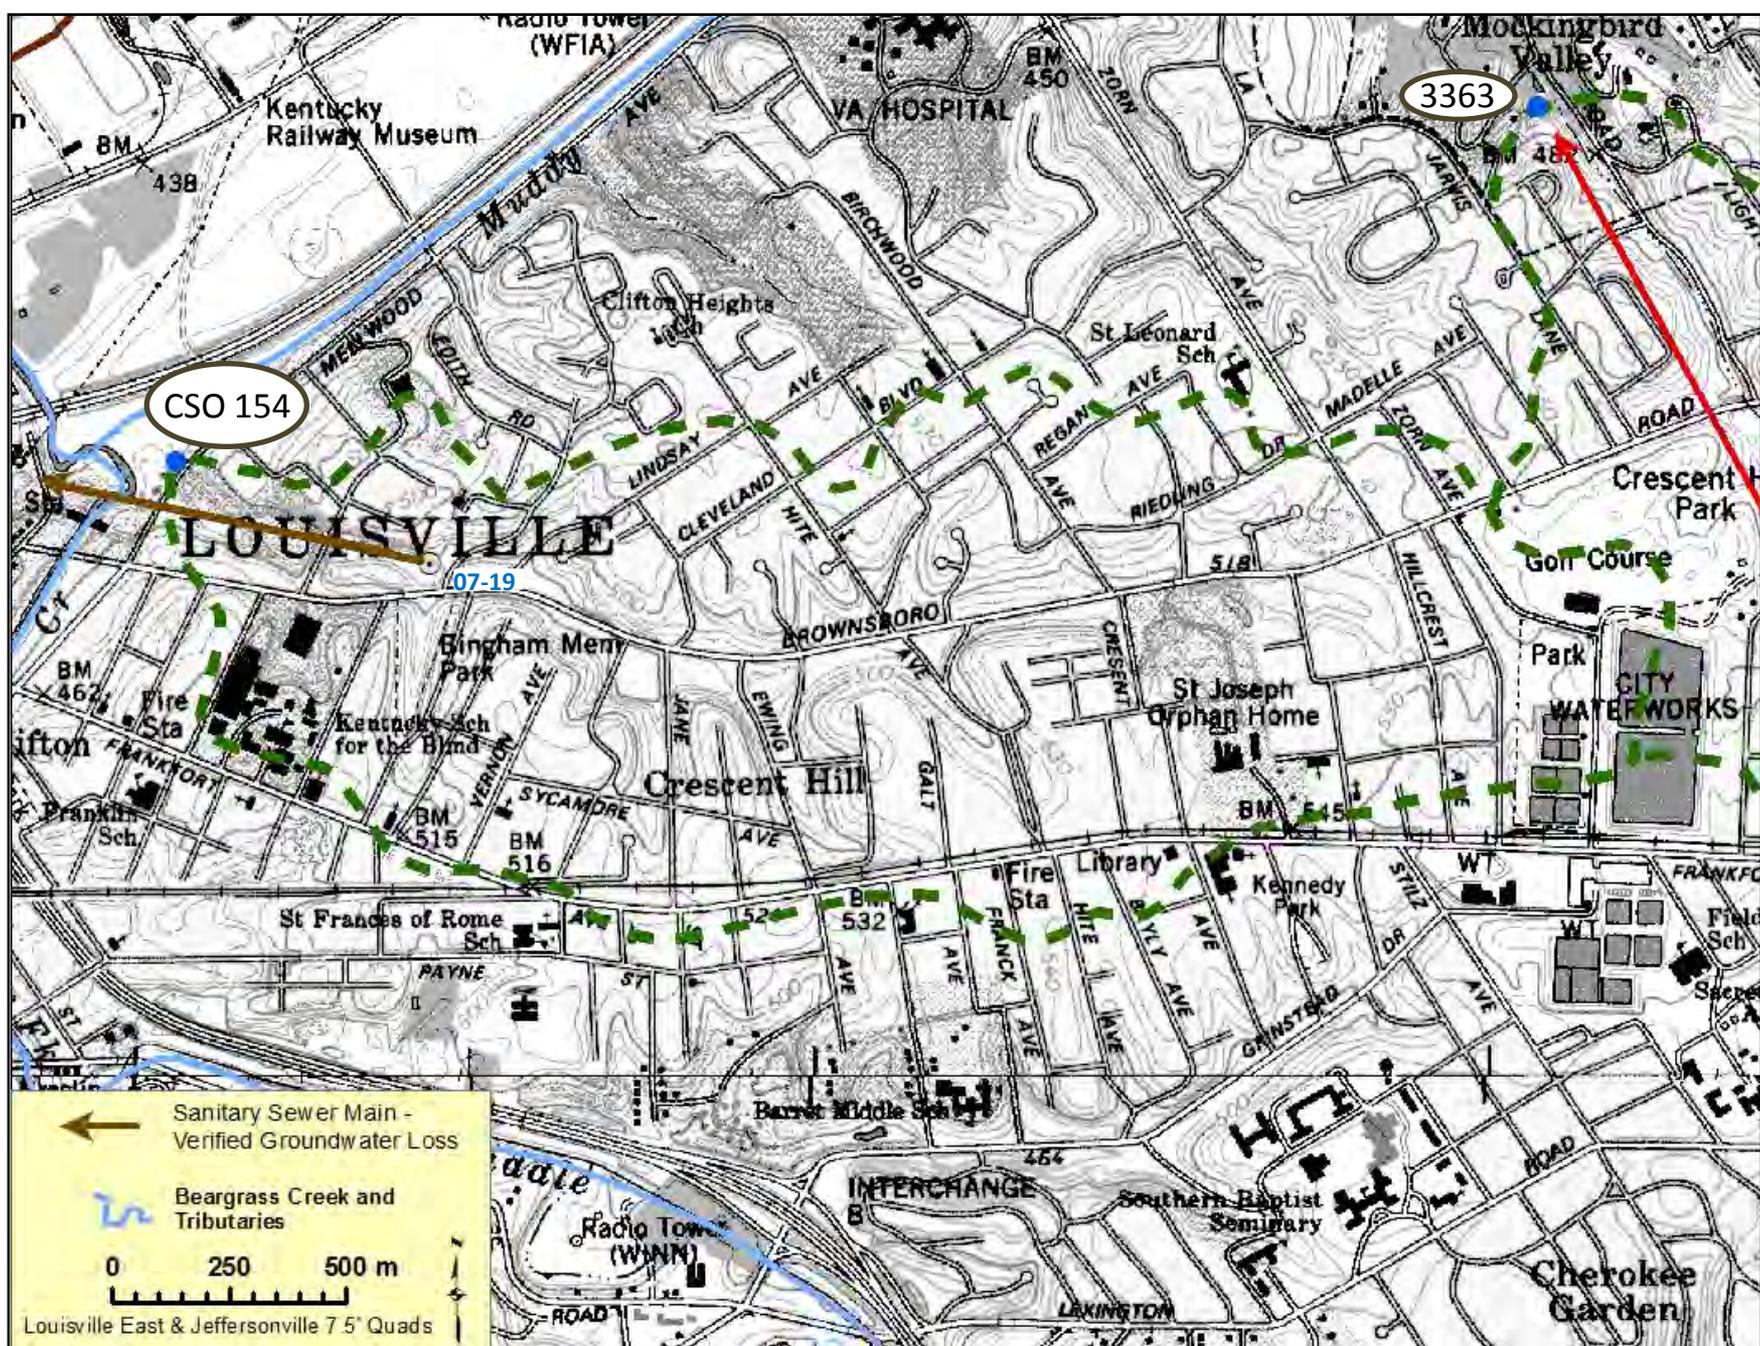
Figure 37. Tracer Data for Groundwater Diversion to Sanitary Sewer at Brownsboro Rd (Drop Box Sp)
