Groundwater Assessment for Nonpoint Source Pollution

Impacts and Spring Basin Delineations within

Sub-watersheds of the Salt River Basin:

Beargrass Creek and Sinking Creek

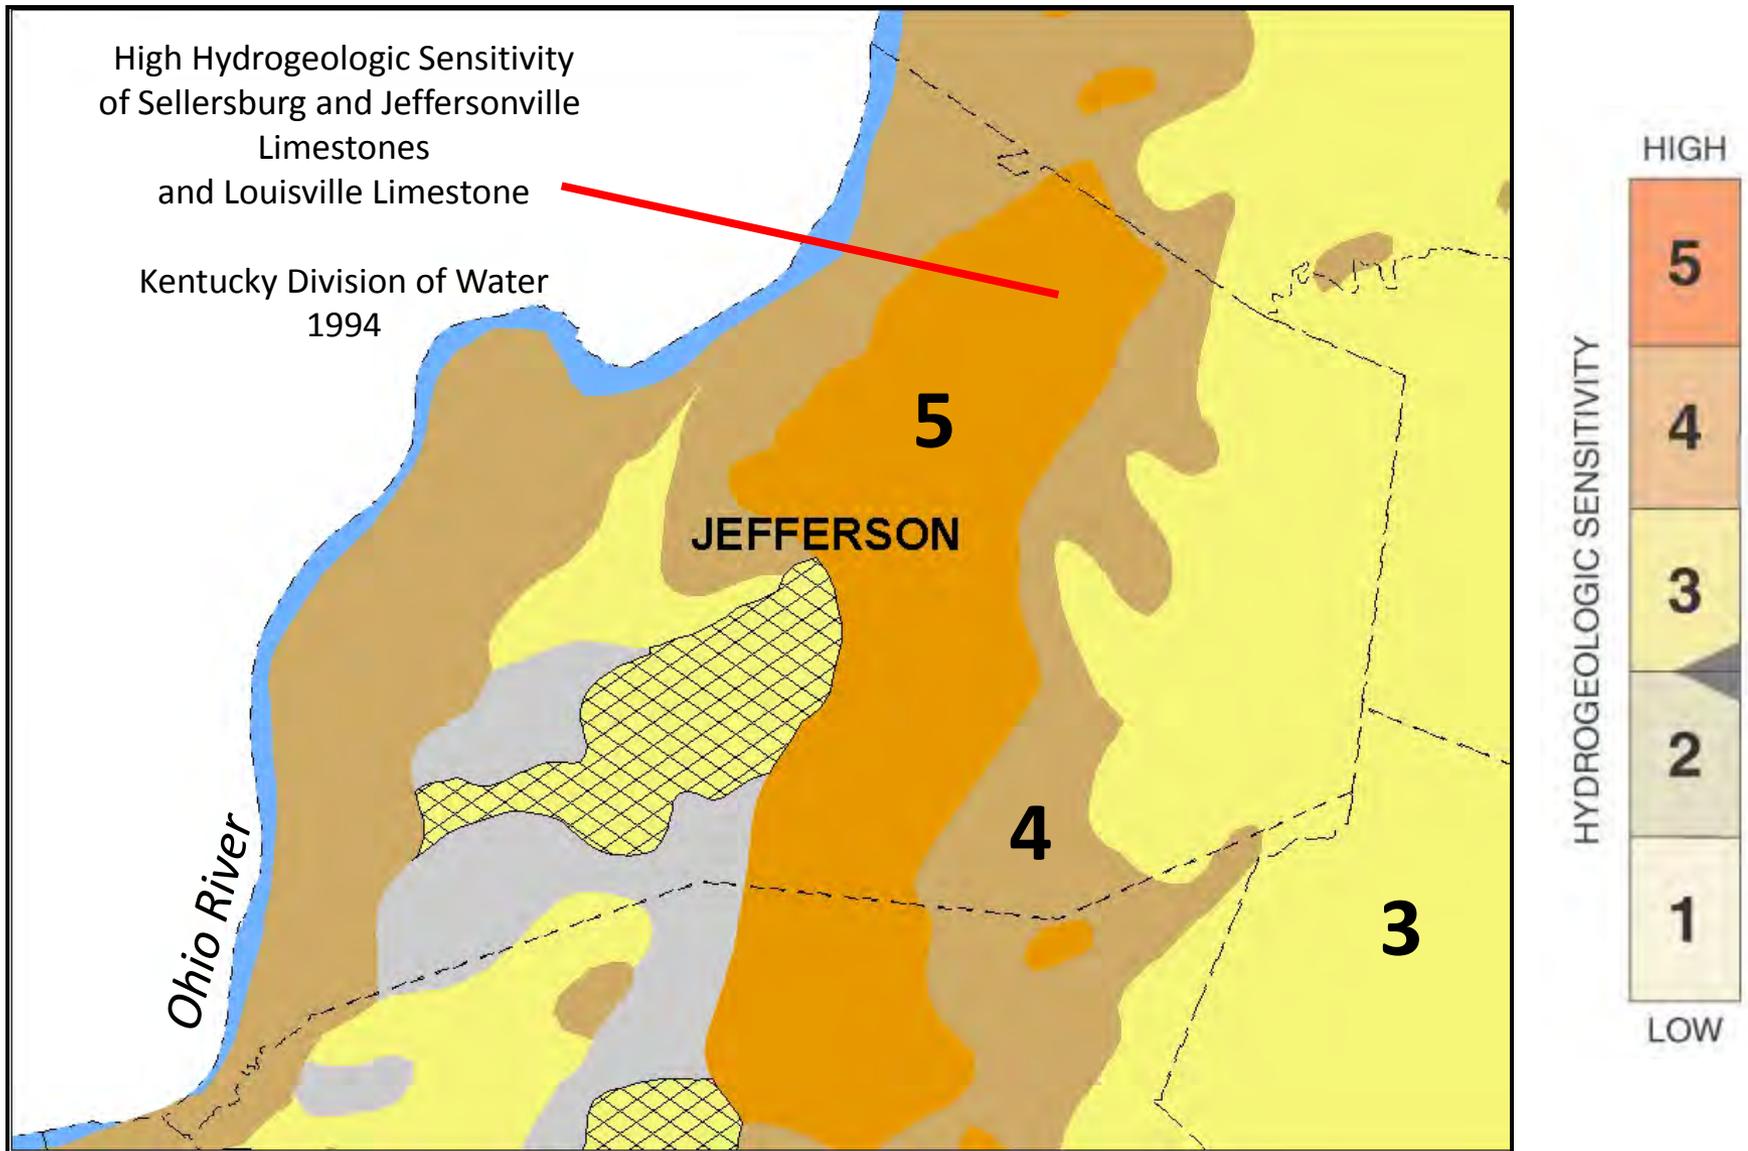
Figure 38. Groundwater Sensitivity Map of Jefferson County

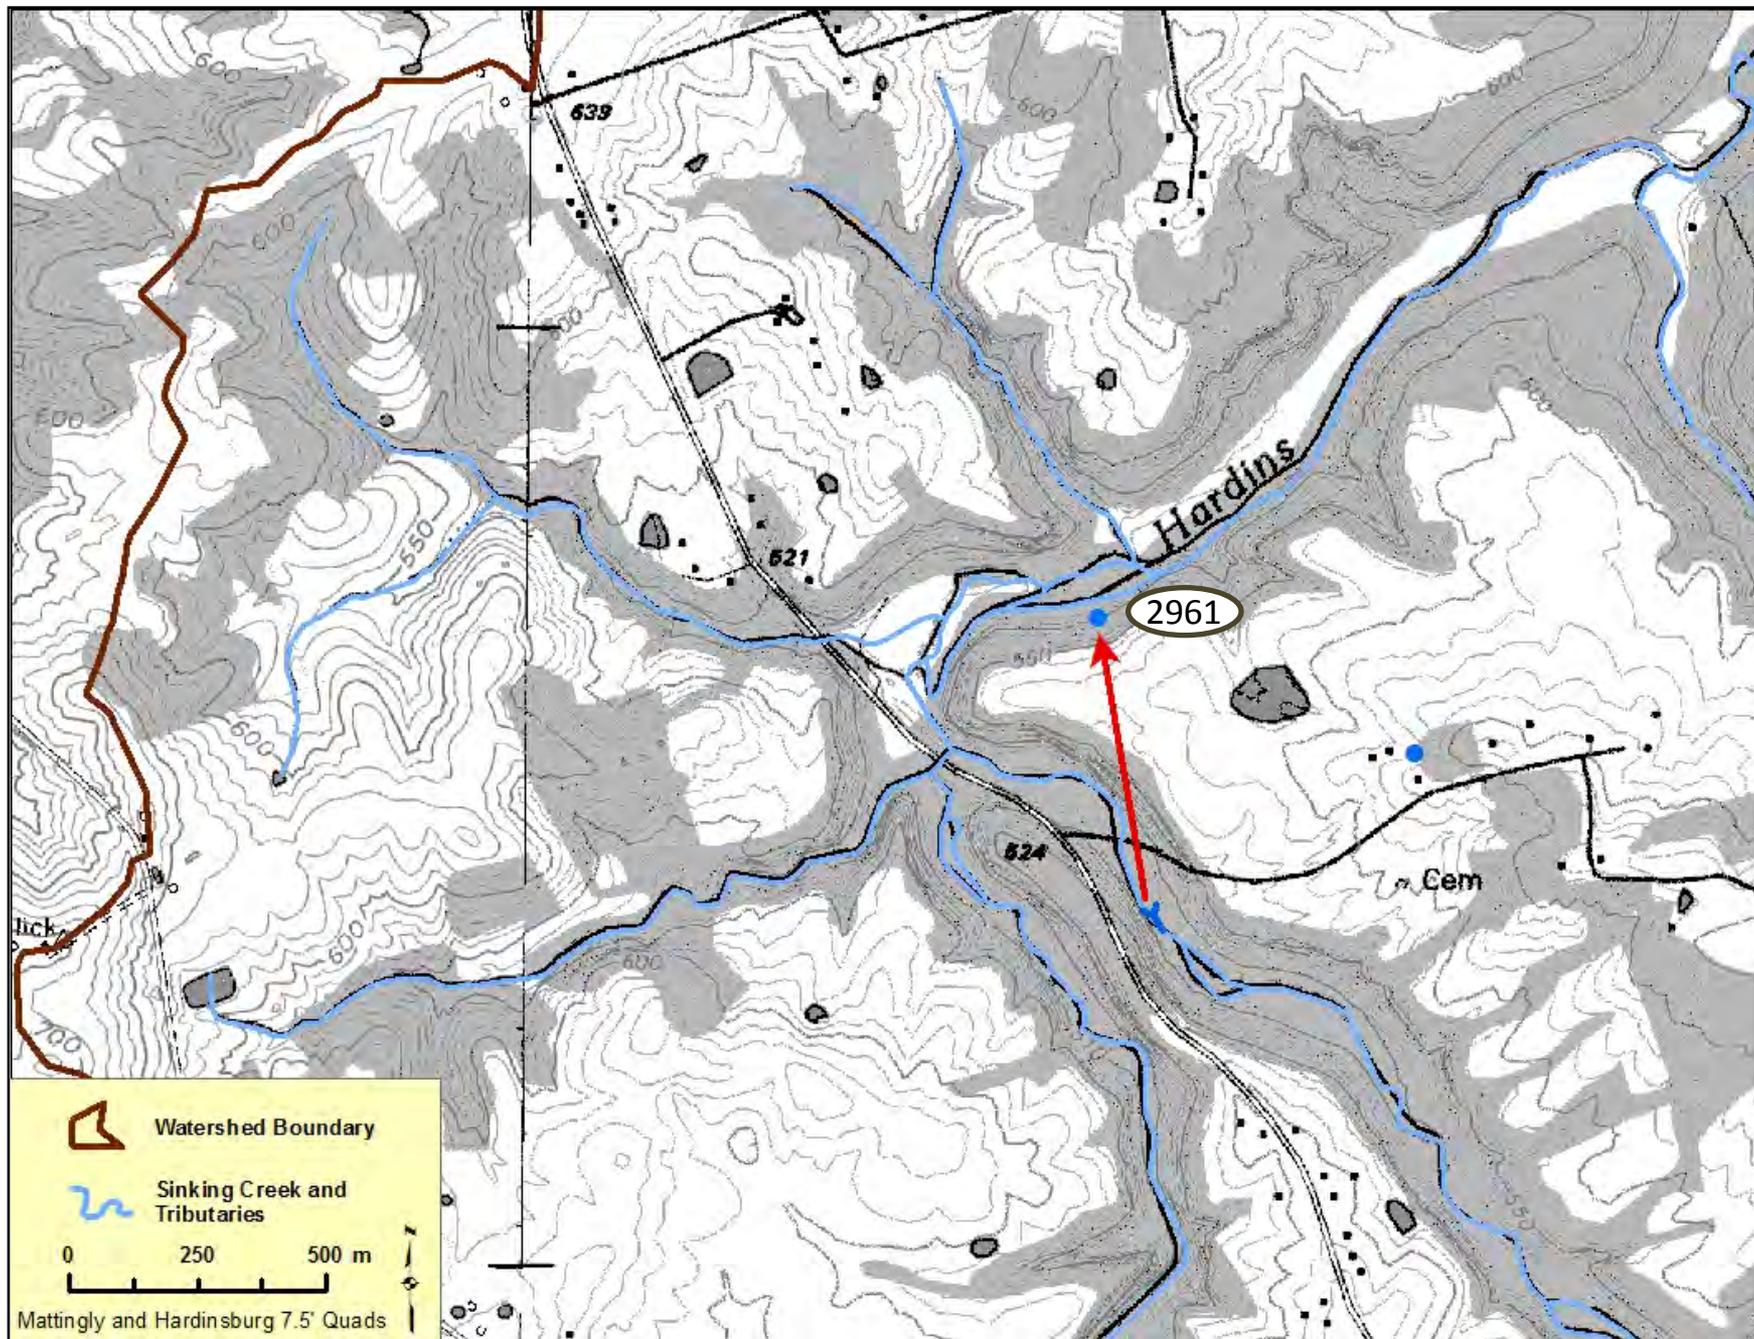
Figure 40. Flow Route for Cutoff Sp (2961)

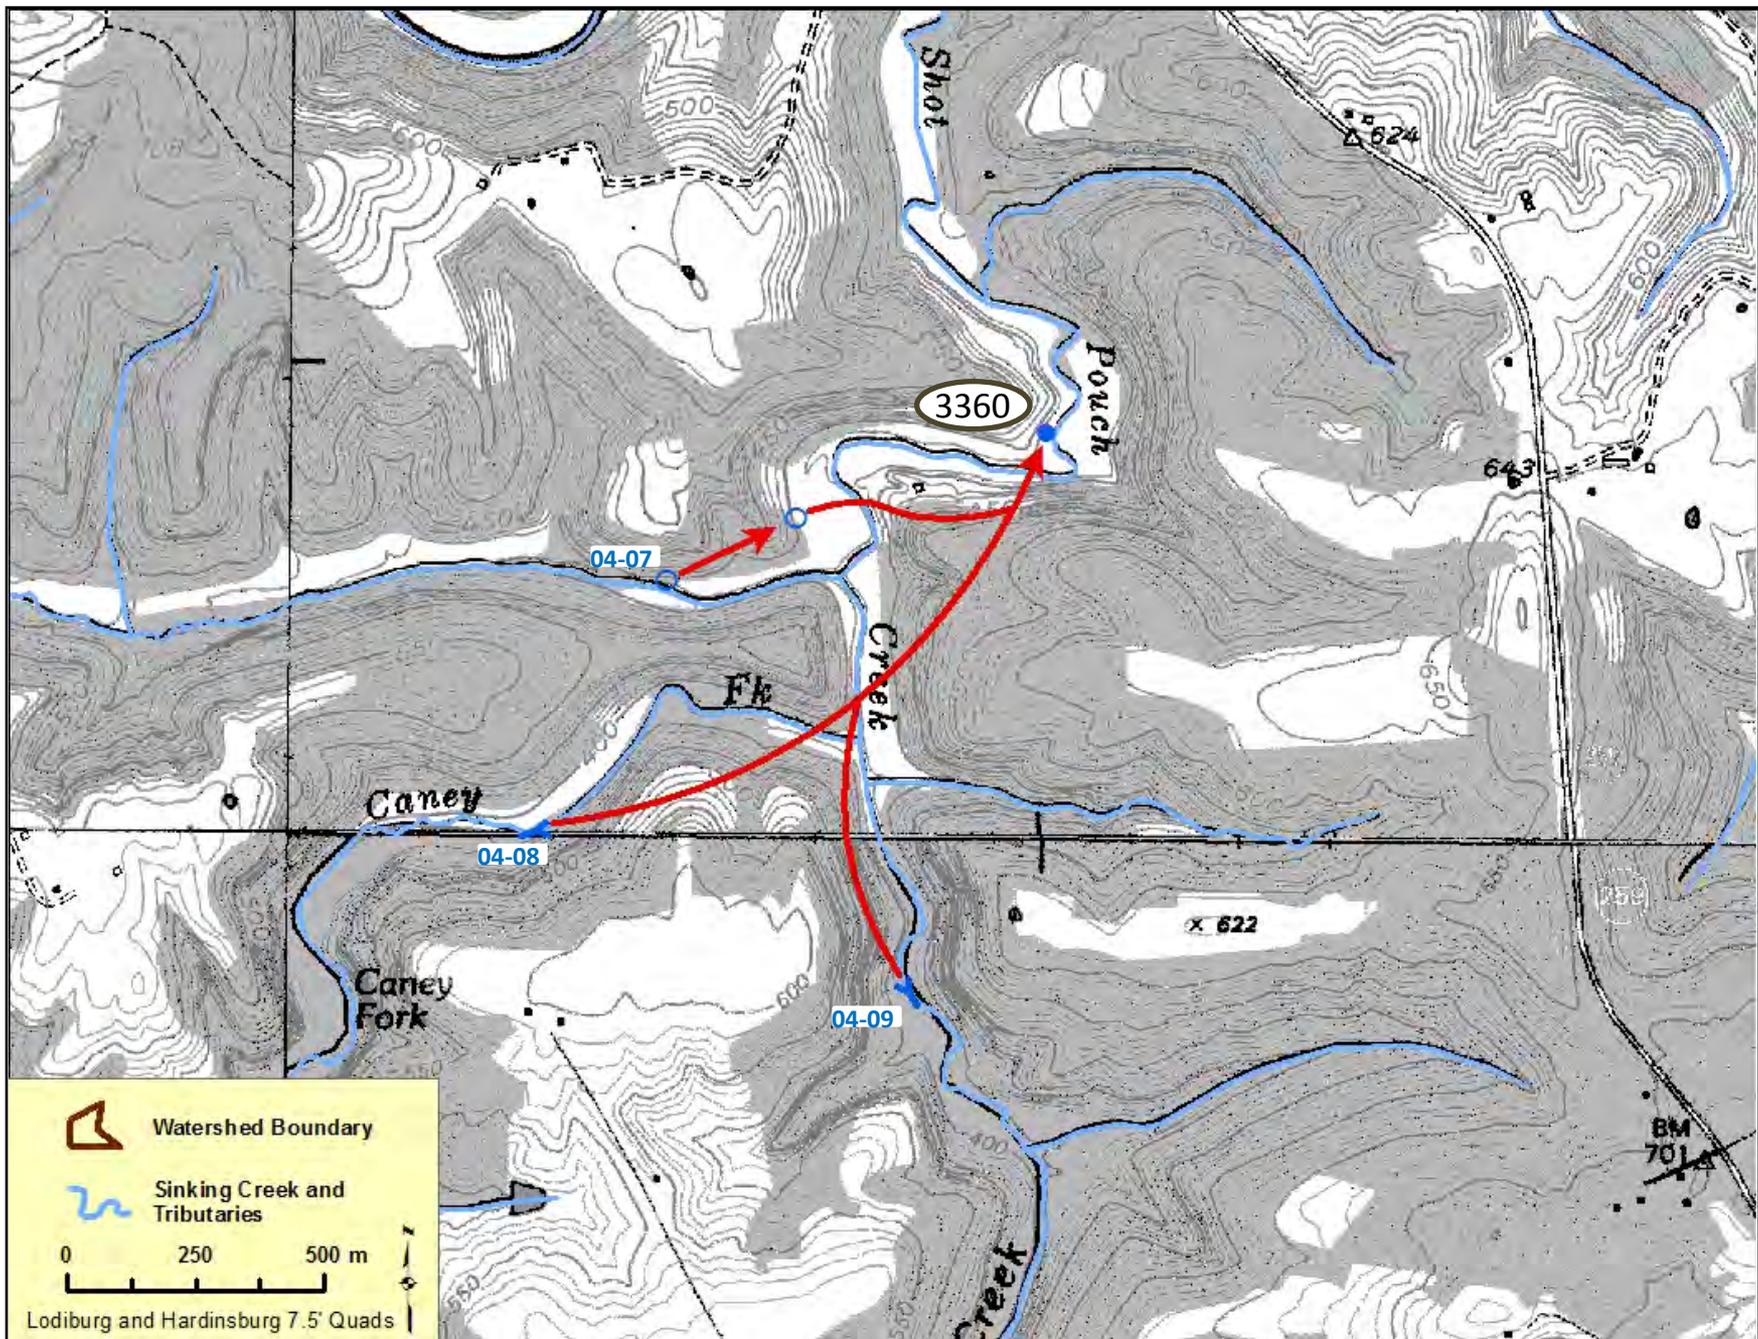
Figure 42. Tracer Data for Shotpouch Sp (3360)

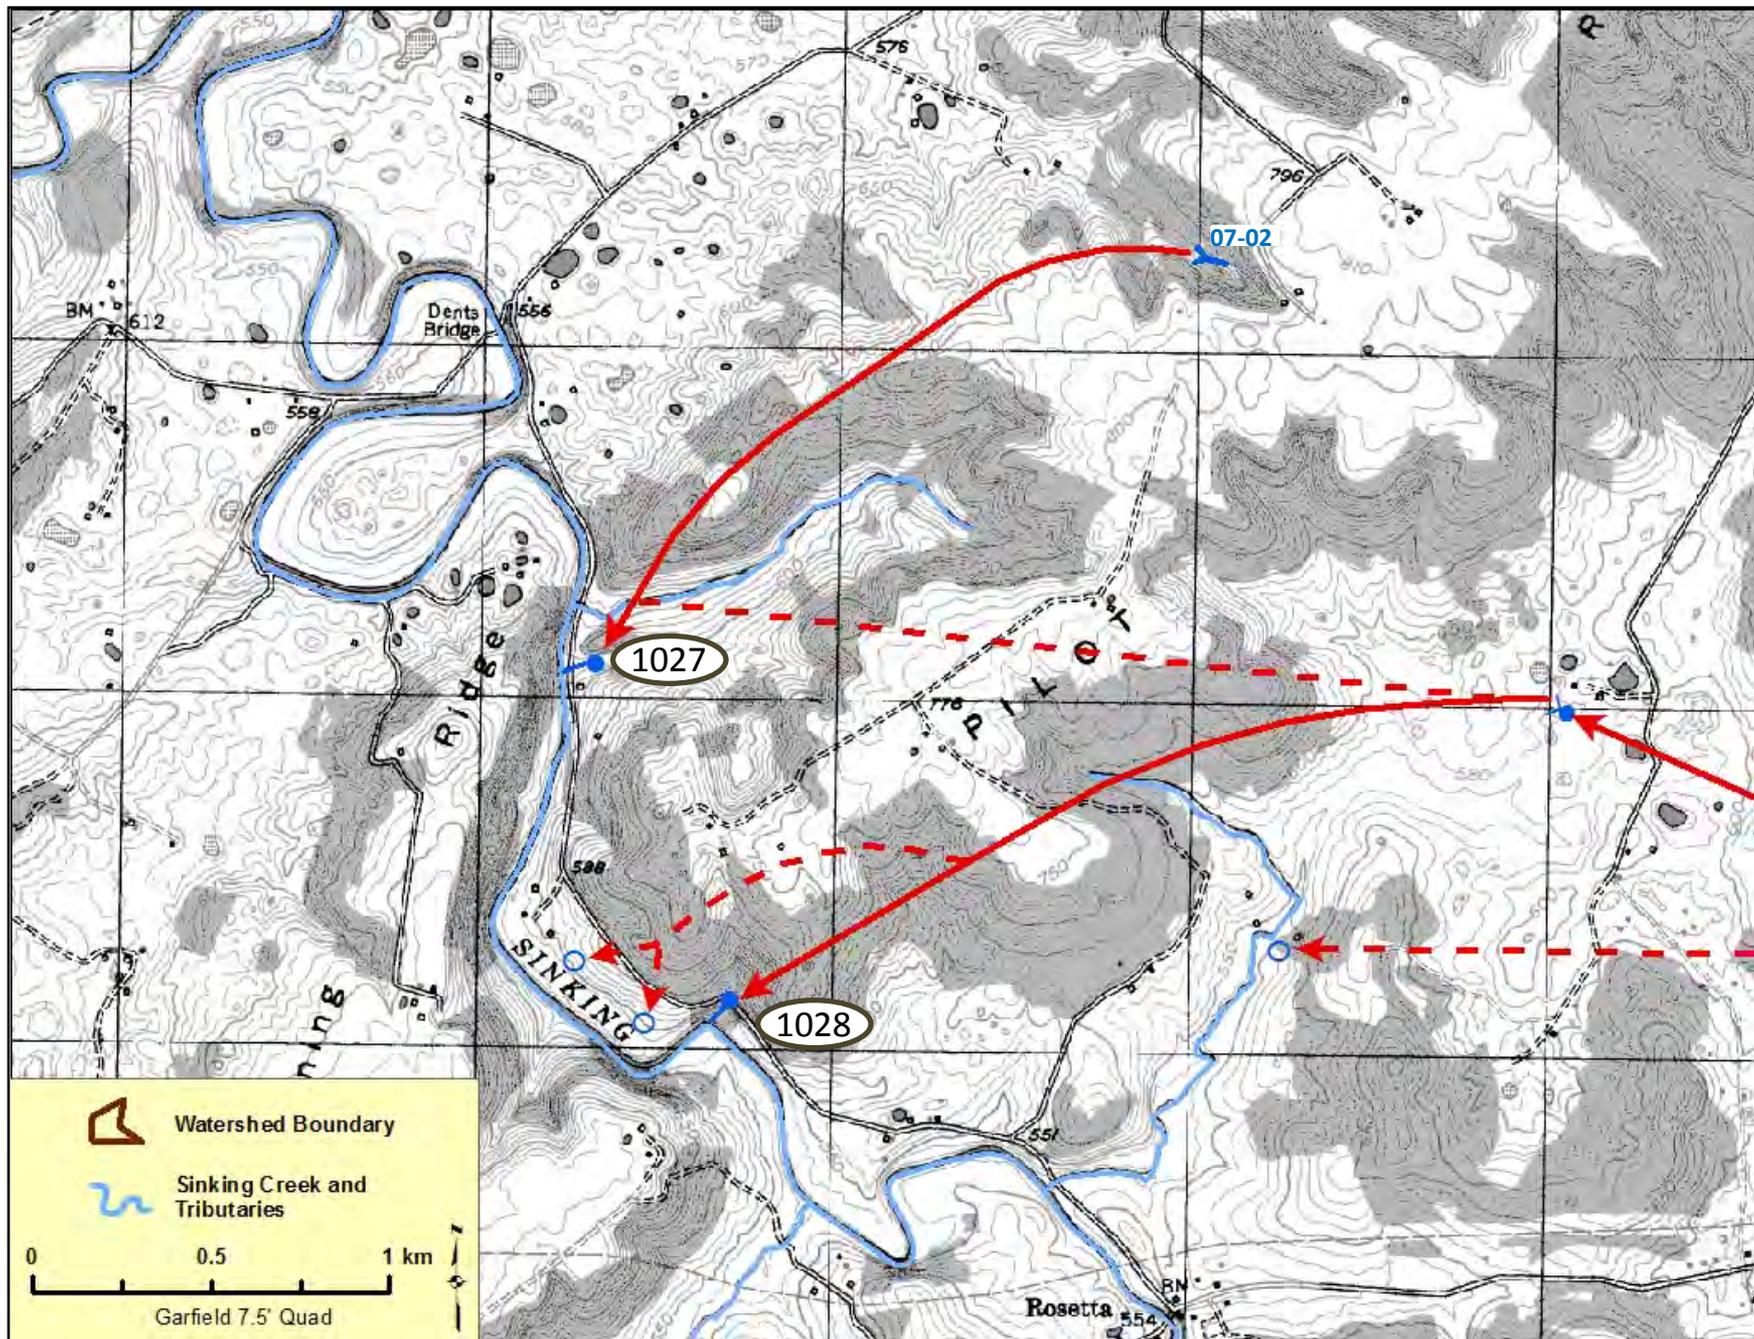
Figure 46. Tracer Data for Fiddle Sp (1027) with part of Flat Rock Sp (1028) groundwater basin

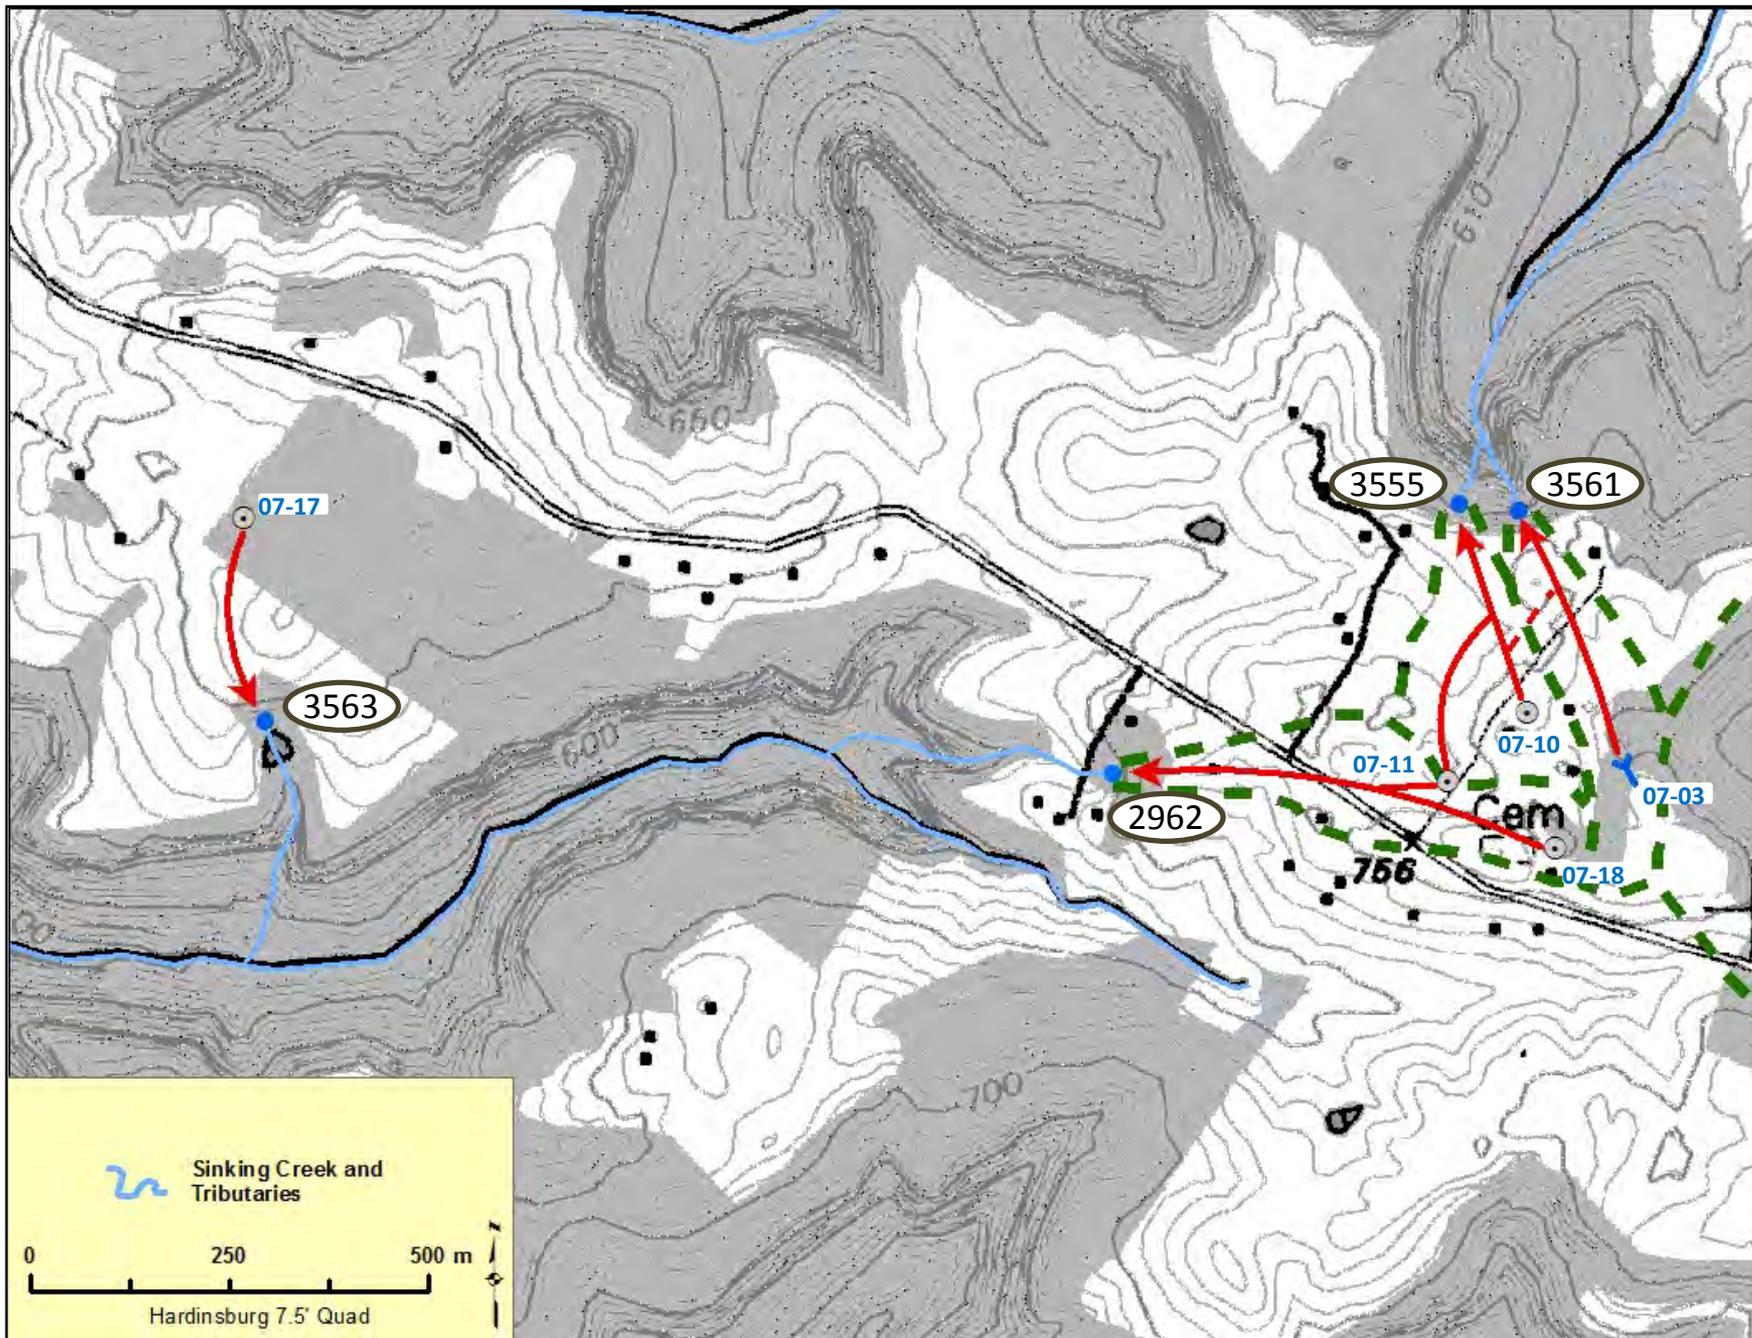
Figure 48. Tracer Data for Dowell Sp (3555), Dowell Sp #2 (3561), O'Reilly Sp (2962) and Thornhill Sp (3563)
