**Clean Water Act §319(h)  
PROJECT FINAL REPORT**

**Application Title:  
Cromer Ridge Watershed Restoration**

**Project Period: 07/01/06 – 03/31/12**

**Submitted by:  
Jon Walker, Hydrologist  
USDA Forest Service  
Daniel Boone National Forest  
1700 Bypass Road  
Winchester, Kentucky 40391**

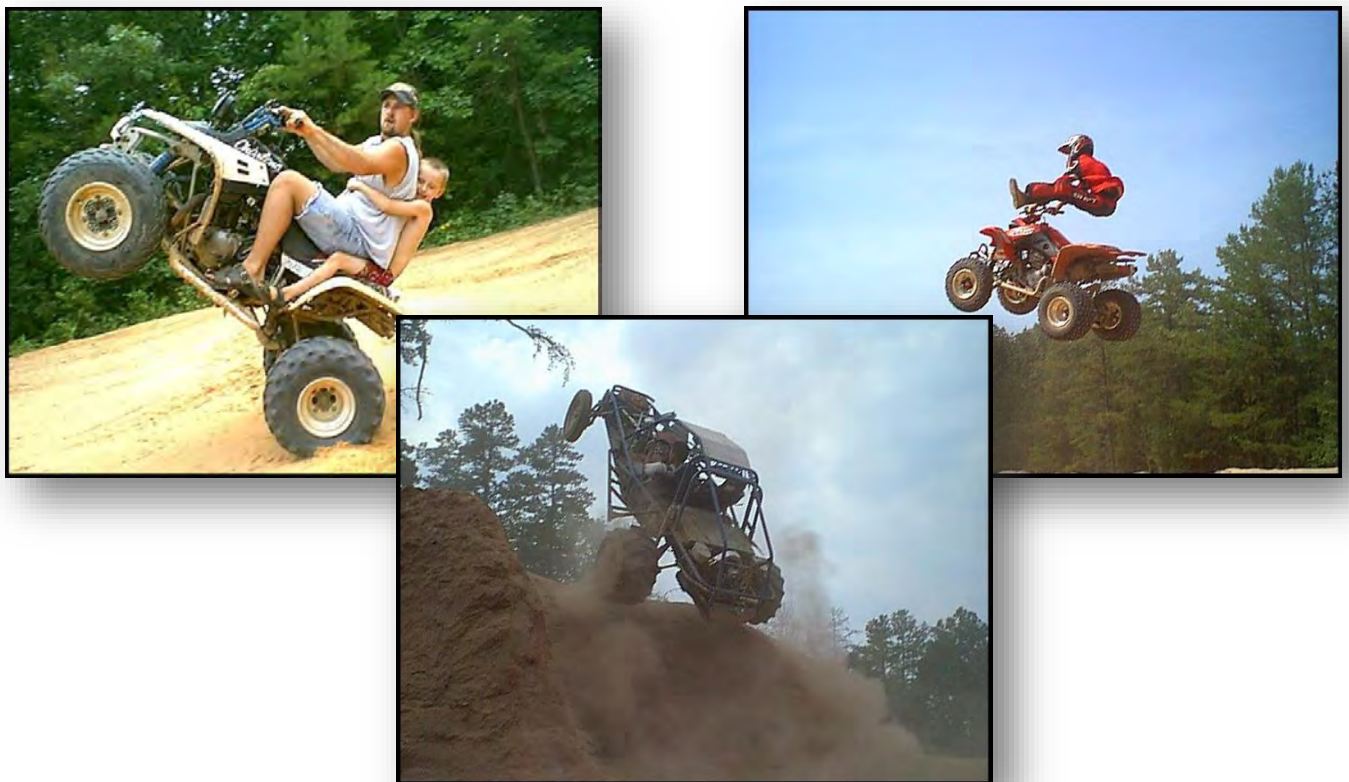
Figure 3: Examples of ATV/OHV use prior to 319(h) grant

Before law enforcement efforts began, the Cromer Ridge area was so popular with OHV riders that weekend traffic on I-75 South would frequently backup along the interstate exit leading to this area. Trucks, trailers and RV's would be lined-up to find a parking spot off the exit, and vendors set up along the state highway and at the parking lots of two local gas stations off the exit (Figures 3& 4).

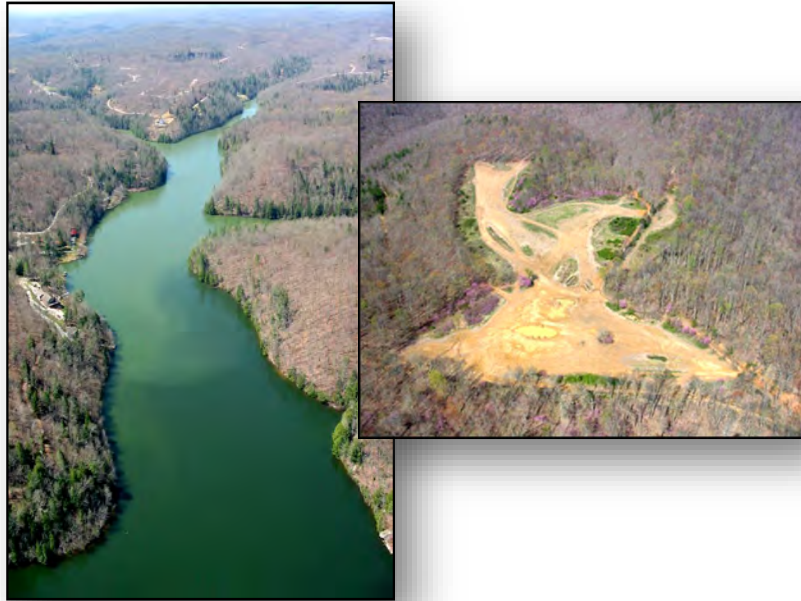
**Figure 5: ATV/OHV playground area and the resulting sediment plume in Woods Creek Lake, a municipal water supply.**

- I. Stop OHV-caused erosion (Figure 5).
  1. Continue policing the area in cooperation with the Laurel County Sheriff's Department to curtail any remaining OHV use.

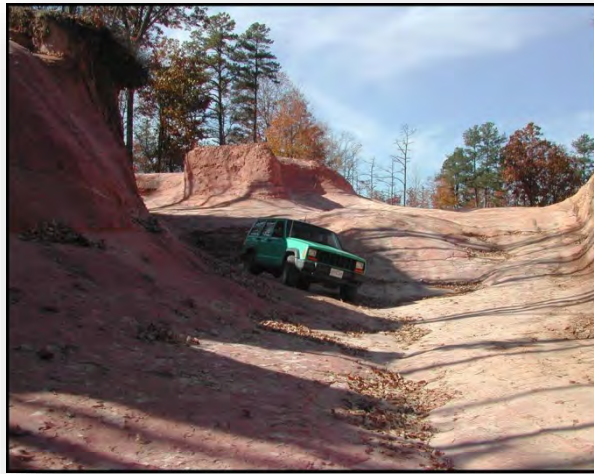
**Figure 6: Many ridges had eroded 10 to 15 feet below original surface level, exposing the bedrock substrate. These areas were reshaped and covered with topsoil.**

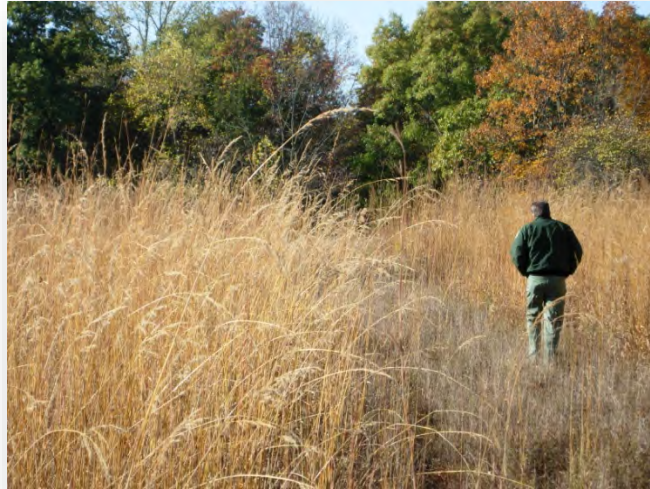
**Figure 11:** Area planted with native grass.

**Seeding, Fertilizing and Mulching:** These activities were completed as soon as possible to reduce erosion and sedimentation (Figure 5). To obtain the best results, seeding was usually accomplished during the spring or fall. The timing was dependent on local weather conditions. Native grasses were used in some of the old fields and at other treatment areas (Figure 11).

Straw was the most commonly used mulch material where slope gradient, slope length and rainfall intensity were not excessive. The straw was applied at approximately two tons per acre to

effectively reduce erosion. Hydro-mulching was used in areas where it was difficult to establish a vegetation cover. Trees were also planted on some disturbed sites.

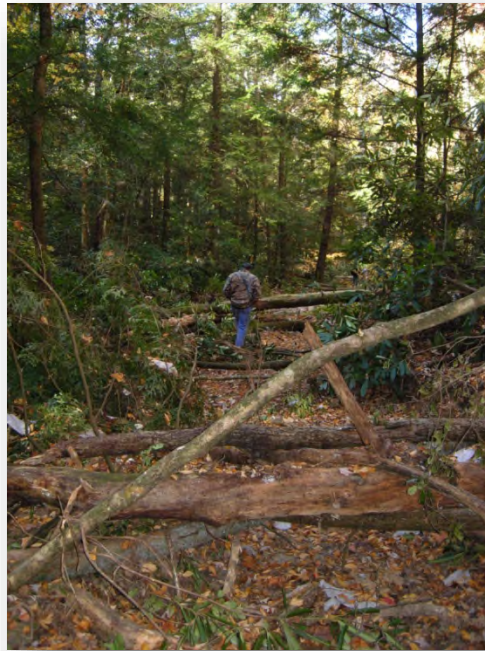
Figure 12: Trail brushing to control OHV use.

**Brushing:** OHV travel corridors at Cromer Ridge were closed by cutting trees and placing them over the road or trail. It was important for the material to be large and frequently placed along the corridor to deter future OHV use (Figure 12). This technique required good chainsaw skills and heavy equipment to place the brush in the proper location.

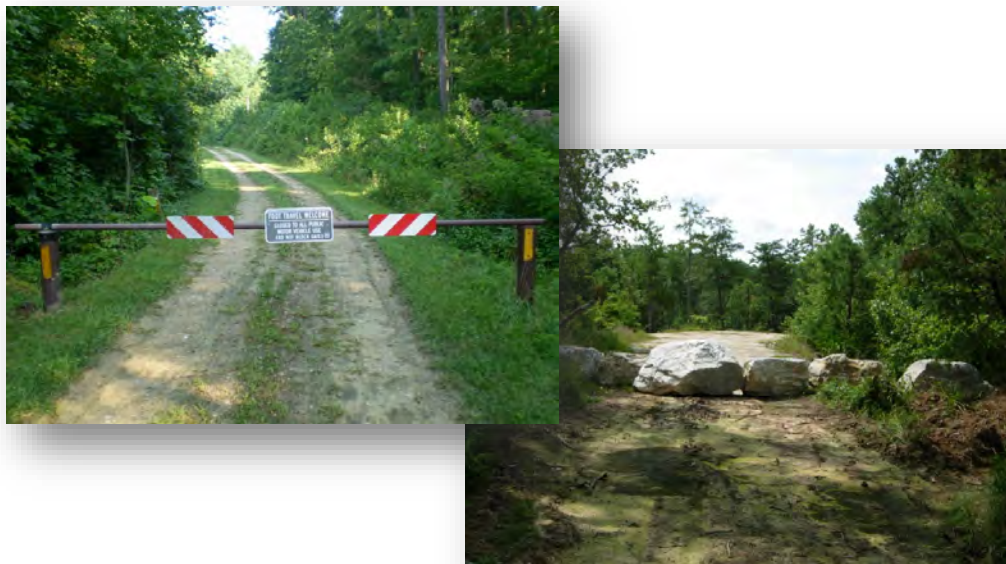
Figure 13: Road blocking techniques.

**Gates and road blocking:** Gates similar to those in Figure 13 were installed at two access points. In areas where permanent closures were needed, boulders and concrete pillars were used.

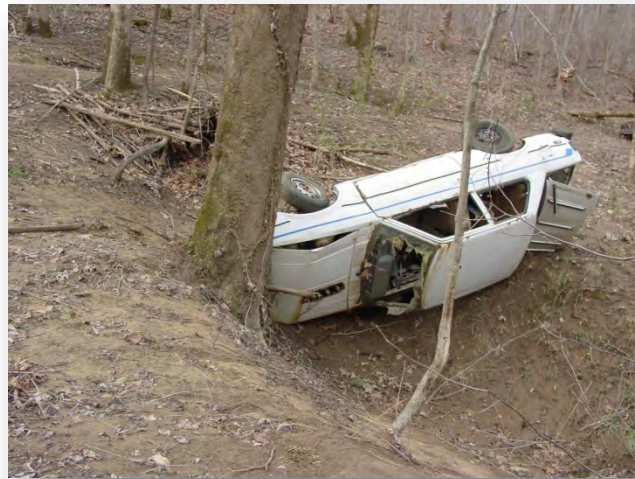
**Figure 14:** Abandoned car on the slopes above Rockcastle River.

**Objective 3:** Unfortunately, the removal of large trash and garbage dumps became a complicated issue. Several abandoned vehicles were encountered along with hundreds of used tires. To remove the vehicles, the contractors used heavy equipment. The tires were removed in cooperation with a private landowner. The Forest Service had the tires skidded to a landing, and the landowner loaded the tires on a tractor-trailer. Agreements were set up with Laurel County solid waste officials to accept the tires at a reduced rate.

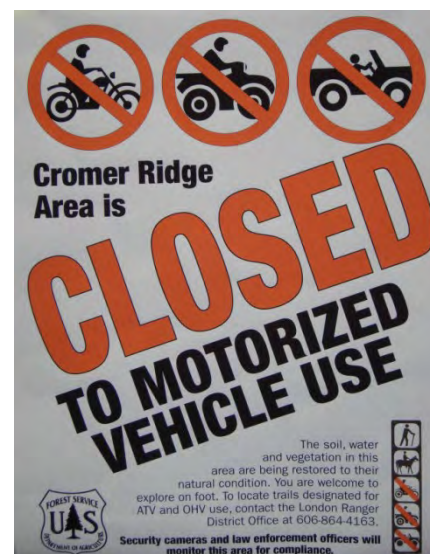
**Figure 15:** Temporary sign that was used early in the project.

The next step was to notify illegal OHV users that the Cromer Ridge area was closed to that type of use. Through a series of internet sites and chat rooms, the Forest Service spread the word that the closure would be enforced. Information was posted on the Daniel Boone National Forest website. Temporary signs were developed and installed at key locations throughout the area (Figure 15). Permanent signs were installed at the end of the project (Figure 16).

**Objective 4:** The environmental education efforts appear to be successful. Cromer Ridge was once a destination for off-highway vehicle users who traveled from multiple states (Figure 4). Information concerning the Cromer Ridge project was distributed via internet, brochures, public service announcements and signs (Figures 15 and 16). These communications helped educate

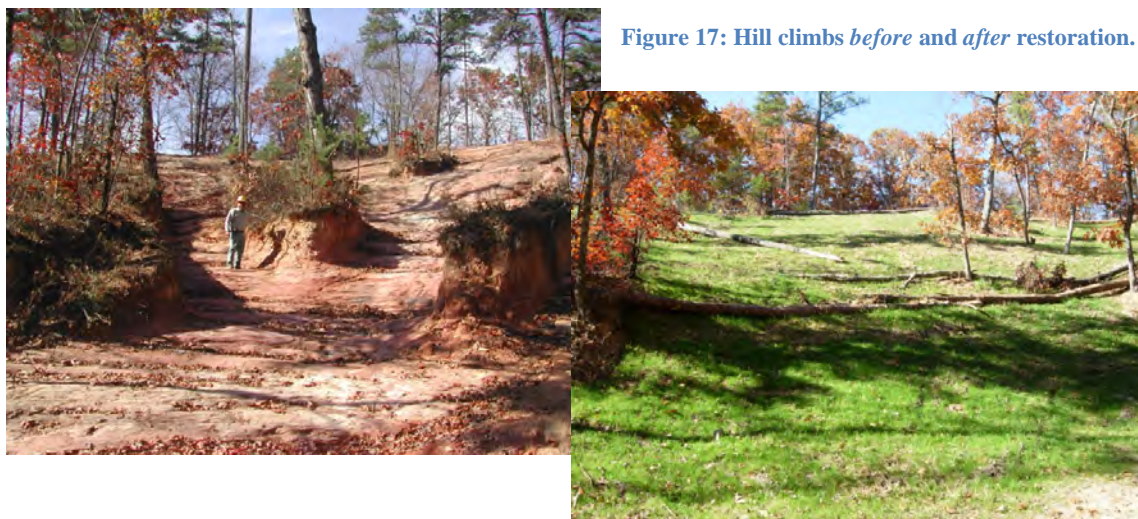
**Figure 17: Hill climbs *before* and *after* restoration.**

Another technique used to measure the success of erosion control efforts was before-and-after photographs. Figures 17 through 20 show at least 90% groundcover was achieved in areas planted with vegetation.

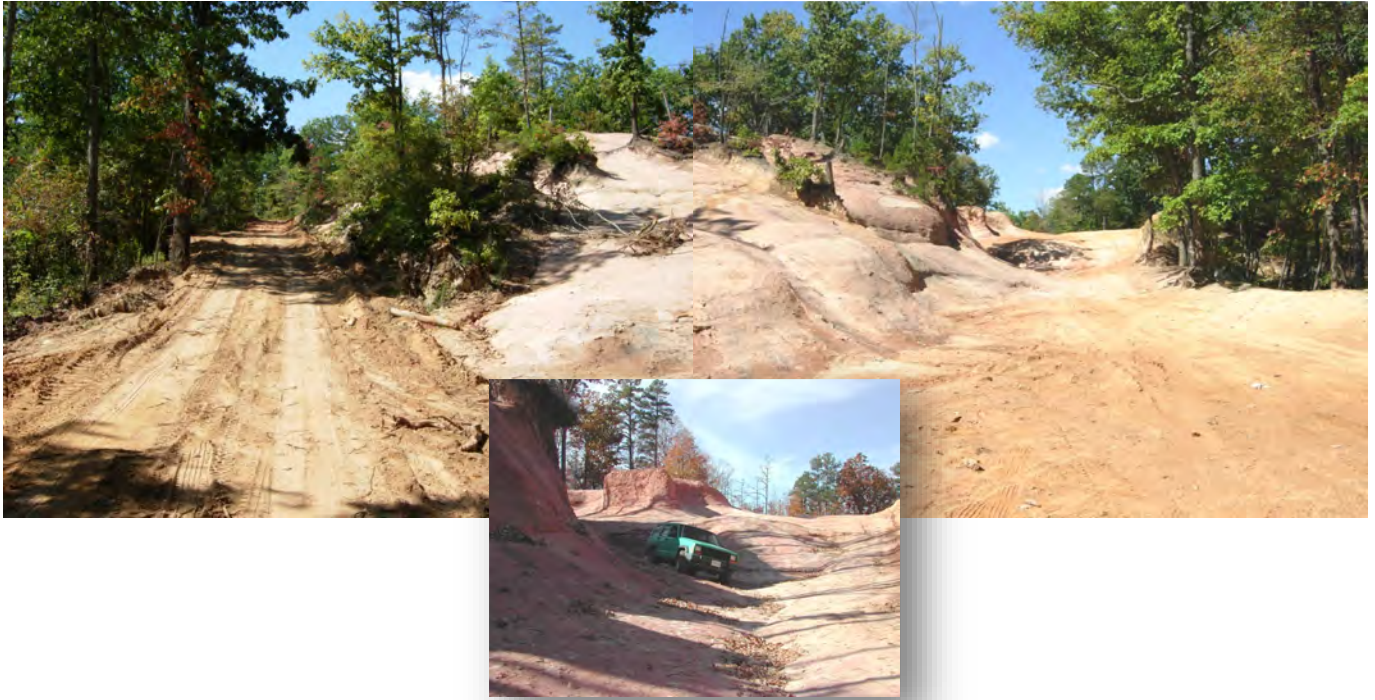
Figure 18: “Pink Rock” *before* restoration.

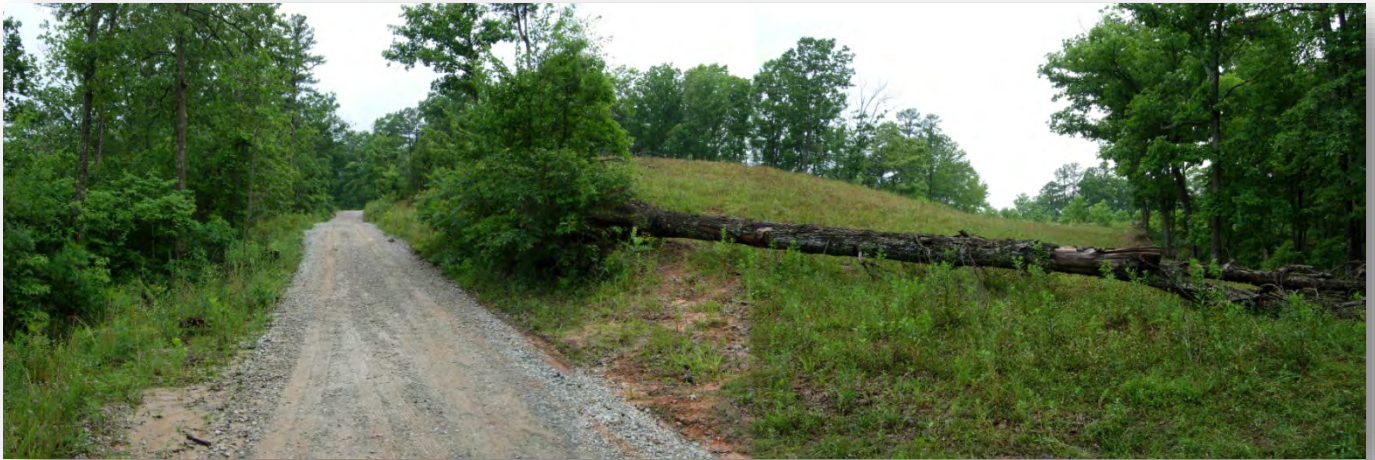
Figure 19: “Pink Rock” *after* restoration.

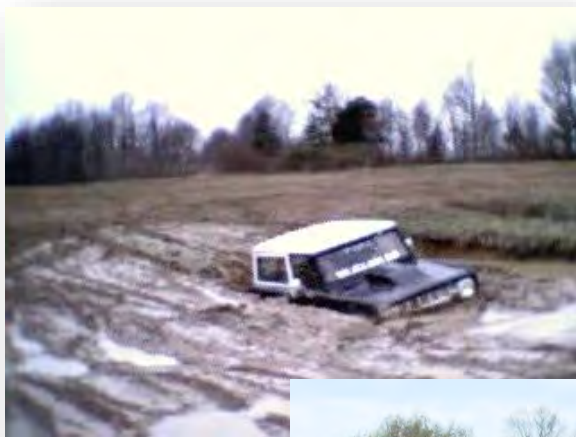
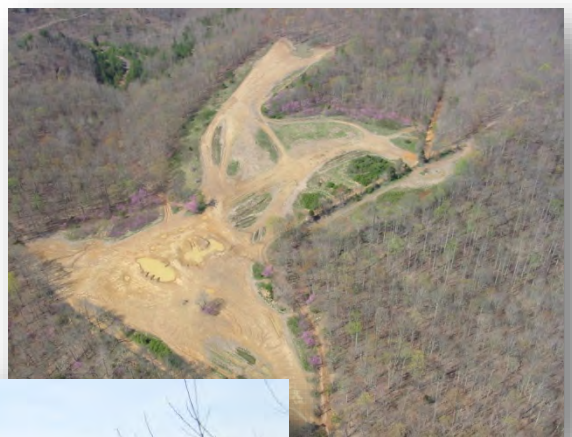
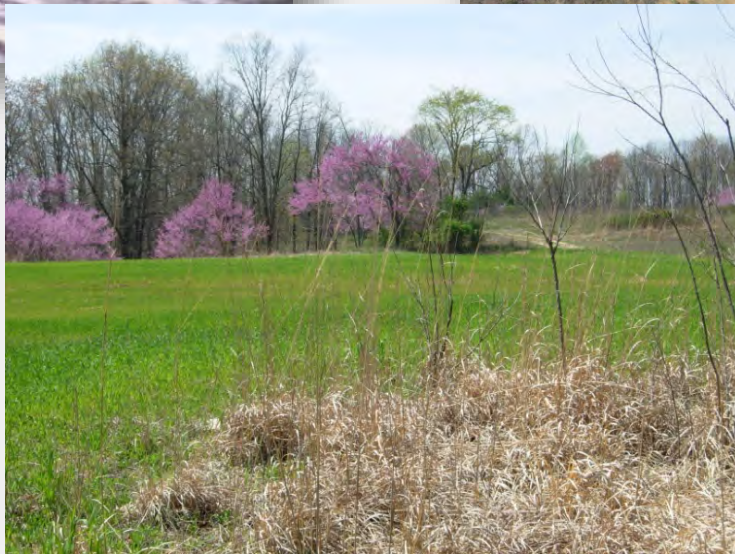
**Figure 21: Playground area *before* and *after* restoration.**

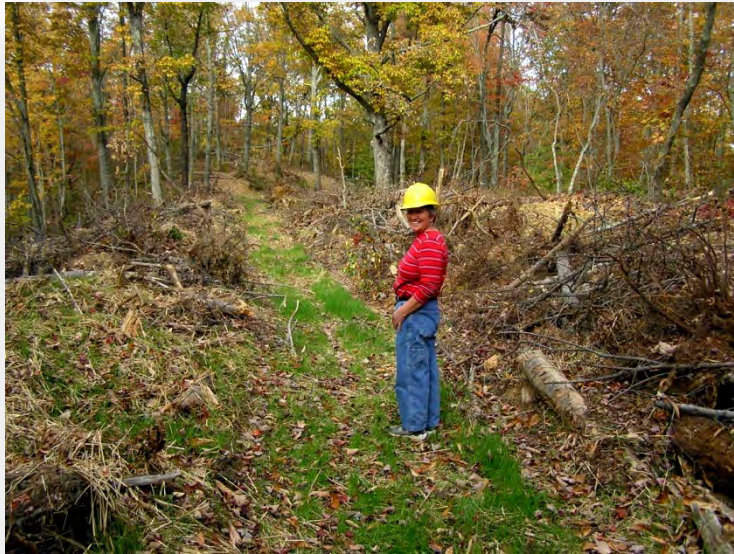
**Figure 22: Narrowed off-highway vehicle road.**

The photo monitoring also showed several different trail and road closure techniques. Depending on the use in the area, the closures ranged from narrowing of trails to allow hiking but eliminate vehicles (Figure 22) to using concrete pillars (Figure 23). The concrete pillars were the most drastic closure method, which was used in an area where OHV riders had reopened a trail on several occasions by removing the closures.

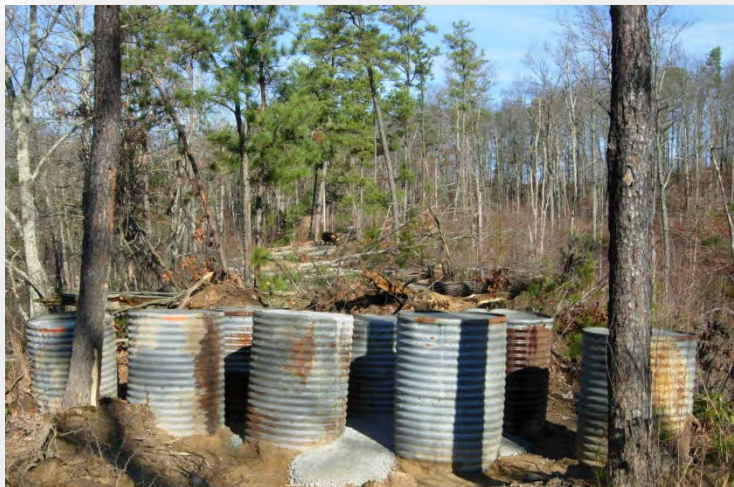
**Figure 23: Concrete pillar closure on a road difficult to close.**

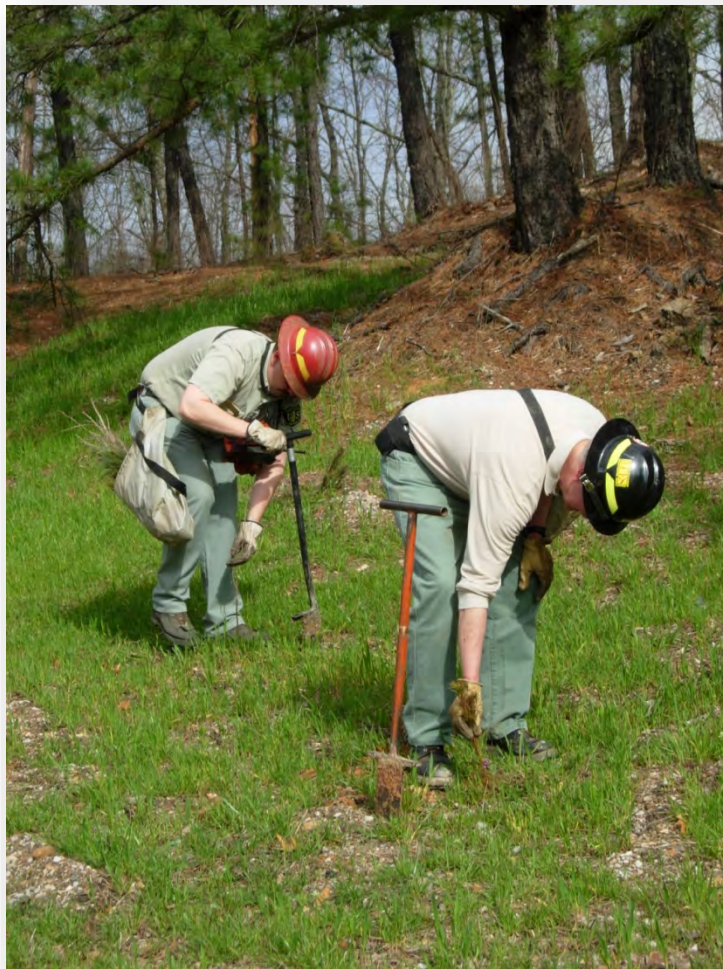
**Figure 24:** Tree planting at an old dump site

**Objective 3:** Trash was picked up from several dump locations. Site rehabilitation began once the tires, old cars and garbage were removed. The dump sites were seeded, mulched and planted with trees (Figure 24). The areas have remained relatively trash-free, which may be a result of changing land-use patterns (from off-highway vehicles to hunters, hikers, mountain bikers and horseback riders). The improved appearance of the land may also deter dumping.
