Cane Run and Royal Spring Watershed-Based Plan Implementation Project: Final Report 2013

The Cane Run and Royal Spring Watershed (HUC 12: 051002050804) is located within Fayette and Scott Counties in central Kentucky (Figure 1). The upper portion of the watershed, located within Fayette County, drains highly urbanized areas of Lexington and a portion of the watershed in Scott County drains the southern part of Georgetown. The rest of the watershed is predominantly agricultural. The 7.5 minute quadrangle maps on which Cane Run can be found are Centerville, Georgetown, Lexington East, and Lexington West. Cane Run contributes to the Kentucky River Watershed (HUC 8: 05100205). Interstate highways I-64 and I-75 traverse the watershed.

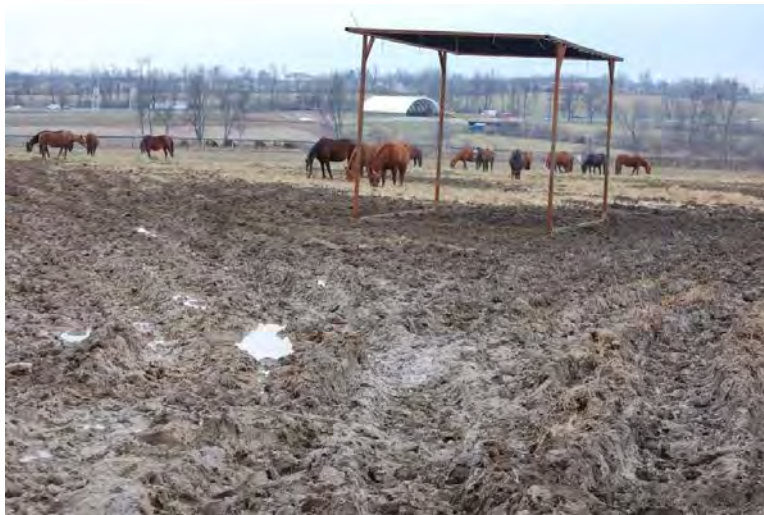
Figure 14. Mud creation due to roll-bale feeding

Although the use of hay huts is not considered an agricultural BMP, water quality can still potentially benefit from their use. Prior to the use of hay huts, roll bales of hay were unrolled in the paddock and would create a feeding area that could be as long as 150 linear feet (Figure 14). Horse congregation along this 150 linear foot strip could potentially create a muddy area as large as 2,100 square feet. By using hay huts, the feeding area is concentrated to around the hut and thus limits the size of the area that becomes denuded, approximately 100 square feet (Figure 15). Approximately forty hay huts have been purchased by UK's CAFE, which could be limiting the amount of denuded pasture by as much as 80,000 square feet.

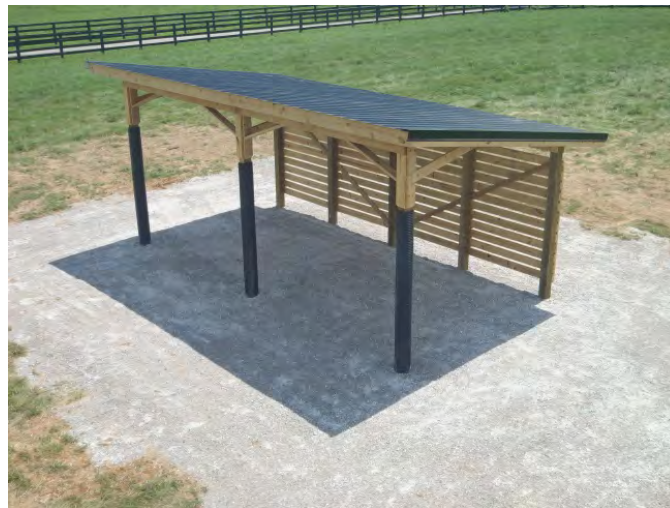
Figure 16. Heavy use areas were installed under 4 permanent shade structures with UK CAFE funds

Heavy use area (HUA) protection was installed under 4 large permanent shade structures (1,410 square feet each) with funding from UK's CAFE (Figure 16). A HUA was also installed in the paddock that was recently altered to create a rotational grazing system using 319(h) funds (Figures 17). Without a HUA, horses congregating in these areas will create mud, increase soil compaction, eliminate desired vegetation, and lead to increased weed infestation. The runoff from these compacted, denuded areas can also pollute nearby surface water bodies. The purpose of a dry lot is to provide a hardened area for the traffic associated with obtaining water and feed or seeking shelter and to eliminate many of the negative impacts that livestock have on water quality.

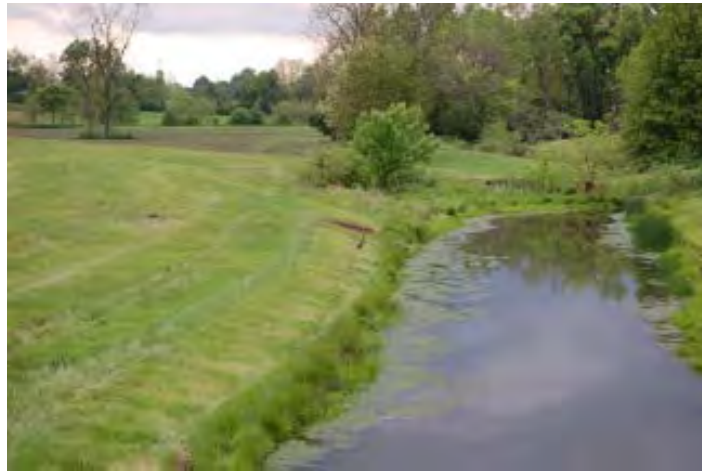
Figure 18. Example of riparian area before the installation of the no-mow zone policy

No-mow zones are areas adjacent to water bodies where mowing is prohibited. These riparian areas were previously mowed to the water's edge (Figure 18). The installation of a no-mow zone allows vegetation, including plants in the seed bank, to grow and create a vegetative buffer between pollutants such as sediment, nutrients, and bacteria and the water (Figure 19). These buffers are approximately 50 feet wide on each side of the water body. During the FFY 2006 project, no-mow zones were established along all streams and water bodies on the farm, with the exception of several small stream sections and Lake Mildred. During this project (FFY 2008), these final areas were delineated as no-mow zones; all streams and water bodies on the entire farm are now protected. Signs are posted to designate no-mow zones areas—these signs also help describe the practices to users and visitors of the farm. As a result of this stewardship, populations of riparian flora such as Great Blue Lobelia (*Lobelia siphilitica*), Swamp Milkweed (*Asclepias incarnate*), sedges, Woodland Sunflower (*Helianthus divaricatus*), and Arrow Arum (*Peltandra*) are returning.

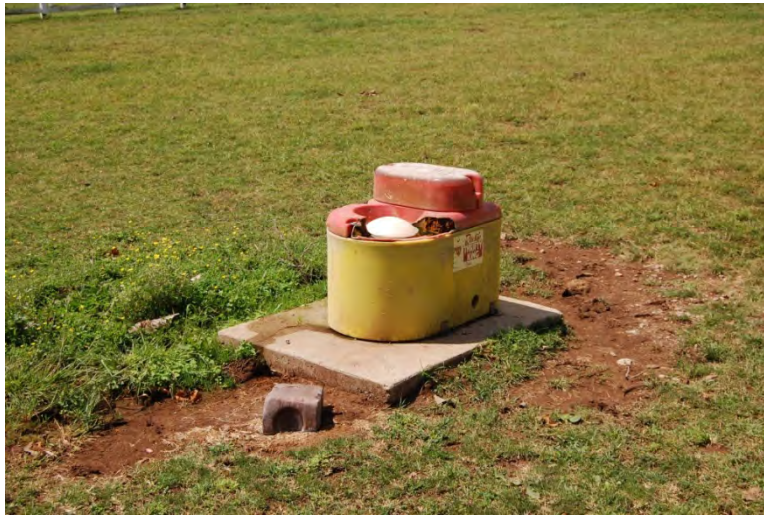
Figure 21. A dilapidated watering fountain that was poorly sited and not placed on a proper HUA

The KHP had four automatic watering fountains that were poorly sited, not properly working, and were not placed on a HUA. The areas surrounding the water facility were denuded and causing other erosion issues in the paddock due to leaking (Figure 21). There were several similar instances of this throughout the park. The worst four fountains were replaced and properly sited within the paddock on a heavy use surface (Figure 22). Horse park staff were trained on how to properly site and develop a HUA in the process so future fountains can be replaced with water quality in mind.

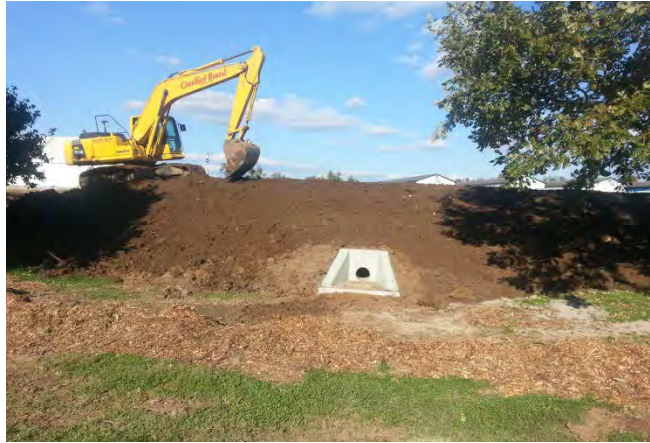
Figure 23. A bioretention pond was installed below an impervious area where horse wash racks and uncovered manure piles are located and labeled with education signage

A 220 linear foot bioretention pond was installed below an impervious area where horse wash racks and uncovered manure piles are located and labeled with educational signage (Figure 23). The bioretention pond is engineered to filter the runoff of sediment and nutrients.

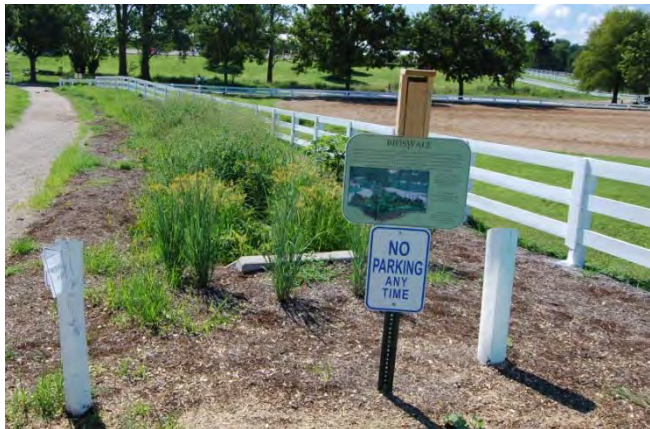
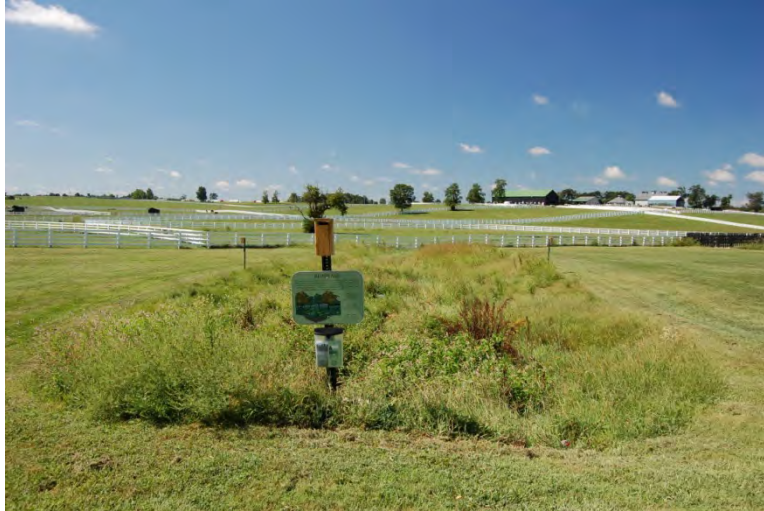
Three bioswales were installed in ditches where stormwater discharges from a point source and designated with educational signage (Figures 24-25). The purpose of the bioswales is to slow the velocity of the discharge to minimize bank erosion and filter pollutants from the stormwater. Bioswales were planted with species such as Black-eyed Susan, Prairie Switchgrass, Little Bluestem, Purple Coneflower, Goldenrod, and Bee Balm, which are known for their ability to assimilate pollutants.

Figure 24. A bioswale and educational signage installed in a stormwater ditch.

Figure 25. A bioswale and educational signage installed in a stormwater ditch.

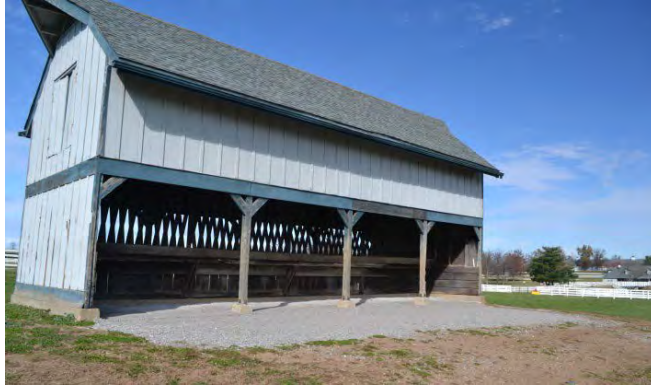
Figure 26. One of two HUAs installed outside of a run-in shed

Heavy use areas (HUAs) were installed under and outside the entrance of two run-in sheds (Figure 26), in the paddock used for trail horses (Figures 27), and along a highly eroded section of the horse trail (Figure 28). All of these areas were completely denuded and experiencing excessive erosion, especially the trail horse paddock (Figure 29). The trail horse paddock is 9,672 square feet and typically contains between 20-25 horses (Figure 30). A paddock with this concentration of animals is prone to muddy conditions; contributing further to the trail horse paddock’s issues is its location downhill of another denuded area containing two large gullies flowing toward it (Figure 31). Relocating the pasture was considered but was not feasible for KHP staff who utilized the paddock. As an alternative, the paddock was filled with a HUA and storm water was diverted around the paddock.

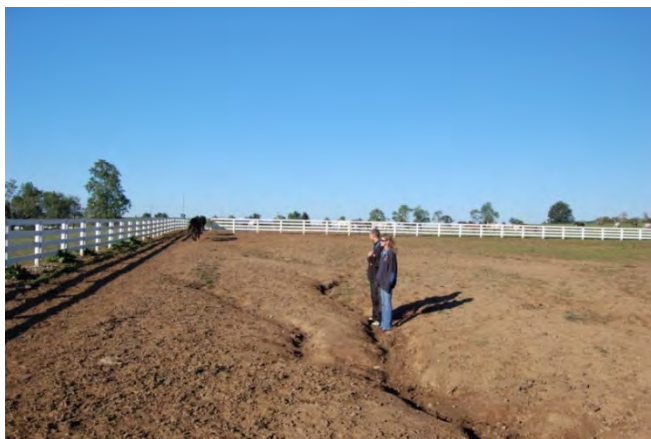
Figure 31. Large gullies flowing toward trail horse paddock

The fourth project site is located in the trail horse paddock where the large HUA was installed. Previously, runoff would flow through large gullies into the paddock. Water was diverted to flow through a designated channel along the side of paddock.

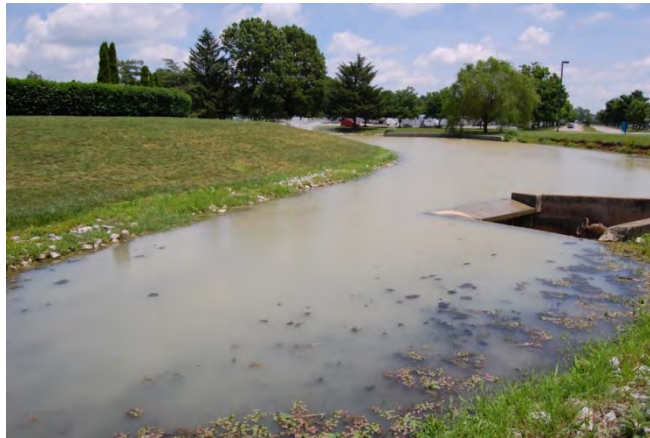
Figure 32. Sand runoff and deposition in this pond resulted in shallow water depth, higher water temperatures, and algae blooms .

A larger pond in the center of the KHP had become a milky color due to the large amount of sand runoff that was entering the pond (Figure 32). The pond essentially acts as settling basin for sand and sediment. The amount of sand and sediment that had deposited was so great that the pond's depth had decreased significantly, thus increasing the water temperature, making it inhospitable to aquatic life and causing algae blooms. In addition, the pond bank had begun to erode in certain areas, making it difficult for native ducks to access the pond. The pond was drained and dredged to remove the large amount of sand and sediment, restoring the pond's capacity to collect sand and sediment and reduce the amount that leaves the pond and enters the Cane Run. Banks were stabilized and a vegetative buffer was established to facilitate duck use and deter invasive Canada geese.

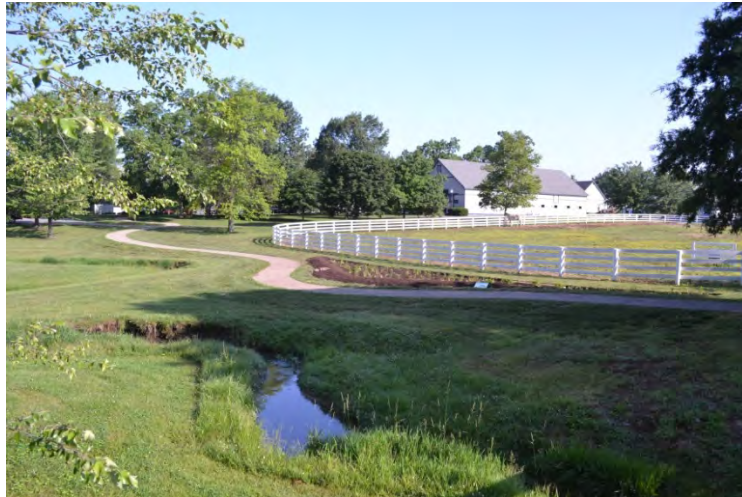
Figure 33. A rain garden was installed to filter runoff from the uphill, partially denuded paddock

A 110 foot long rain garden was installed below a partially denuded paddock at the KHP (Figure 33). The paddock has a moderate slope and lacks a sufficient amount of vegetation to slow the velocity of runoff. Prior to the rain garden's installation, runoff would flow over a pedestrian sidewalk and enter a tributary of the Cane Run—carrying sediment and nutrients. The rain garden was filled with native plants such as wild bergamot (*Monarda fistulosa*), cardinal flower (*Lobelia cardinalis*), and blue flag iris (*Iris versicolor*) and designated with educational signage (Figures 34). Runoff is now captured and filtered within the rain garden. However, during large rain events water breaches the berm and overflows from the rain garden. The size of the rain garden was limited to the space that was available, but ideally the rain garden should be larger for the amount of runoff that it receives.

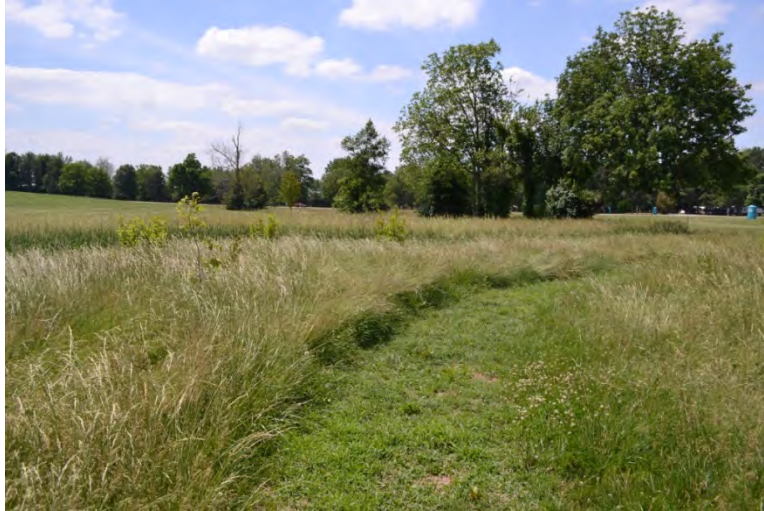
Figure 35. Established a riparian area and recreational trail walkway with educational signage

A riparian area and recreational walking trail were established along approximately 1,200 linear feet of an unnamed tributary at the KHP campground. The riparian area was planted with large and small trees, shrubs, grasses, and flowers (Figure 35). The walking trail pathway is covered in mulch to provide a pervious surface. The riparian area is now a great place to educate visitors about water quality.

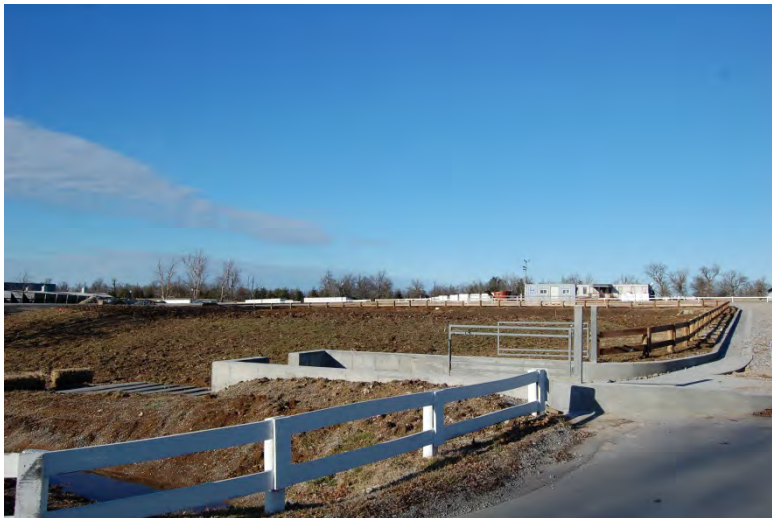
Figure 36. A settling basin was installed in a gravel parking lot at the KHP and labeled with educational signage

An 80 foot long settling basin was installed in a gravel parking lot at the KHP and labeled with educational signage (Figure 36). Prior to the settling basin's installation, runoff from the parking lot was carrying gravel offsite into the stream channel (Figure 37). The settling basin filters the runoff so the gravel can be collected and reapplied to the parking lot. Storm water diversion was also installed in the parking lot to direct runoff toward the settling basin.

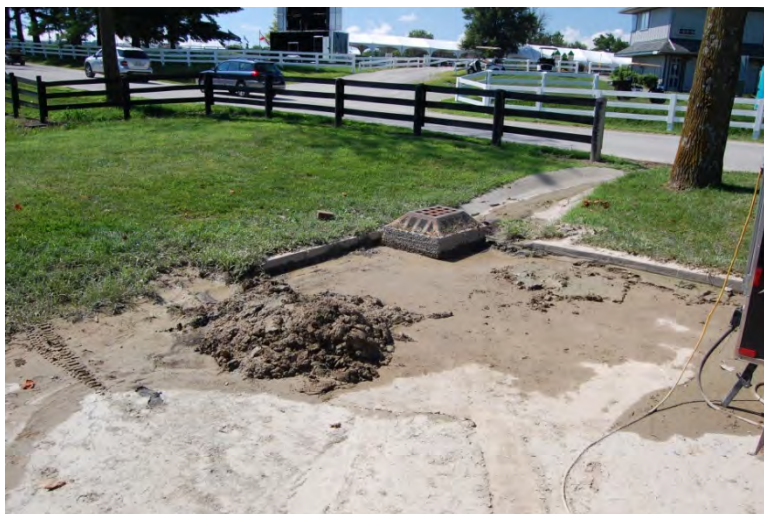
Figure 38. A pervious concrete frame was installed around the storm drain inlet to filter the sand and sediment from runoff and topped with a grate covered in a wire mesh.

A small parking lot at the KHP that is primarily used for heavy equipment is located downhill of several sand arenas where erosion is prevalent. A single storm drain receives the vast majority of this sand/sediment runoff. A pervious concrete frame was installed around the storm drain inlet to filter sand and sediment from the runoff (Figure 38). A grate covered in a wire mesh was installed above the pervious concrete frame to filter excess runoff during large rain events.

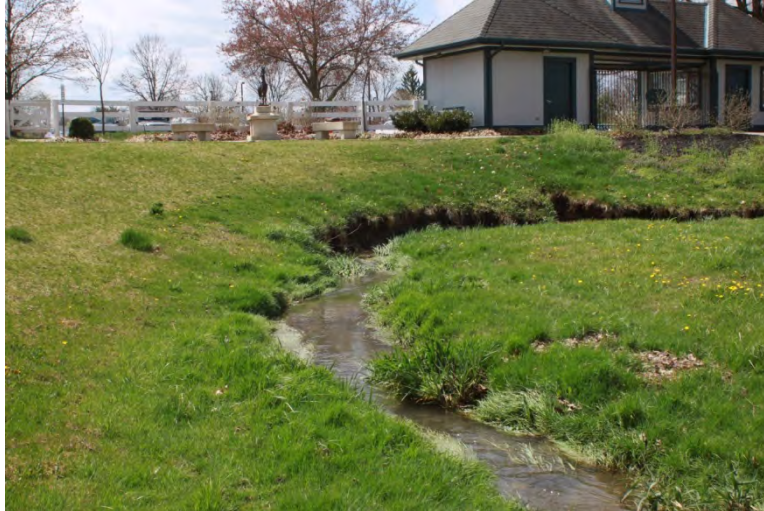
Figure 40. A section of an unnamed tributary lacked floodplain access and concentrated flow resulted in gulley formation.

A large stream restoration project was conducted along 1,400 linear feet of an unnamed tributary of the Cane Run. The tributary was experiencing stream bank erosion in multiple locations due to the lack of floodplain access; concentrated flow subsequently resulted in a large gully (Figure 40). A floodplain was created to allow excess water from large rain events to escape from the stream channel, thus limiting gully creation (Figure 41). Stream banks were stabilized with toe rock in various sections (Figure 42). Pools and riffles were also created to slow velocity and create habitat for macroinvertebrates and other aquatic life (Figure 43). The riparian area will also be planted in Spring 2014 to provide shading, increased stream bank stabilization, and to create a vegetative filter.

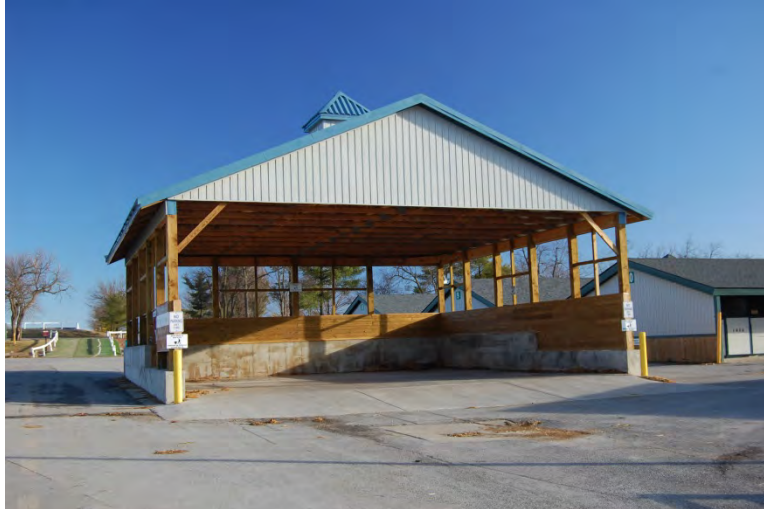
Figure 44. A waste storage facility was constructed to provide a designated, covered storage area

A 2,000 square foot waste storage facility was constructed at the Kentucky Horse Park (Figure 44). Prior to building the structure, manure was piled at the end of barns, uncovered (Figure 45). Signage was installed at the end of barns to inform visitors of the new manure storage location.

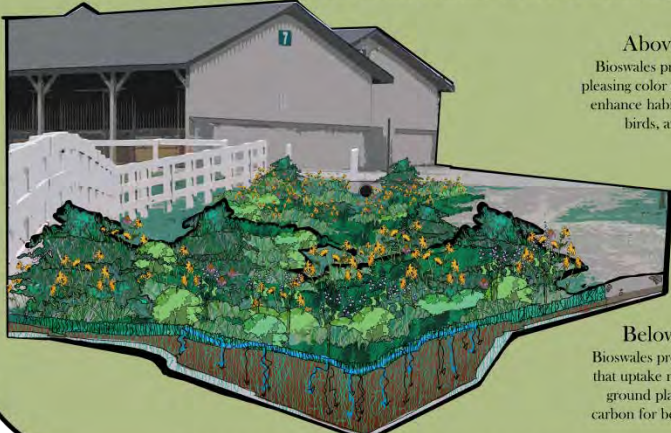
BIOSWALE

Bioswales are living filters that use vegetation, soil, and microorganisms to trap and filter pollutants and protect water quality. Bioswales are typically used in urban settings to filter runoff from paved surfaces. They can also be used in rural settings to filter runoff from agricultural production areas. This area is intentionally thick with native grasses, forbs, and other plants chosen for their ability to create a healthy ecosystem.

Above Ground
Bioswales provide aesthetically pleasing color to the landscape and enhance habitat for amphibians, birds, and butterflies.

At the Surface
Bioswales intercept silt, nutrients, and pathogens in runoff and enhance infiltration.

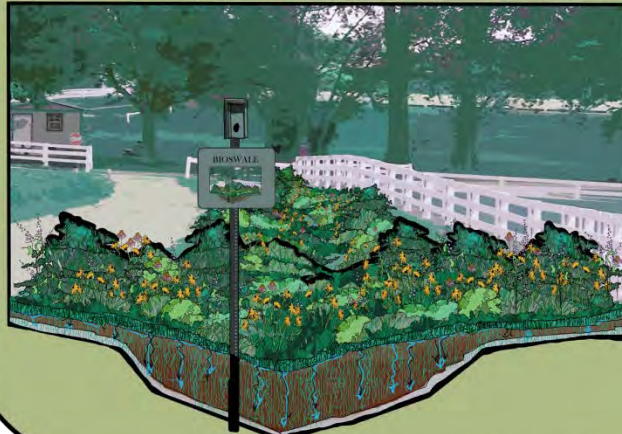
BIOSWALE

Bioswales are living filters that use vegetation, soil, and microorganisms to trap and filter pollutants and protect water quality. Bioswales are typically used in urban settings to filter runoff from paved surfaces. They can also be used in rural settings to filter runoff from agricultural production areas. This area is intentionally thick with native grasses, forbs, and other plants chosen for their ability to create a healthy ecosystem.

Above Ground
Bioswales provide aesthetically pleasing color to the landscape and enhance habitat for amphibians, birds, and butterflies.

At the Surface
Bioswales intercept silt, nutrients, and pathogens in runoff and enhance infiltration.

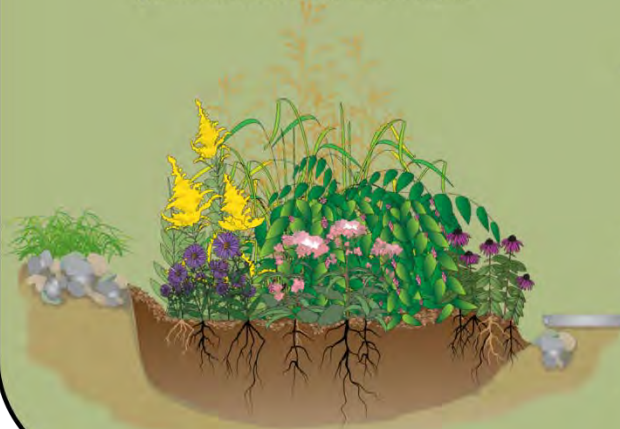
RAIN GARDEN

Rain gardens are intentionally planted in low-lying, soggy areas. These gardens use native vegetation, soil, mulch, and an earthen berm to keep water clean by filtering out pollutants from stormwater runoff.

Biodiverse plants are chosen for their deep root systems, adaptation to wet and dry cycles, and aesthetically pleasing appearance.

Hardwood mulch is used to minimize weeds and maintain moisture in the garden.

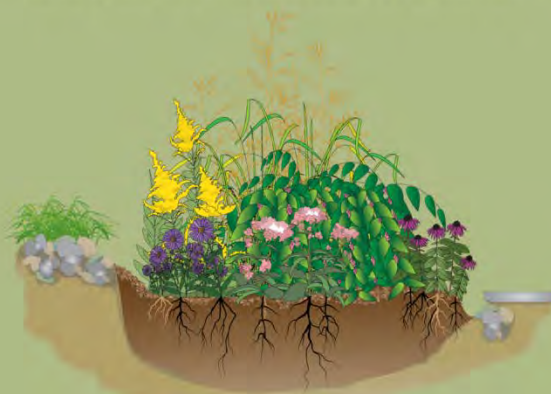
BIORETENTION BASIN

Bioretention basins are soil and plant-based filtration structures that collect stormwater runoff and remove pollutants and sediments through a variety of natural processes such as filtration and plant uptake. This bioretention basin was constructed to treat the runoff from the main horse washing station. This project was a joint effort between the University of Kentucky and the Kentucky Horse Park Foundation.

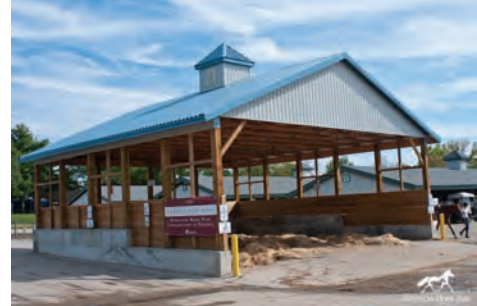
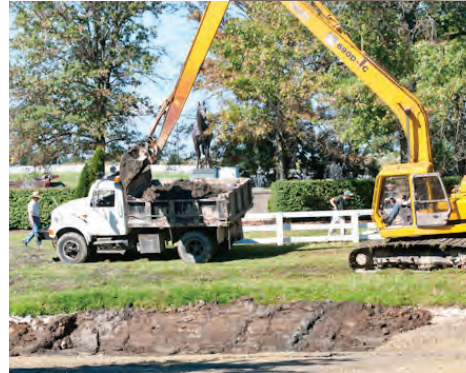
ABOVE: New landscaping, Covered muck storage and dredging the Pond are all part of the Cane Run Watershed Project.
