Project Final Report

Section 319(h) Kentucky Nonpoint Source Implementation Grant Workplan "Geomorphic Characteristics of Streams in the Mississippi Embayment Physiographic Region of Kentucky"

UNIVERSITY of IOUISVILLE STREAM INSTITUTE Geomorphic Characteristics of Streams in the Mississippi Embayment Physiographic Region of Kentucky

of The Stream Institute Department of Civil and Environmental Engineering University of Louisville Louisville, Kentucky

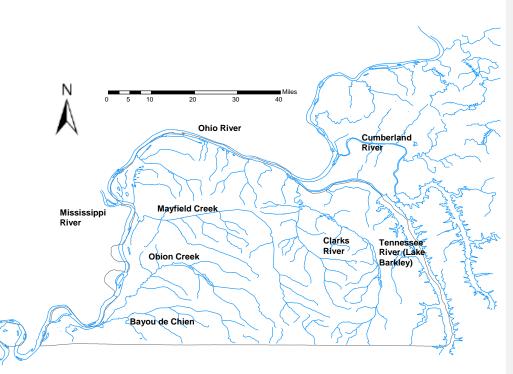
Figure 2.2 Major stream systems of the Mississippi Embayment (Noger, 1998).

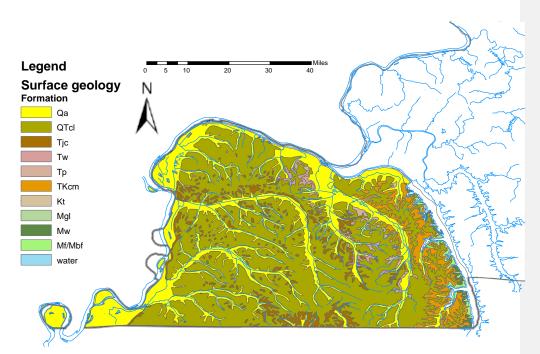
Figure 2.4 Generalized surface geologic map of the Mississippi Embayment (Noger, 2002).

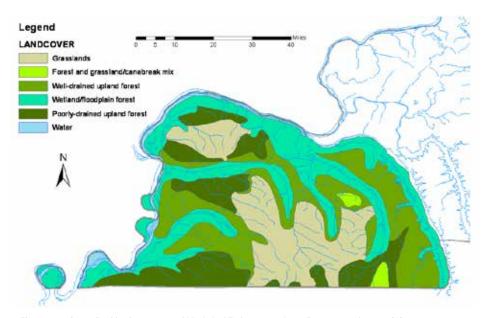
Figure 2.5 Generalized land-cover map of Mississippi Embayment prior to European settlement. GIS coverage provided by Kentucky Nature Preserve Commission—historic land-cover data collaboratively developed by Kentucky Environmental and Public Protection Cabinet, Kentucky State Nature Preserves Commission, Kentucky Heritage Council and the Kentucky Chapter of the Nature Conservancy (Mitchell, 2005).

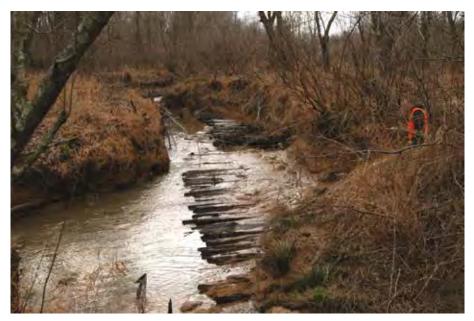
Figure 2.6 Exposure of a buried wood structure indicating the depth of deposits in the Panther Creek valley, Calloway County.

For example, Figure 2.6 shows the exposure of a wooden crossing or primitive corduroy road buried in the sediments on the wide floodplain of Panther Creek, a tributary to the Blood River. A headcut migrating upstream through the deposit exposed the wood structure. The deposition over the structure is approximately 4.5 feet in thickness. The alluvial deposits along the Clarks River near Almo, shown in Figure 2.7, indicate a sequence similar to those found in other

locations of the midwestern and eastern US—recent alluvium (top brown loose sandy silt) deposited over what appears to be buried wetland soils (gray mottled silty soil) underlain by gravel. Observations made during this assessment indicate that current application of soil conservation practices has reduced the overland component of erosion significantly compared to that of the early part of the 20th century. Still, gullies in upland fields are not difficult to find.

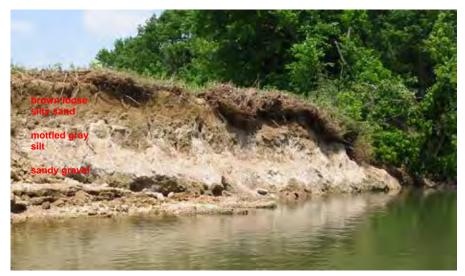
Figure 2.7 Eroding bank on the Clarks River near Almo, Calloway County.

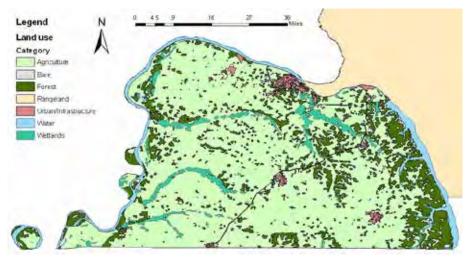
Figure 2.8 2001 land-use map of the Mississippi Embayment (USGS, 2004).

Figure 2.8 shows the regional land-use in 2001. Land use is now predominantly agricultural, with over 52 percent of the region in agricultural production. Remnant forests account for 28 percent of the land use, with lesser amounts of land devoted to other covers.

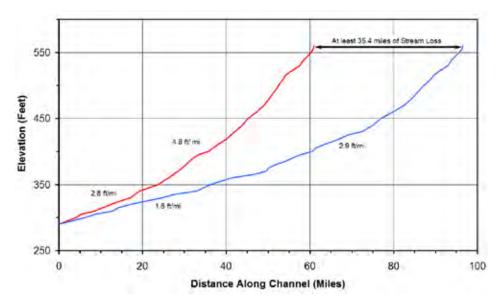
Figure 2.9 Estimated stream profile of Mayfield Creek before and after channelization (Calloway, Graves, McCracken, Ballard and Carlisle Counties).

Mayfield Creek provides a good example of the effect of channelization on channel length and stream slope. The sinuous channel of Mayfield Creek prior to channelization formed the boundary of Carlisle and Ballard counties; therefore, it was possible to compare the existing and pre-channelized lengths of Mayfield Creek. In addition, the changes in channel slope were estimated from existing land contours. Upstream of the county boundaries, estimates of the prechannelized reach lengths were developed from the sinuosity (stream length to valley length ratio) obtained from remnant channels found in aerial photographs of the pre-channelized stream reaches. Figure 2.9 shows the estimated stream profiles for Mayfield Creek before and after channelization. Note that the use of floodplain contours results in a profile that is approximately coincident with the top of the bank above the streambed and does not include fluctuations for topographic variation in the streambed; however, the approximation does provide valuable information about the change in steam length and the overall change in channel slope. Figure 2.9 shows that the length of the main stem was shortened by 35.4 miles and the slopes were increased by 75 percent and 65 percent in the lower and upper reaches, respectively. In addition to the stream morphological implications associated with changes in length and slope, bends that provide form drag on the flow were removed. Removal of bends also tends to cause a general flattening of the streambed as well as a decrease in bed form resistance. These changes lead to a general increase in sediment transport capacity and a tendency for channel bed incision. As a consequence of the effects of channelization, Mayfield Creek is deeply incised, as are all streams examined in the Mississippi Embayment except the few that have not been extensively channelized.

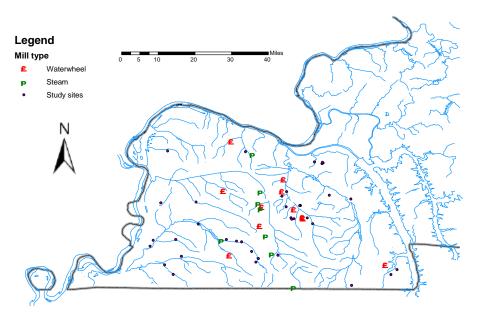
Figure 2.10 Mississippi Embayment mills and geomorphic assessment study sites.

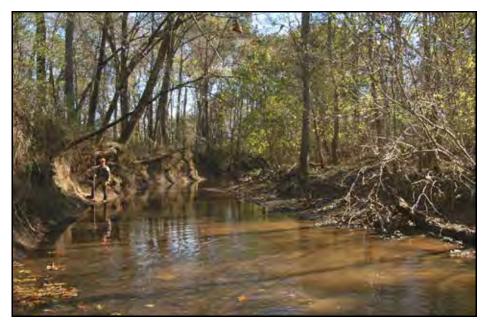
Figure 2.11 Late stage channel evolution in Obion Creek downstream of Waggoner Bottom Road, Graves County.

Many of the larger low gradient streams in wide valley bottoms appear to be in the later stages of adjustment (response 2c, above). In later stages, the bed is aggrading (vertical adjustment), severe bank erosion and lateral migration are progressing, and a new, lower level floodplain is forming. This is shown in Figure 2.11 of Obion Creek and Figure 2.12 of Mayfield Creek. The most severe bank erosion was observed at locations where channel bends were constructed in the channelized (mostly straightened channel) networks. In straight reaches remote from constructed bends, severe bank erosion was not typical in the larger stream channels (shown in Figure 2.13). Well-vegetated banks were observed in most of these straight reaches. Aggradation of beds in channelized reaches appears to be resulting in a large storage of sand and gravel as also indicated in Figure 2.13. Lateral adjustment appears to be propagating upstream and downstream from constructed channel bends.

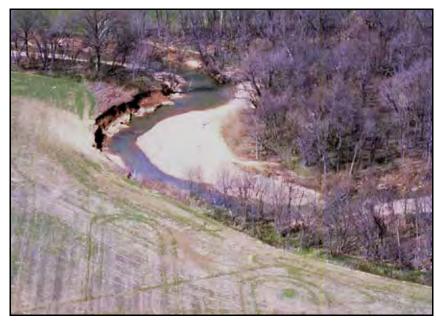
Figure 2.12 Late-stage channel evolution in Mayfield Creek, Graves County.

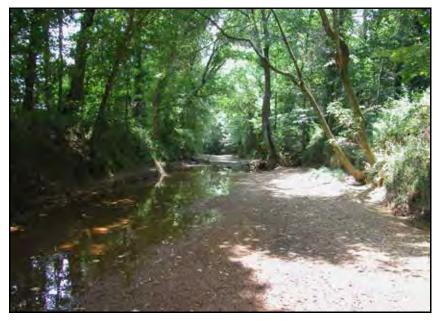
Figure 2.13 Laterally stable straight channelized reach of Obion Creek, Graves County, downstream of Pryorsburg. Note apparent aggradation of the streambed and storage of sandy gravel in the streambed.

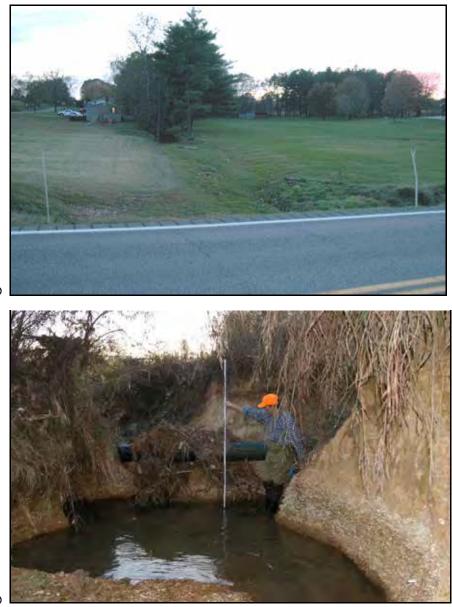
Figure 2.14 Small unnamed headwater tributary of the west fork of Mayfield Creek near the intersection of Kentucky Routes 80 and 384 in Graves County (a) upstream of pipeline and culvert and (b) downstream of pipeline and culvert. Note undermining of waterline in (b).

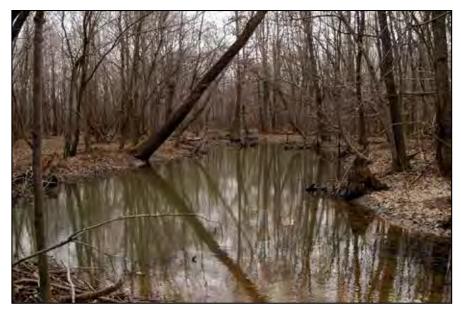
Figure 2.15 Remnant reach of pre-channelized Obion Creek upstream of Kentucky 307 bridge, Hickman County.

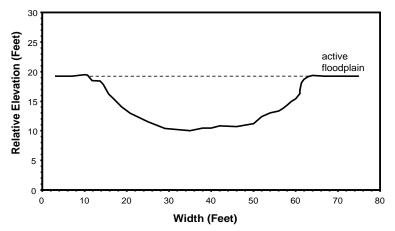
Figure 3.1 Cross section of Obion Creek, Hickman County, where the valley flat is the active floodplain (bankfull level indicated by dashed line).

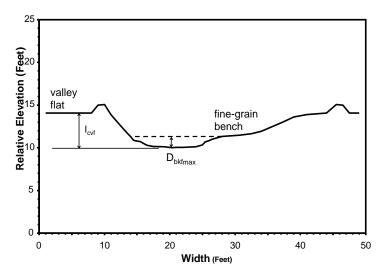
Figure 3.2 Cross section of Grindstone Creek, Calloway County (bench and bankfull level indicated by dashed line)

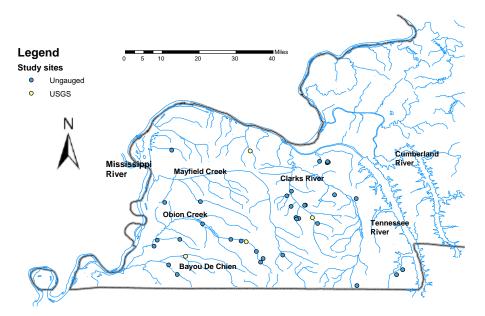
Figure 3.3 Study sites within the Mississippi Embayment.

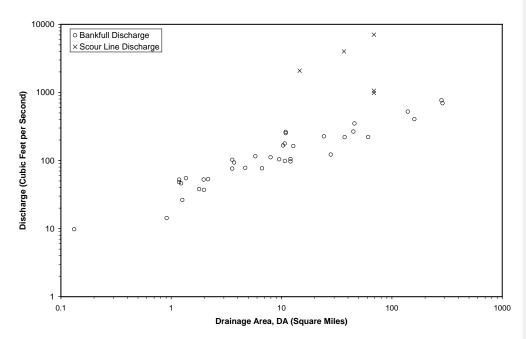
Figure 4.1 Bankfull and scour line discharge as a function of drainage area.

Comparisons of flows associated with the various stain or scour lines and the estimated bankfull discharges are shown in Figure 4.1. Bankfull discharge estimates associated with the two aforementioned Bayou de Chien and West Fork Charles River scour lines are, for the same drainage area, close to the bankfull discharge estimates based on morphologic features. Mean velocities associated with the stain line at Bayou de Chien and the lower line at West Fork Clarks River, both bimodal bed sediment streams, are 2.5 and 2.6 feet per second, respectively.

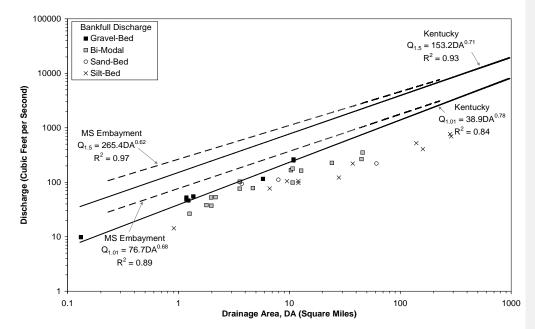
Figure 4.2 Regression Curves for Q1.01 and Q1.5 Derived from Gauges Across Kentucky and from the Mississippi Embayment, with Estimated Bankfull Flows from the Mississippi Embayment.

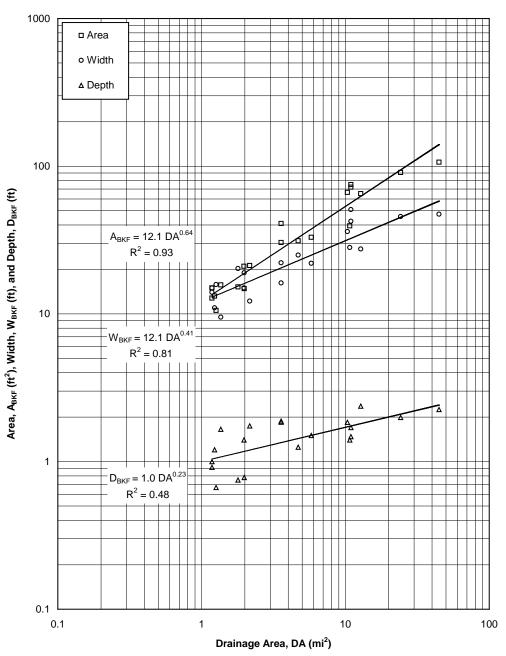
Figure 4.3 Bankfull cross-sectional characteristics of gravel bed streams in the Mississippi Embayment of Kentucky.

drainage area. Table 4.4 provides the results of the regression analysis for each, and Figures 4.3 through 4.5 show plots of the resulting power curves and data from which they were developed.

Bed Material	Regression Equation	Coefficient of Determination, R ²	Standard Error*, S _e
	$A_{BKF} = 12.1 \text{ DA}^{0.64}$	0.93	21%
Gravel bed	$W_{BKF} = 12.1 \text{ DA}^{0.41}$	0.81	21%
	$D_{BKF} = 1.00 \text{ DA}^{0.23}$	0.48	28%
	$A_{BKF} = 16.7 \text{ DA}^{0.57}$	0.91	41%
Sand bed	$W_{BKF} = 10.5 \text{ DA}^{0.34}$	0.90	26%
	$D_{BKF} = 1.60 \text{ DA}^{0.22}$	0.79	26%
	$A_{BKF} = 13.1 \text{ DA}^{0.63}$	0.93	31%
Silt bed	$W_{BKF} = 9.47 \text{ DA}^{0.35}$	0.92	19%
	$D_{BKF} = 1.38 \ DA^{0.28}$	0.83	23%

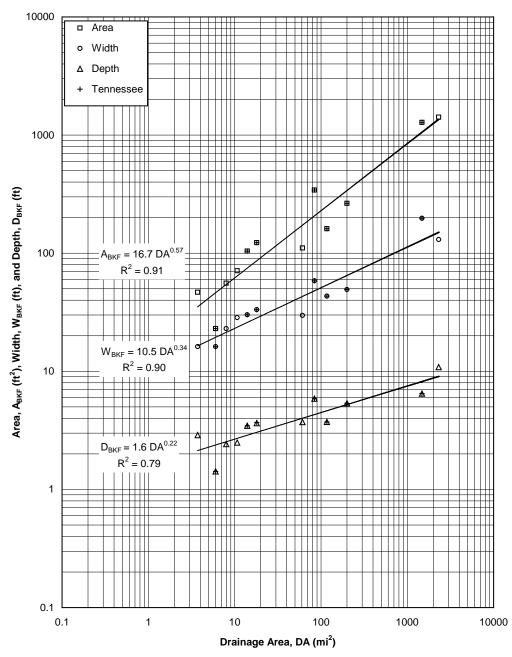
Figure 4.4 Bankfull cross-sectional characteristics of sand bed streams in the Mississippi Embayment of Kentucky and western Tennessee.

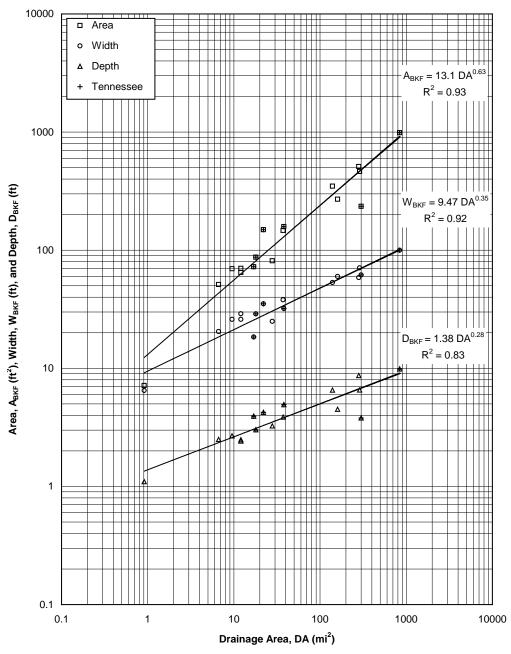
Figure 4.5 Bankfull cross-sectional characteristics of silt bed streams in the Mississippi Embayment of Kentucky and western Tennessee.
