Watershed Based Plan

Clarks Run Watershed Boyle County, Kentucky

Prepared for
Kentucky Division of Water
200 Fair Oaks Lane
Frankfort, KY 40601

Prepared by
Third Rock Consultants, LLC
2526 Regency Road, Suite 180
Lexington, KY 40503
859.977.2000

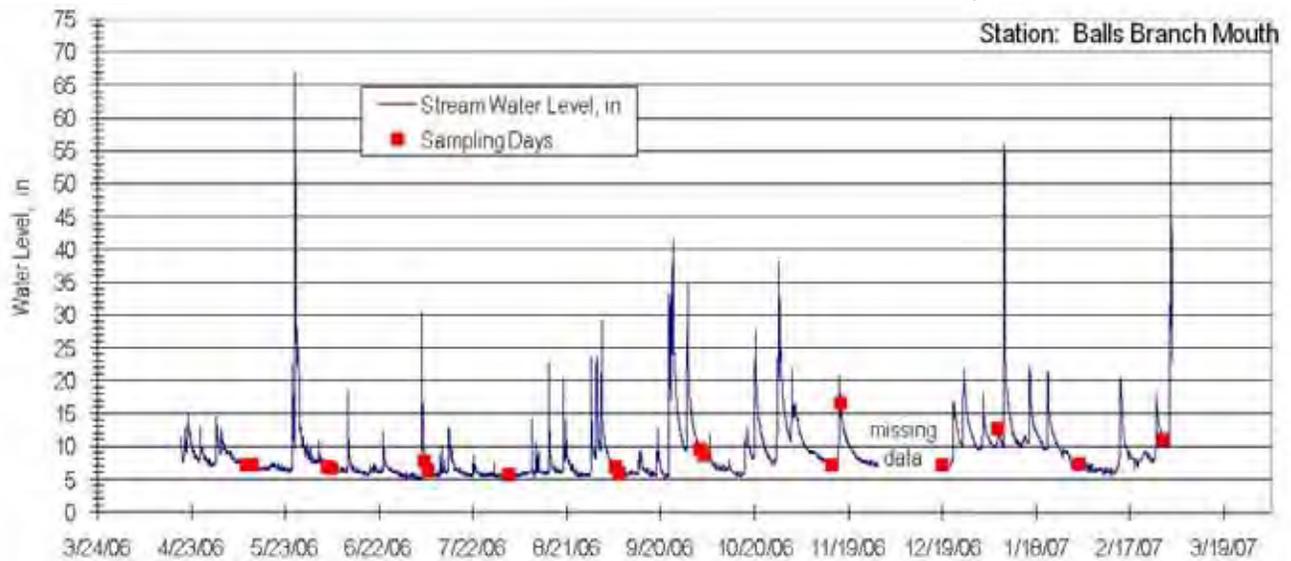
FIGURE 1 – WATER LEVEL AT BALLS BRANCH MOUTH, 2006-2007

As part of a yearlong water quality monitoring study in Clarks Run, two water level data loggers were utilized to evaluate the relationship between the daily stream water depth and the flow data captured. These data loggers captured daily changes in the water level at the mouth of Balls Branch and at the US 127 overpass of Clarks Run. Figures 1 and 2 (pages 6 and 7, respectively) graphically illustrate the results of this study.

Cumulatively, Figures 1 and 2 indicate that the water levels in the stream show wide variance, increasing over 5 feet at the mouth of Balls Branch and as much as 4.5 feet at Clarks Run at US 127 Bypass. The hydrographs show that the streams exhibit a flashy response to storm events, quickly rising and falling in response to the runoff and groundwater influx. As shown in these figures, the water quality sampling conducted concurrently with these water level readings were usually measured during the lowering of the water level to base flow conditions subsequent to a storm, although several events did capture rising stream conditions. The water quality study is discussed further in Section 2.1.8 of this document.

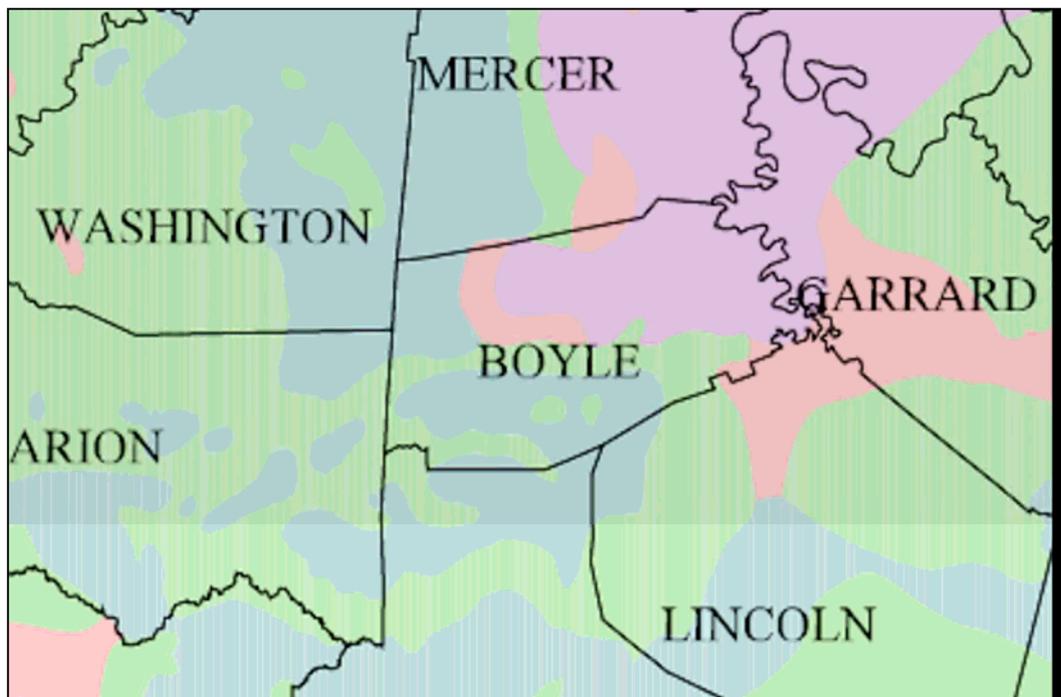
FIGURE 3 – HYDROLOGIC SENSITIVITY INDEX MAP OF COUNTIES SURROUNDING THE CLARKS RUN WATERSHED

The sensitivity index in the Clarks Run watershed is largely a product of the underlying geology. The hydrology is strongly influenced by the amount of shale in the subsurface, which generally impedes the infiltration of precipitation. As shown in Figure 3 (page 8), a large portion of Clarks Run shows the highest karst sensitivity index (5) due to greater limestone influence. In the southern area of the watershed, karst sensitivity is lower (3) with potential for karst but not extensive development due to interbedded shales and limestone.

Hydrologic Sensitivity Ratings from Low to High are as follows: Grey=1 (not shown), Blue = 2, Green=3, Pink=4, Purple=5 (from Ray *et al.* 1994).

The hydrologic sensitivity ratings are well correlated with the potential for karst areas and known groundwater features in the watershed as mapped by the Kentucky Geological Survey. As shown in Exhibit 2 on page 9, major karst potential is found along the northern portion of the watershed, no potential along the central west to east band, and moderate karst potential to the south. Springs are mostly found in or nearby these karst potential areas. The groundwater wells scattered throughout the watershed utilize this resource for a variety of purposes.

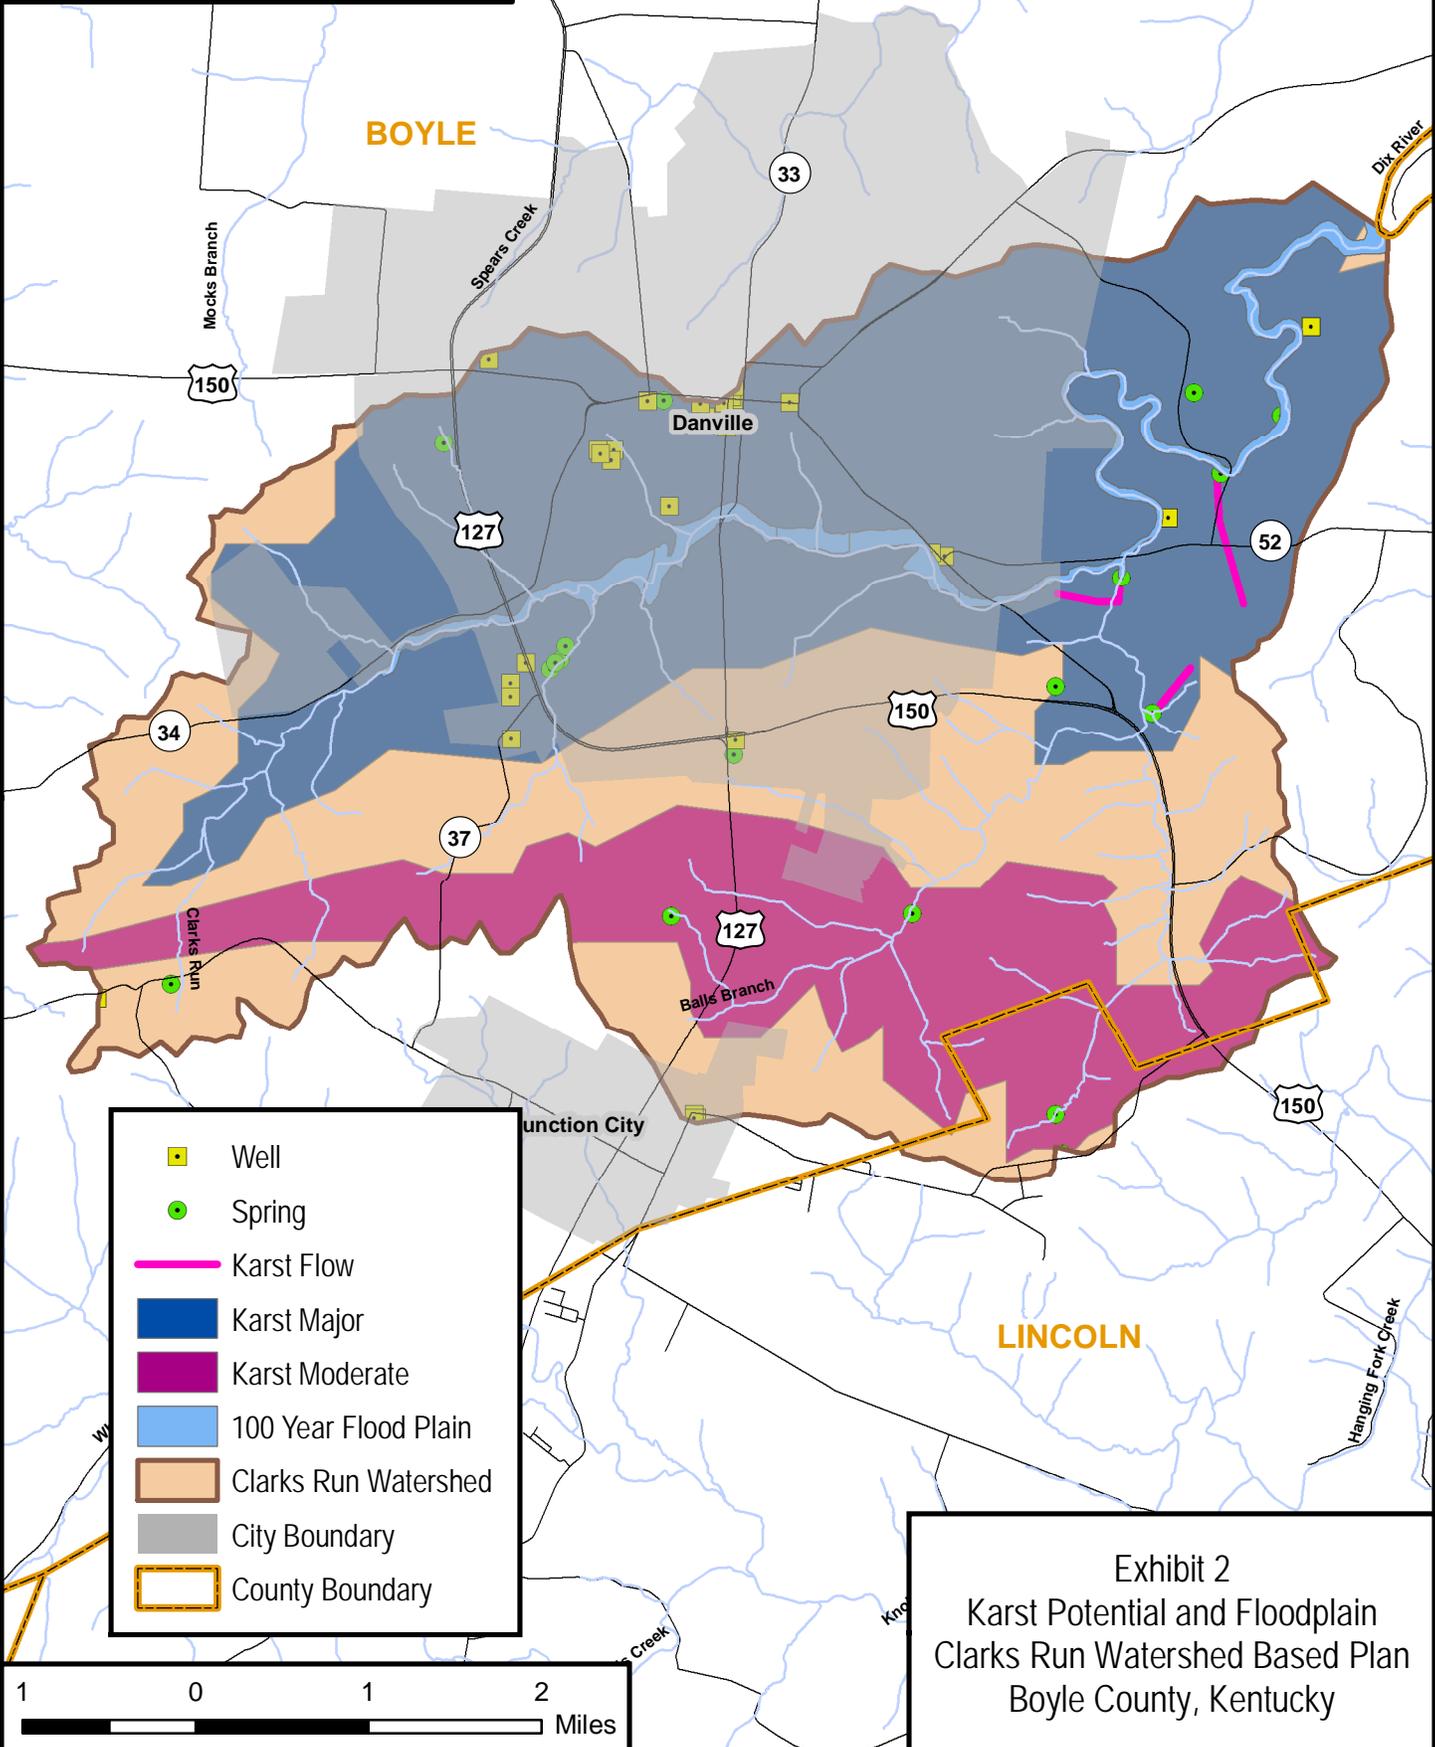
Karst and springs mapping obtained from Kentucky Geological Survey, <http://kgsmap.uky.edu/website/KGSGeology/>. County Road mapping was obtained from the Kentucky Transportation Cabinet. National hydrography dataset downloaded from the Kentucky Office of GIS at <http://ogi.ky.gov/gisdata.htm>. County and city boundaries downloaded via the Kentucky GeoNet.

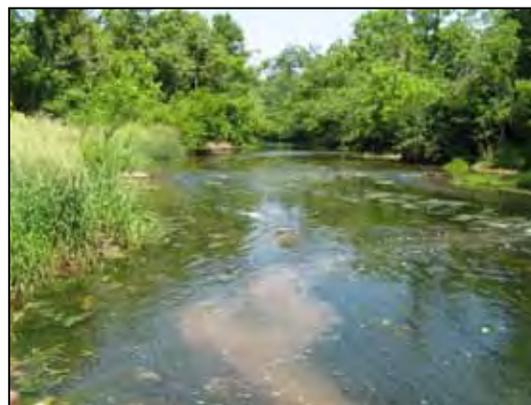
Algal Bloom at Goggin Lane During Un-ionized Ammonia Exceedance

Algal blooms were observed throughout the watershed, but were especially dense at Goggin Lane, where they clogged the entire stream. Algal blooms also occurred at KY 52, but shading of the stream by the tree canopy minimized the severity of these blooms. No dissolved oxygen problems were detected in Clarks Run, most likely due to frequent aeration at riffles in the shallow streams.

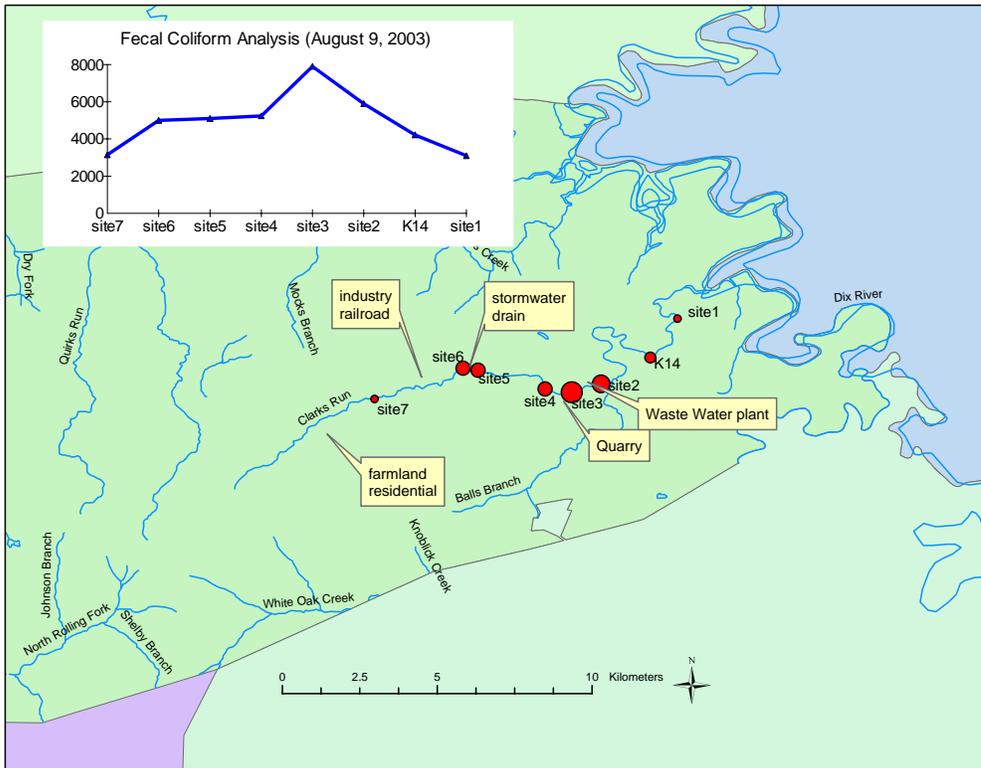
Figure 1. Focused sampling sites and fecal coliform data from August 2003.

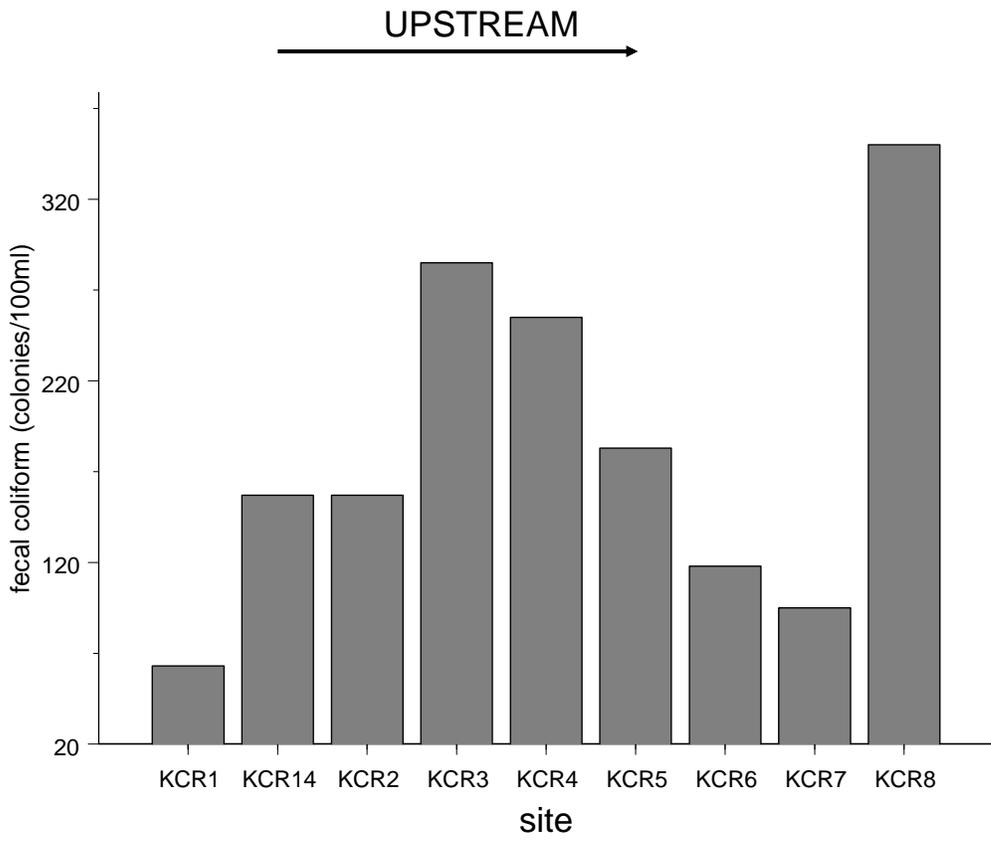
Figure 2. Fecal Coliform data for October 2003

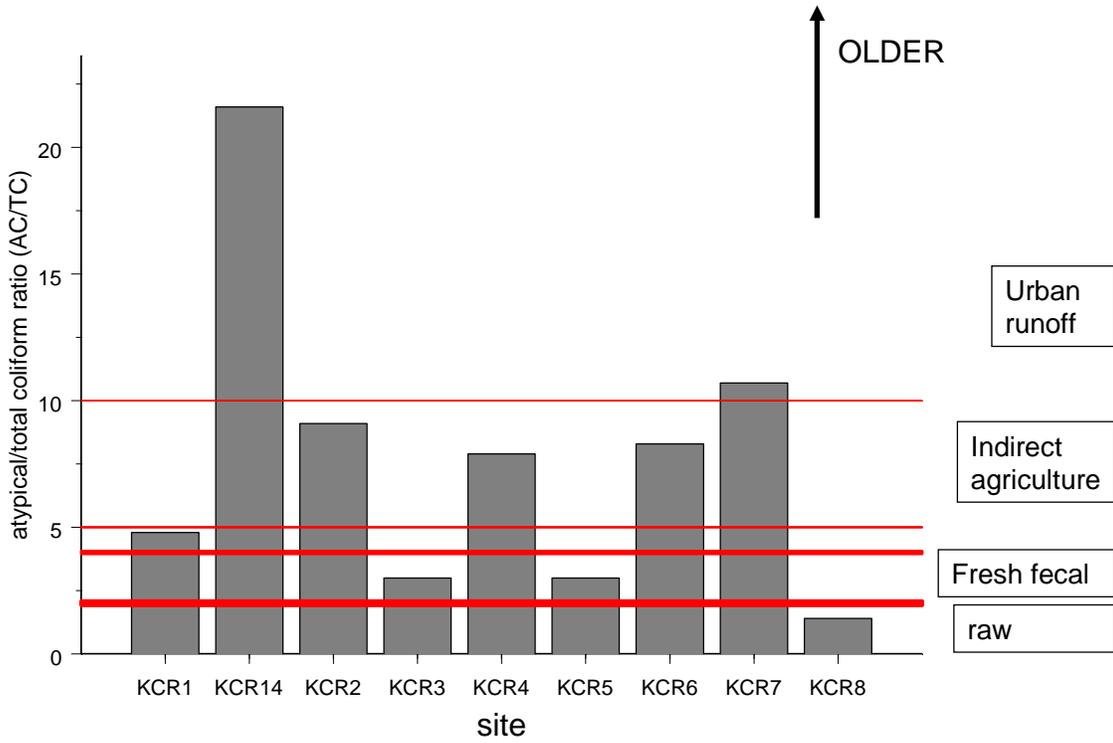
Figure 3. Atypical colony analysis for October 2003

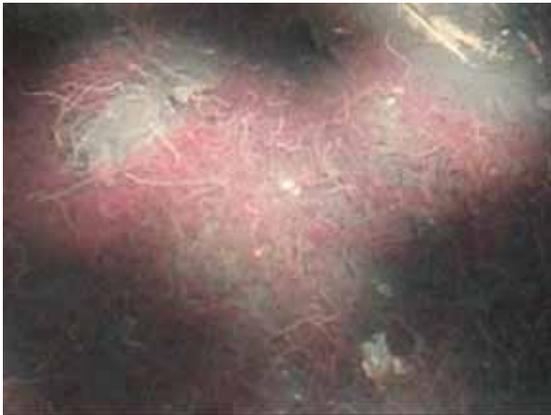
Nematodes as indicator of sewage overflow upstream of CR08

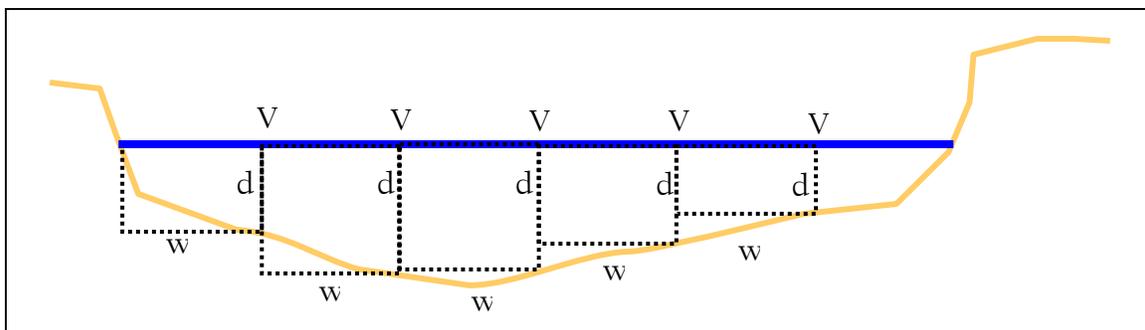
Stream cross-section showing intervals where water depth and velocity are measured. Flow will be calculated for each "box" (flow area for each box is $d \cdot w$) and summed to obtain the flow for the entire stream.
