Red Bird River Watershed Restoration Project Draft Watershed Plan

April 2016

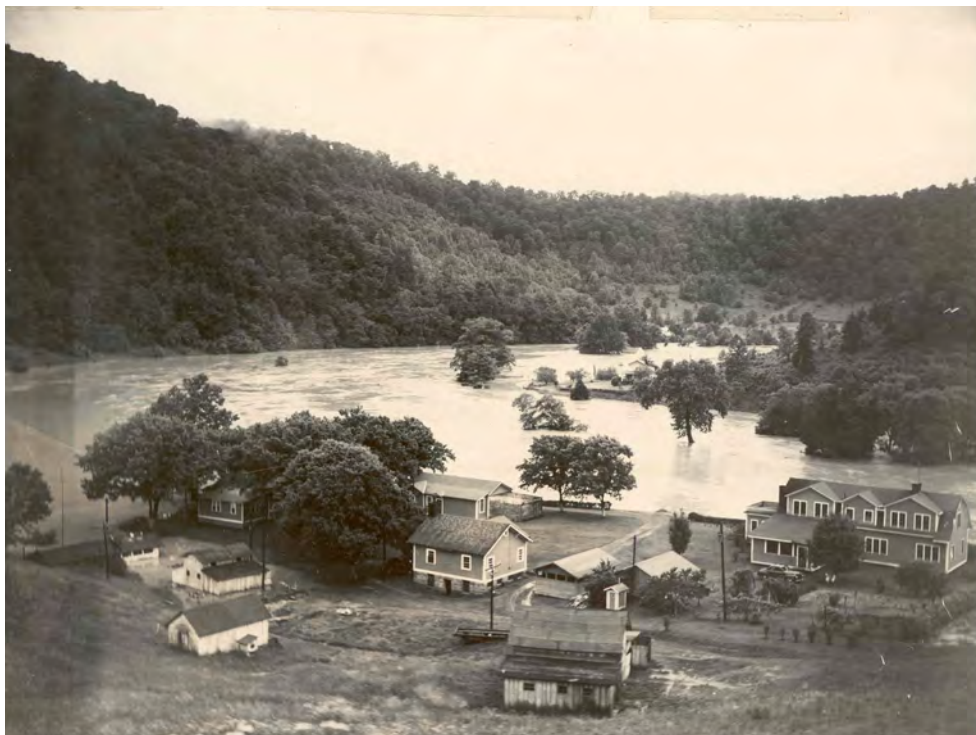
Figure 2.4: The June 28, 1947 Red Bird River flood as seen from the USFS office in Peabody, KY.

Two of the largest floods in the Red Bird River Watershed were in 1947 and 1957. The heaviest damage occurred in built up areas where a higher percentage of homes were built in the flood plain than homes in less developed areas. Figure 2.3 shows the Ranger Station in the Peabody area in 1940, before the 1947 flood. Figure 2.4 shows the same area during the 1947 flood.

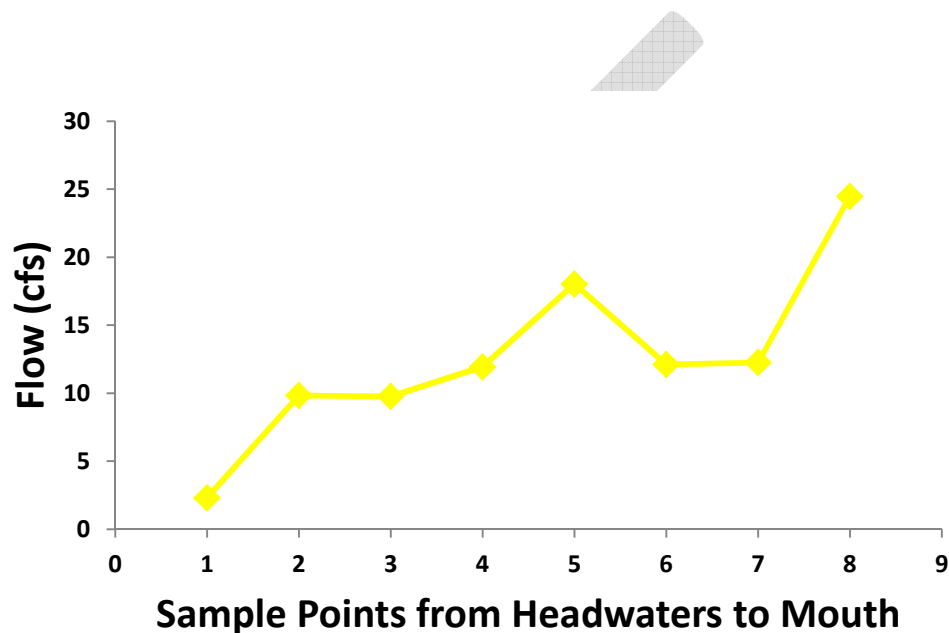
Figure 4.4: Flow, measured in cubic feet per second, in the Red Bird River from the headwaters (Sample point 1) to the mouth (Sample point 8).

The following figures (Figures 4.4 through 4.13) depict water quality measurements taken during the sampling event that occurred between August 29 and September 1, 2011. All water quality parameters, except *E. coli*, were sampled one time during this sampling event. The amount of the measured parameter is on the vertical axis, and the sample point/location is on the horizontal axis (see mapped location of sample points on Figures 4.1 and 4.2). Data was graphed this way so that one may compare the differences in amounts of a specific parameter, such as flow, at different locations in the watershed, from the headwaters to the mouth.

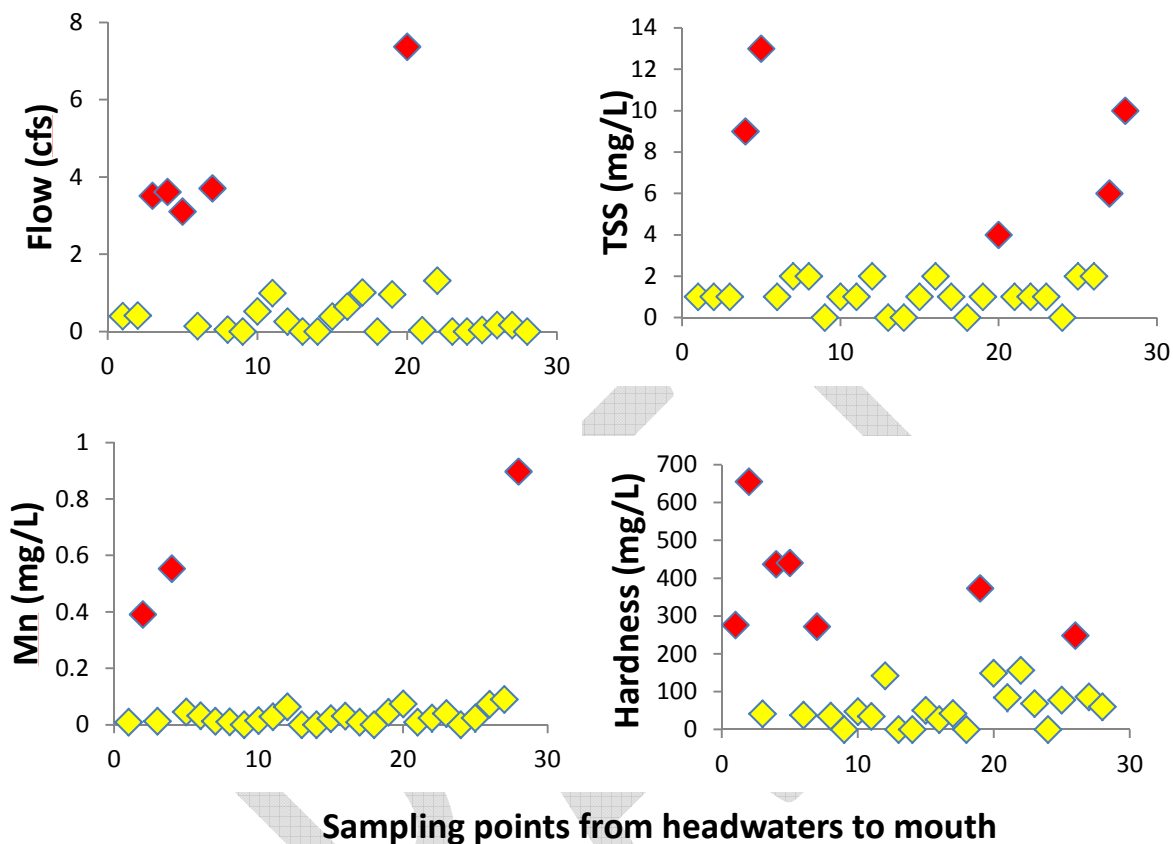
Figure 4.9: Red Bird River tributary sampling points, in order from the headwaters to the mouth, which had increased flow, total manganese, hardness, and total suspended solids. Data are from a single sampling event. Red sampling points are higher than most values and could signify potential problems at that sampling location.

- flow
- total suspended solids
- total manganese
- hardness (as CaCO₃)

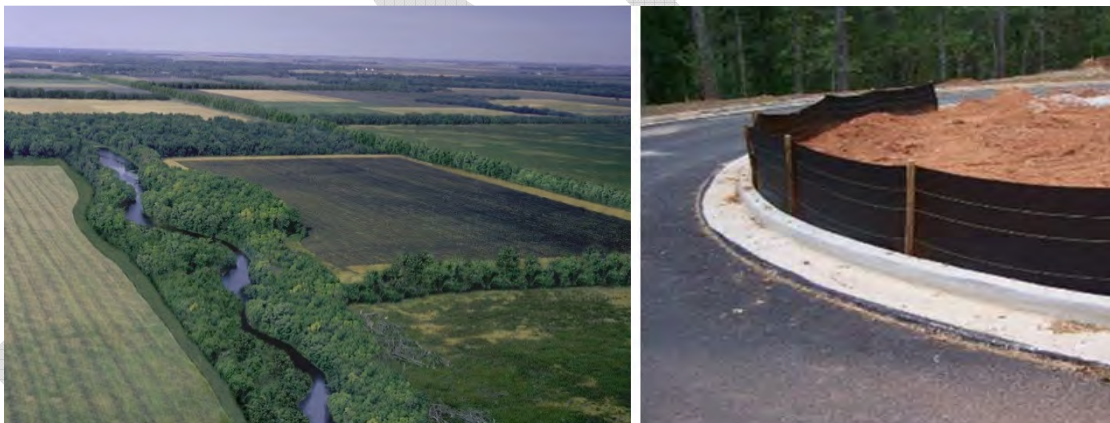
Figure 5.1: Riparian stream buffers and silt fences are structural BMPs that help protect water quality.
