West Hickman Creek was first listed as impaired for aquatic life in the 1998 303(d) list of Kentucky impaired waters. In subsequent years, additional segments and causes were listed including impairment to recreational use due to pathogens in 2004. The US Environmental Protection Agency (EPA) and the Kentucky Environmental and Public Protection Cabinet (KY EPPC) also filed a lawsuit (United States 2006) against LFUCG over violations of the Clean Water Act in 2006. The lawsuit was due to failure of the city to maintain the sanitary and storm sewer systems causing raw sewer discharges into streams. On March 14, 2008, LFUCG lodged a Consent Decree to resolve this lawsuit (United States 2008), which was officially entered into effect on January 3, 2011 (United States 2011). The stormwater portion of the Consent Decree was fulfilled and removed in 2021.

The West Hickman Creek Watershed, Hydrologic Unit Code (HUC) number 05100205-120-040, is a 22.35 square-mile (14,305-acre) watershed located in Fayette and Jessamine Counties, Kentucky. The confluence of West Hickman and East Hickman Creeks marks the beginning of Hickman Creek, which flows into the Kentucky River near Camp Nelson (appro

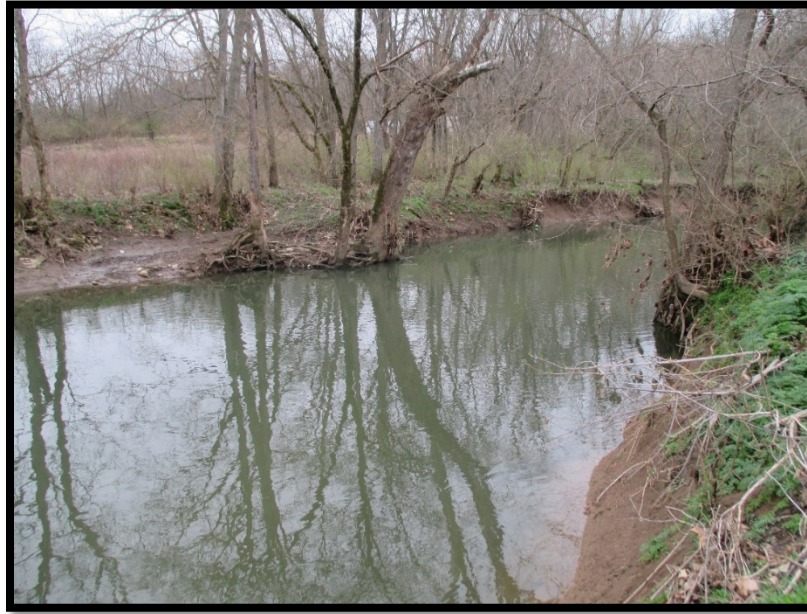
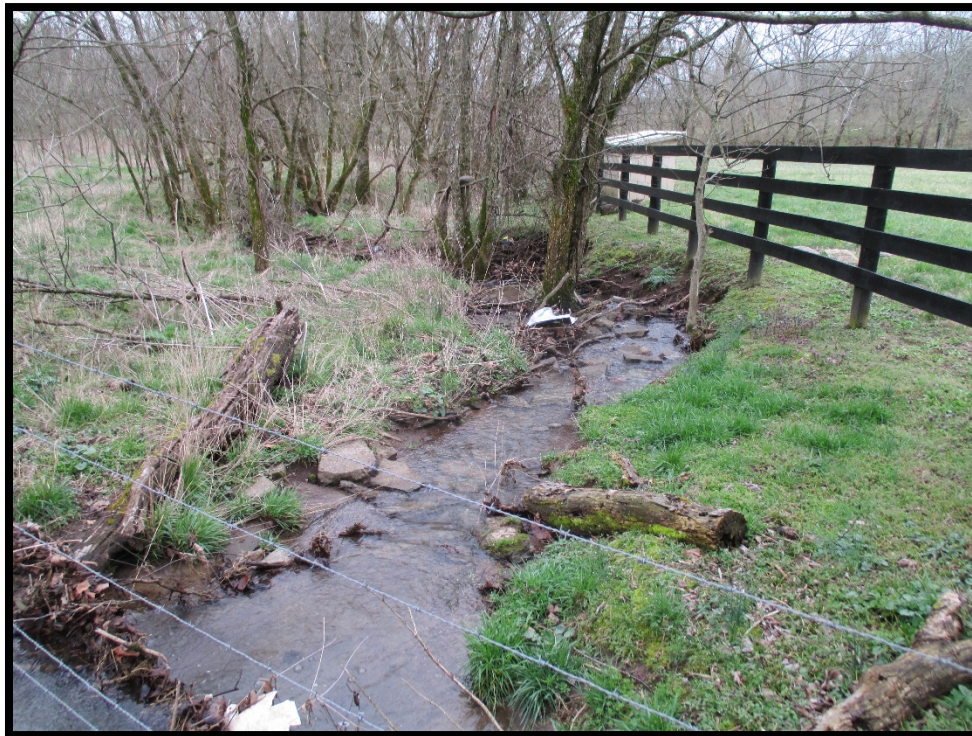
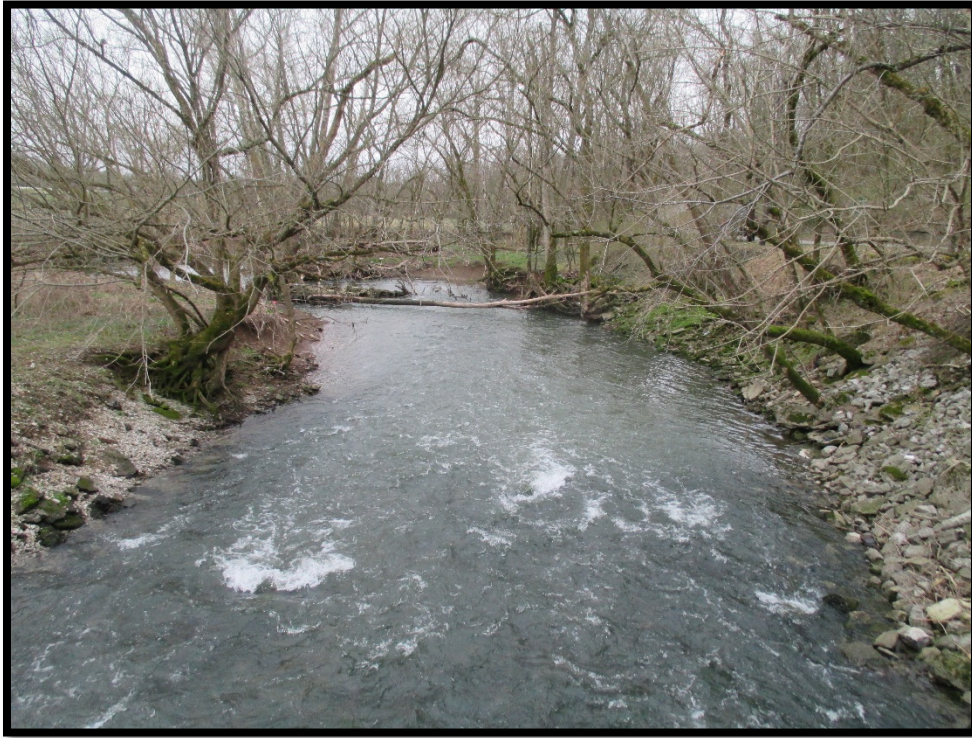
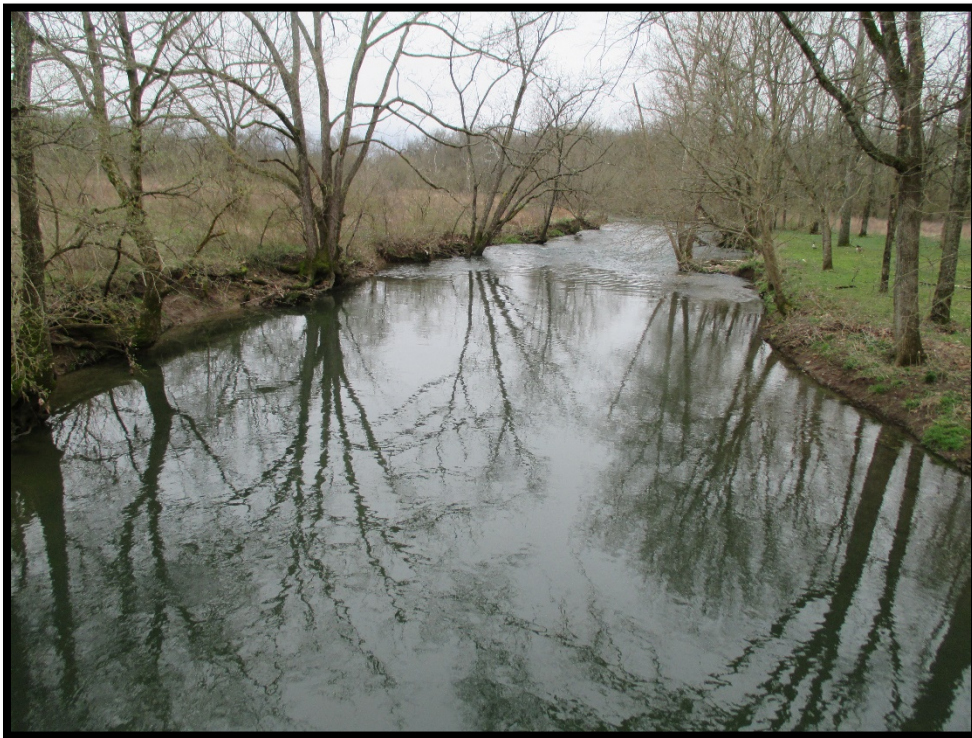
Predominately West Hickman Creek is a very urban watershed, especially through the portions of Fayette County. The development is extending into the northern portions of Jessamine County, but overall the Jessamine County portions are far less developed. Photographs taken during the site visits in Jessamine County are shown in Figure 3-25 through Figure 3-28. Lack of riparian corridor appears to be a large problem through the watershed.

**Figure 3-25: WH-24 Looking Up Stream**

**Figure 3-26: WH-25 Looking Downstream**

**Figure 3-27: WH-26 Looking Downstream**

**Figure 3-28: WH-27 Looking Downstream**

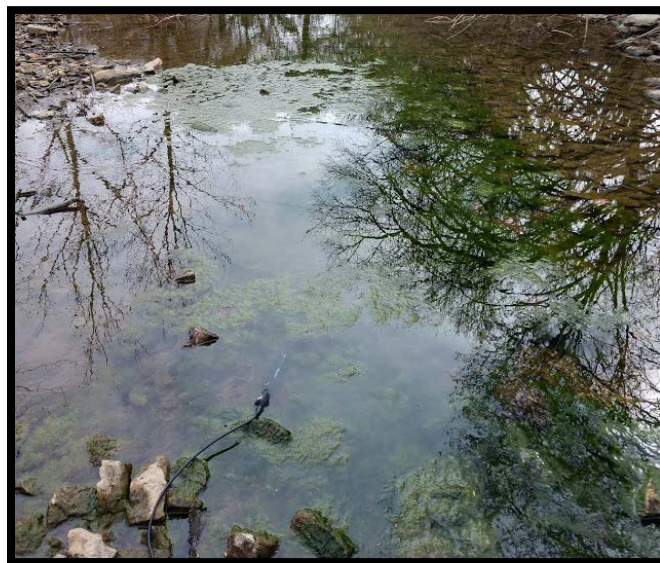
Nitrogen and phosphorus are the two primary nutrients discussed in this plan. Nitrogen and phosphorus are found in fertilizers applied to farm land and residential lawns and gardens and are essential for plant growth. Nitrogen and phosphorus can be measured in several forms. The critical parameters for nitrogen are nitrate-nitrogen ( $\text{NO}_3\text{-N}$ ) and ammonia nitrogen ( $\text{NH}_3\text{-N}$ ). Elevated nitrogen and phosphorus levels may indicate the presence of a pollution source. Ammonia-nitrogen was measured using field Hanna Checkers (handheld colorimeter units). Total nitrogen as nitrate was also measured via grab sample lab analysis and reported in milligrams per liter. The critical parameter for phosphorus is total phosphorus (TP). Total phosphorus was measured by collecting grab samples and sending them to Town Branch WWTP Laboratory for analysis. The results are reported in milligrams (mg) per liter (L).

Figure 4-1: Algae and Other Plant Life on Water Surface at WH - 20

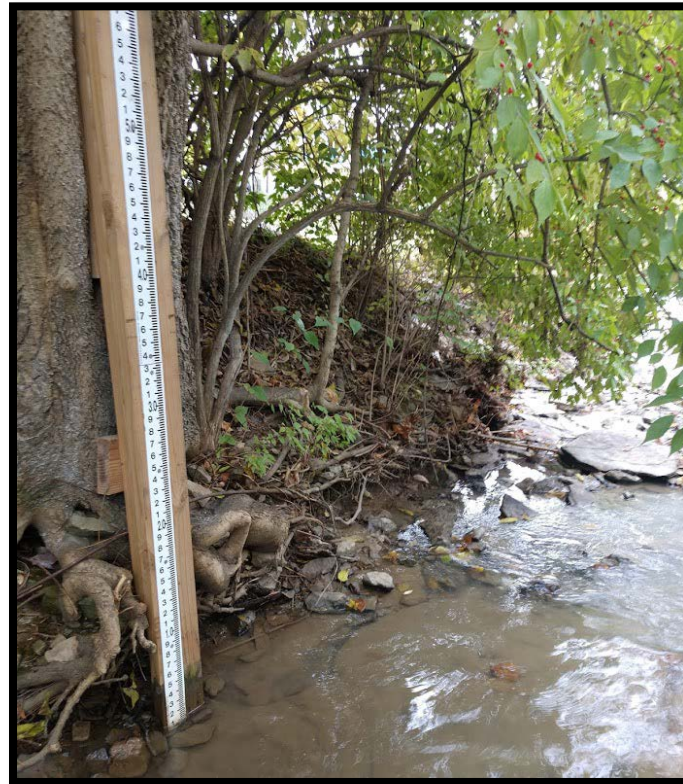
Flow is determined by measuring stream discharge. Stream discharge is the volume of water that passes through a stream in one second. Stream discharge is calculated using measurements of stream width, depth, and velocity. Prior to sampling, physical characteristics (i.e. cross-section, slope, roughness) of each in-stream site and outfall location were measured such that stream or pipe flow could be calculated using water depth values measured during sampling events. The USGS gage at West Hickman Creek at Veteran's Park (Station 03284552) was used to validate flow estimates when needed.

**Figure 4-2: Staff Gauge for Water Depth at WH 08 Site**

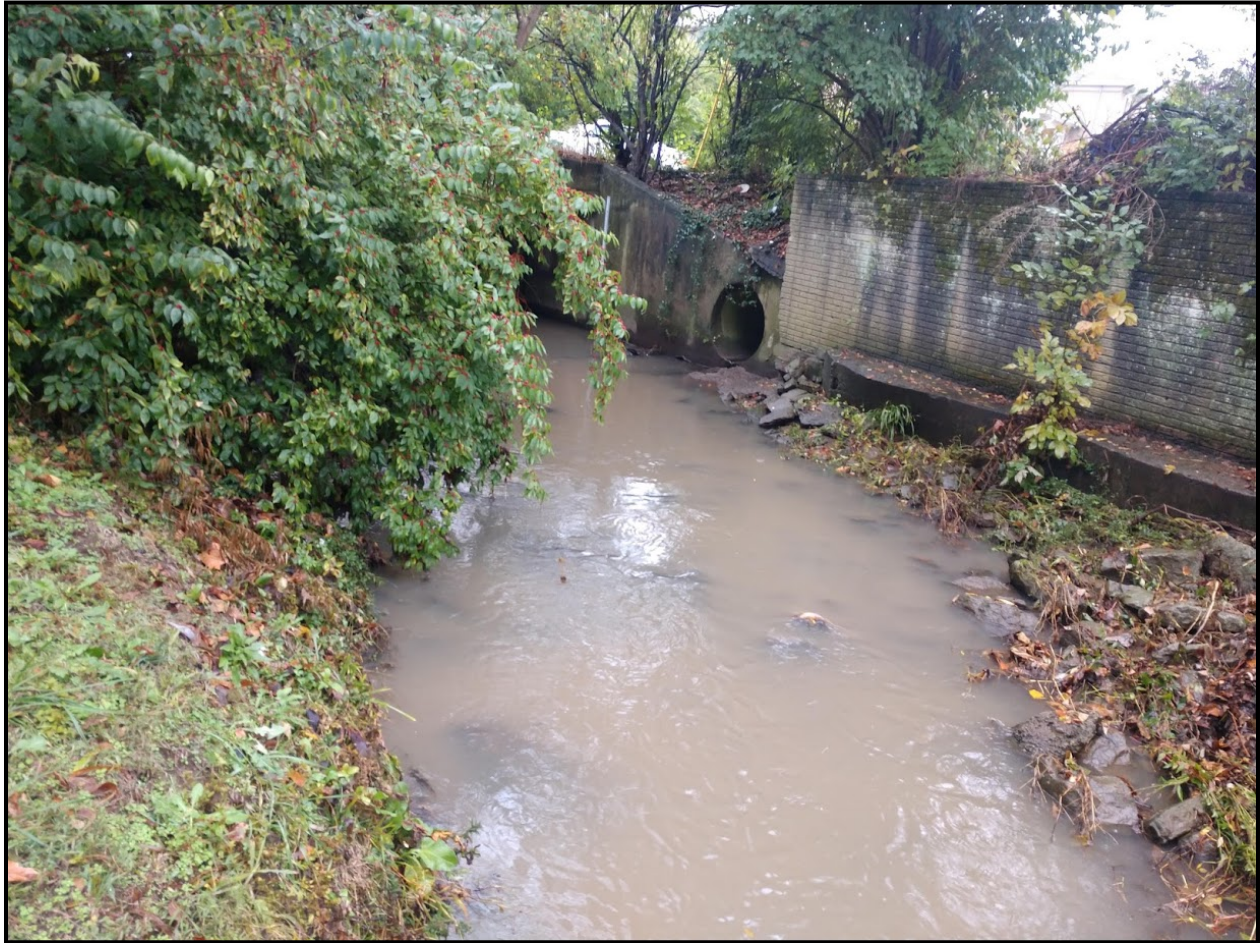
Total suspended solids concentrations and turbidity are critical parameters used to measure the amount of solid material suspended in the water. High levels of total suspended solids and turbidity will often cause the water to appear muddy. In a water body, suspended materials block light from reaching plants on the streambed, limiting photosynthesis. These materials can harm fish spawning beds and impair fish gill function. These impacts combine to reduce plant and animal life in the stream. Suspended materials often carry other pollutants such as metals and bacteria. Turbidity is the cloudiness of a fluid caused by suspended solids and measures the amount of light scattered. The total suspended solids test measures the actual weight of material in a given volume of water. High total suspended solids concentrations and turbidity values can be an indicator of a source of sediment. Total suspended solids were measured via grab samples analyzed in the Town Branch WWTP Laboratory and were reported in milligrams per liter.

**Figure 4-3: Turbid Water at WH-17 on October 30th 2019**

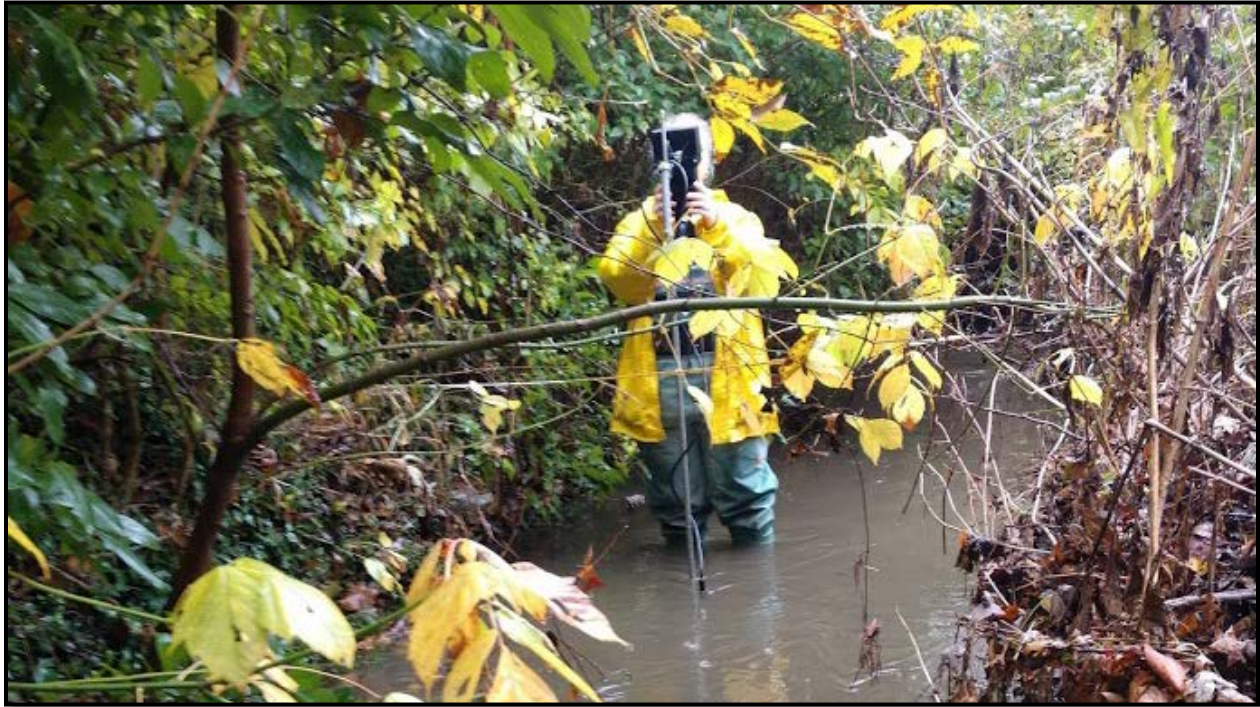
The measure of a material's ability to conduct electricity is known as conductivity. According to the EPA, conductivity can indicate the presence of inorganic dissolved solids such as chloride, nitrate, sulfate, and phosphate anions or sodium, magnesium, calcium, iron, and aluminum cations. Pure water has a very low conductivity. Water temperature also effects conductivity; typically the warmer the water, the higher the conductivity. Conductivity can also be affected by the geology of the region in which stream is located. Areas where the stream flows through limestone and clay soils tend to have high conductivity. Discharges into streams may also change the conductivity. Discharge from a sanitary sewer overflow would raise the conductivity due to the presence of chloride, phosphate, and nitrate. Specific conductivity was measured because it normalizes the reading to 25 degrees Celsius. Specific conductivity was measured in microsiemens per centimeter ( $\mu\text{S}/\text{cm}$ ).

**Figure 4-4: Field Data Collection at WH - 22**

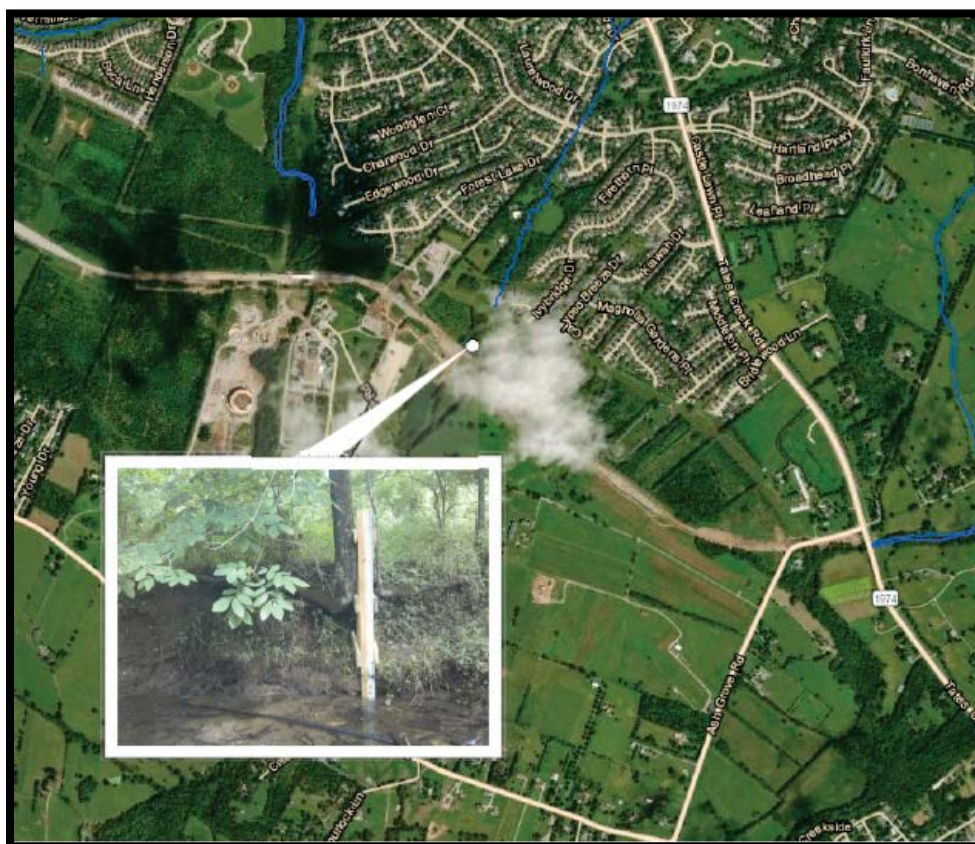
**Figure 4-6: Monitoring Location WH-1**

Site WH-1 is located within an unnamed tributary in the southern portion of the watershed just outside Fayette County. The site is located approximately 3,000 linear feet upstream of the confluence with West Hickman Creek. Site WH-1 is accessible via the bridge along East Brannon Road or from Ivybridge Drive. The unnamed tributary discharges to impaired waters per the 2016 303(d) list published by KDOW. Site WH-1 is characterized by low density residential land use. Notable features upstream of this site include the Cumberland Hill Neighborhood Association, Hartland Estates Homeowner Association, the Woodfield Homes Association, the Charleston Woods Homeowners' Association, and the White Pine Homeowners' Association. This site represents an unnamed tributary to West Hickman Creek which joins downstream of the wastewater treatment plant. The Site location and photo can be seen below in Figure 4-6.

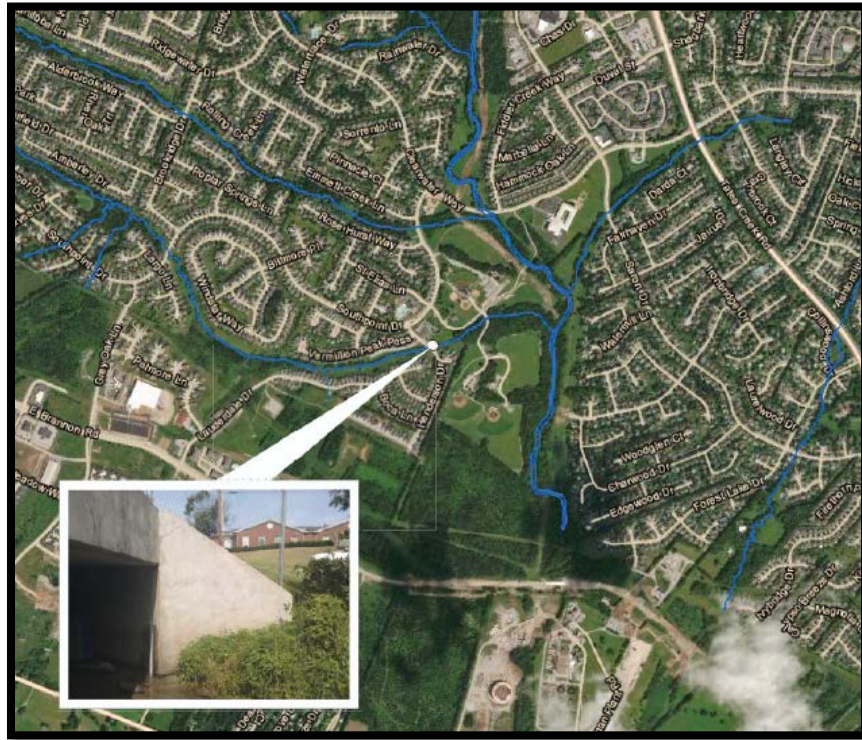
Figure 4-7: Monitoring Location WH-2

Site WH-2 is located within the Southpoint Tributary in the southern portion of the watershed at Veterans Park. The site is located approximately 1,800 linear feet upstream of the confluence with West Hickman Creek. Site WH-2 is accessible via Henderson Drive near Lexington Clinic. The unnamed tributary discharges to impaired waters per the 2016 303(d) list published by KDOW. Site WH-2 is characterized by low density residential land use and at the box culvert for Henderson Drive. Notable features upstream of this site include Southpoint Park, Southpoint Neighborhood Association and the Pinnacle Homeowners Association. This site represents the Southpoint Tributary to West Hickman Creek. Site location and photo can be seen below in Figure 4-7.

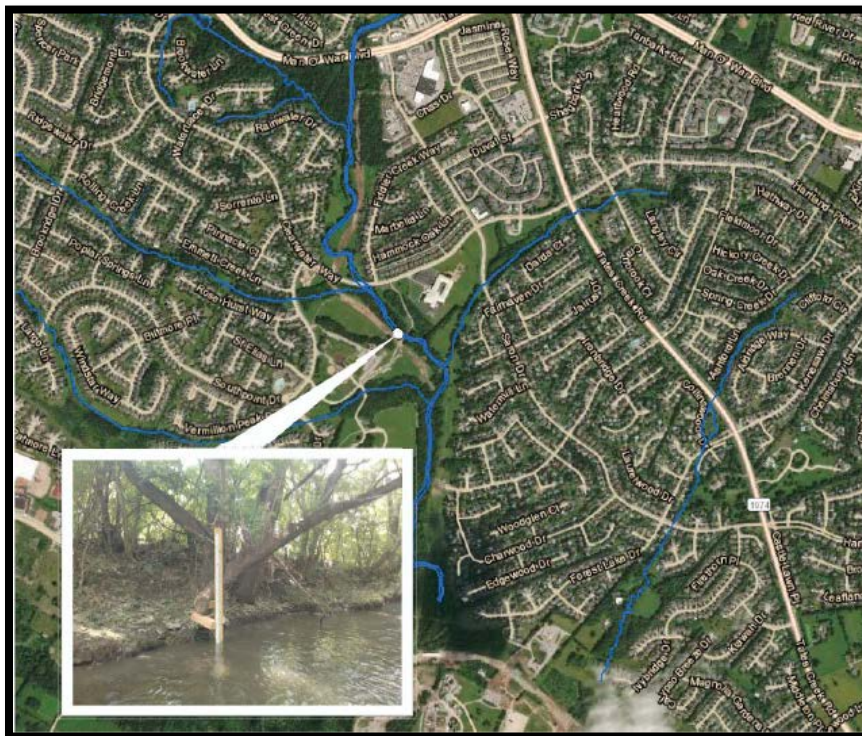
Figure 4-8: Monitoring Location WH-3

Site WH-3 is located along West Hickman Creek in the southern portion of the watershed at Veterans Park. Site WH-3 is accessible by utilizing a concrete path within Veterans Park. The site is within the limits of impaired waters per the 2016 303(d) list published by KDOW. Site WH-3 is characterized by low density residential land use. Notable features upstream of this site include the north tip of Veterans Park and Veterans Park Elementary. Immediately downstream of this site is one of the LFUCG MS4 sites (WH-S0). Site location and photo can be seen in Figure 4-8 on page 91.

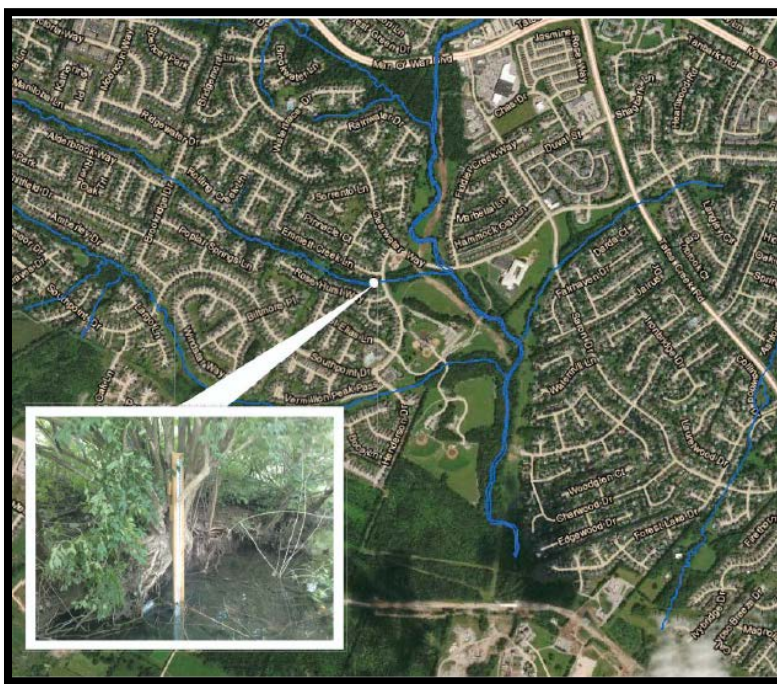
**Figure 4-9: Monitoring Location WH-4**

Site WH-4 is located along the Higbee Mill Road Tributary in the southern portion of the watershed at Southpoint Drive. The site is located approximately 1,000 linear feet upstream of the confluence with West Hickman Creek inside Veterans Park. Site WH-4 is accessible via Southpoint Drive. The Higbee Mill Road Tributary discharges to impaired waters per the 2016 303(d) list published by KDOW. Site WH-4 is characterized by low density residential land use. Notable features upstream of this site include the Pickway Korner Neighborhood Association, the Waterford II Home Owners' Association and the Pinnacle Homeowners Association. This site represents the Higbee Mill Road Tributary to West Hickman Creek. Site location and photo can be seen below in Figure 4-9.

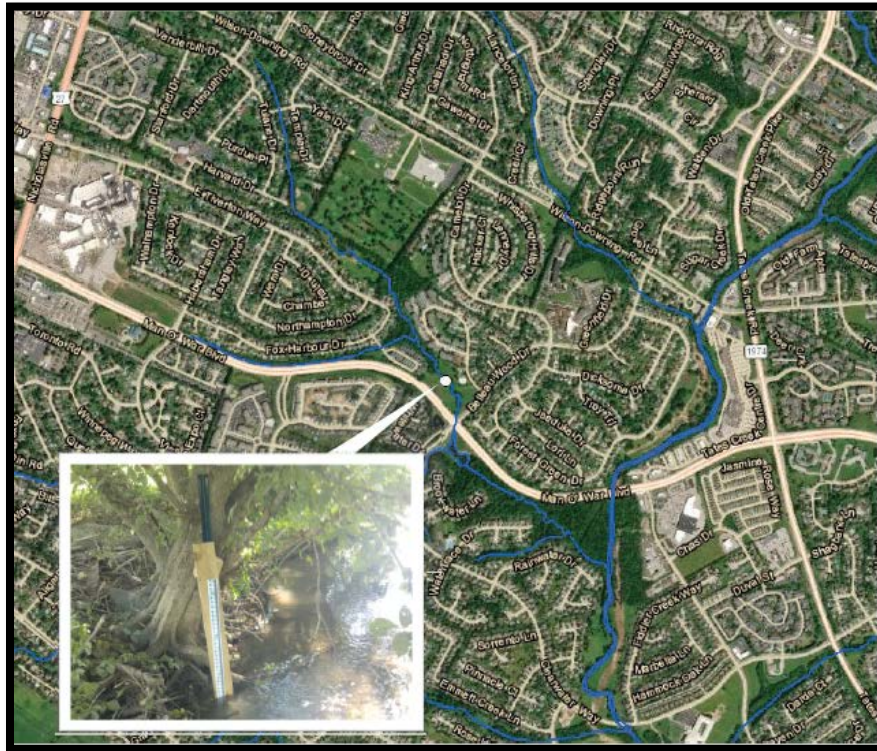
Figure 4-10: Monitoring Location WH-7

Site WH-7 is located along the Belleau Wood Drive Tributary in the central portion of the watershed just inside of Man-O-War Boulevard. The site is located approximately 3,800 linear feet upstream of the confluence with West Hickman Creek. Site WH-7 is accessible via Belleau Wood Drive. The Belleau Wood Drive Tributary discharges to impaired waters per the 2016 303(d) list published by KDOW. Site WH-7 is characterized by low density residential land use. The site is downstream of the Meadowbrook Golf Course and the Summit Shopping District. More notable features upstream of this site include Southern Middle School, Southern Elementary School and the Forest View Town Home Association. This site represents the Tiverton Way Tributary to West Hickman Creek. Site location and photo can be seen in Figure 4-10 on page 93.

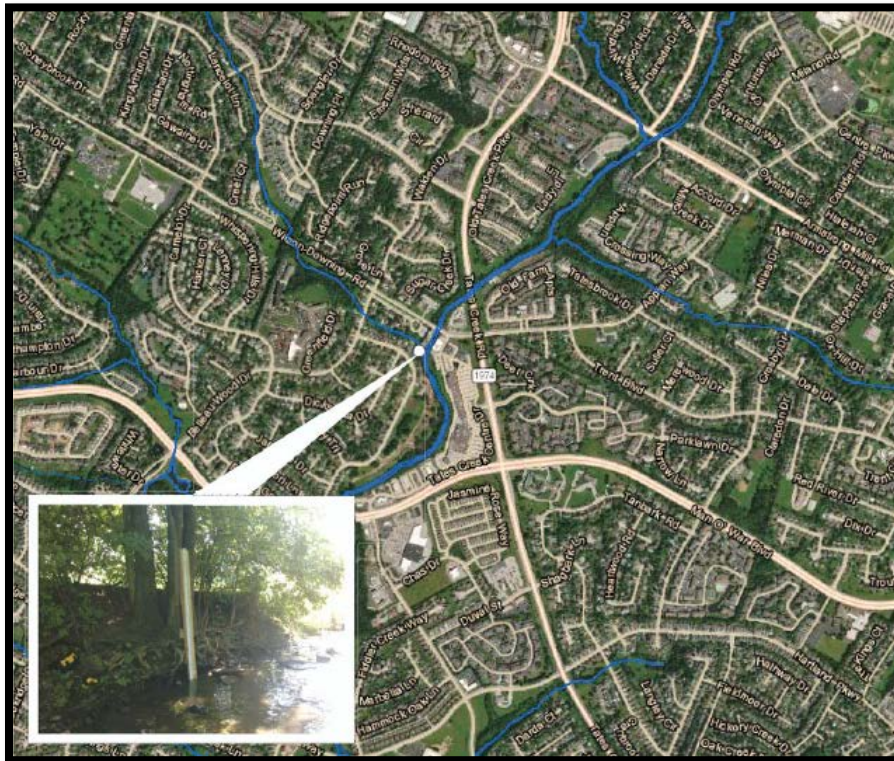
Figure 4-11: Monitoring Location WH-8

Site WH-8 is located along the Wilson Downing Tributary just upstream of the confluence with West Hickman Creek. Site WH-8 is accessible via Tates Creek Center Drive. The Wilson Downing Tributary discharges to impaired waters per the 2016 303(d) list published by KDOW. Site WH-8 is characterized by low density residential land use. This site captures West Hickman Creek after the joining with the tributary sampled at WH-10. Site location and photo can be seen in Figure 4-11 on page 93.

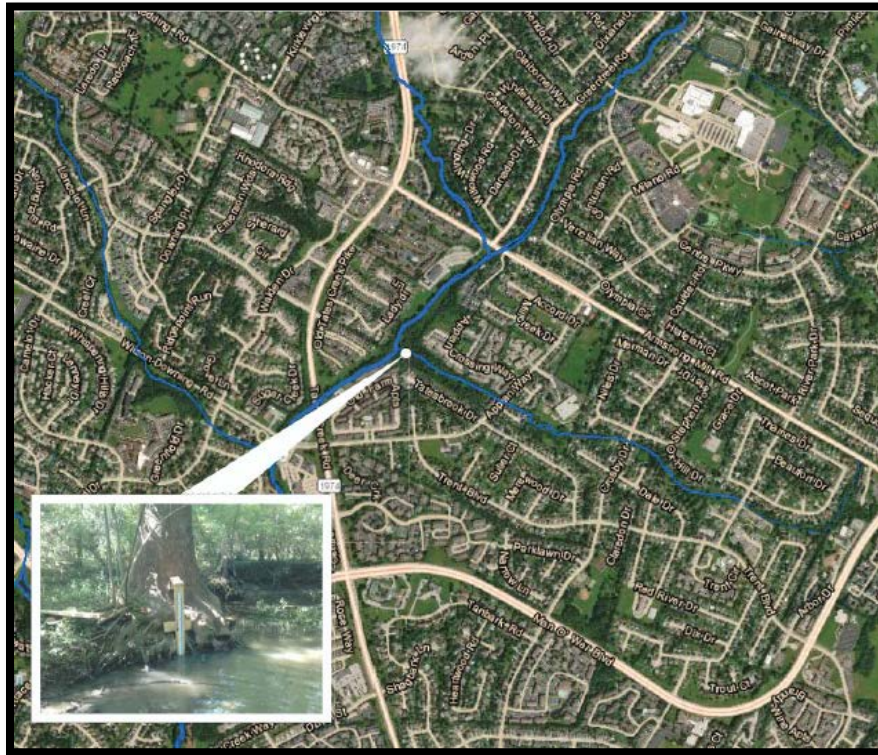
Figure 4-14: Monitoring Location WH-11

Site WH-11 is located along Mill Creek in the central portion of the watershed just upstream of the confluence with West Hickman Creek. Site WH-11 is accessible via Lady Di Lane and following a small trail to the stream. Mill Creek discharges to impaired waters per the 2016 303(d) list published by KDOW. Site WH-11 is characterized by low density residential land use. Notable features upstream of this site include Mill Creek Elementary, Armstrong Mill Parkway, Southeastern Hills Neighborhood Association and River Park Neighborhood Association. This site represents the Mill Creek tributary to West Hickman Creek. Site location and photo can be seen in Figure 4-14 on page 96.

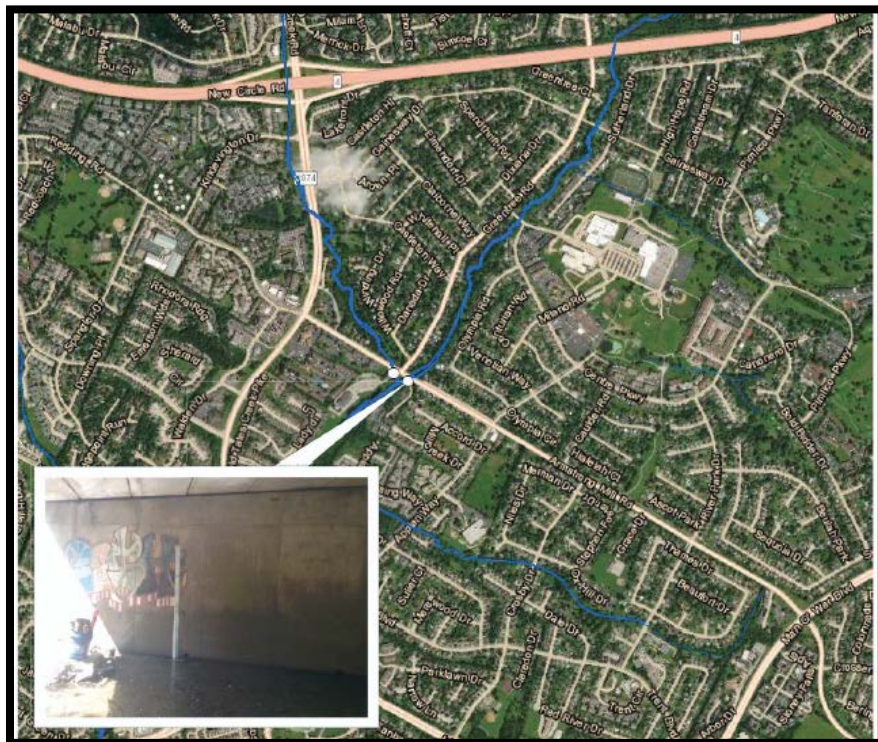
Figure 4-15: Monitoring Location WH-13

Site WH-13 is located along West Hickman Creek in the central portion of the watershed. Site WH-13 is accessible via Armstrong Mill Road. The site is within the limits of impaired waters per the 2016 303(d) list published by KDOW. Site WH-13 is characterized by low density residential land use and the Bates Creek School complex. The site is downstream of Gainesway Park and the Bates Creek Golf Course. Upstream neighborhood associations include Center Parkway and Southeastern Hills. Site location and photo can be seen in Figure 4-15 on page 96.

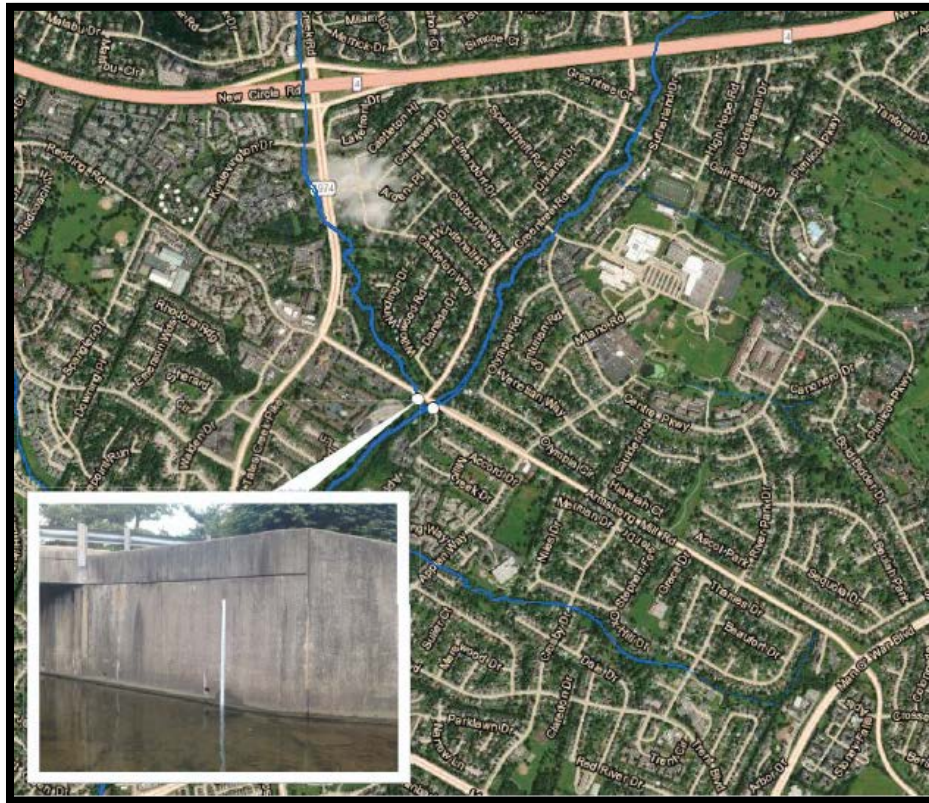
**Figure 4-16: Monitoring Location WH-14**

Site WH-14 is along Bates Creek in the central portion of the watershed. The site is located just upstream of the confluence with West Hickman Creek. Site WH-14 is accessible via Armstrong Mill Road. Bates Creek discharges to impaired waters per the 2016 303(d) list published by KDOW. Site WH-14 is characterized by low density residential land use and is next to a bridge. Notable features upstream of this site include the Oaks Condominium Association and the Gainesway Neighborhood Association. This site represents the Landsdowne Drive Tributary just before joining with West Hickman Creek. Site location and photo can be seen below in Figure 4-16.

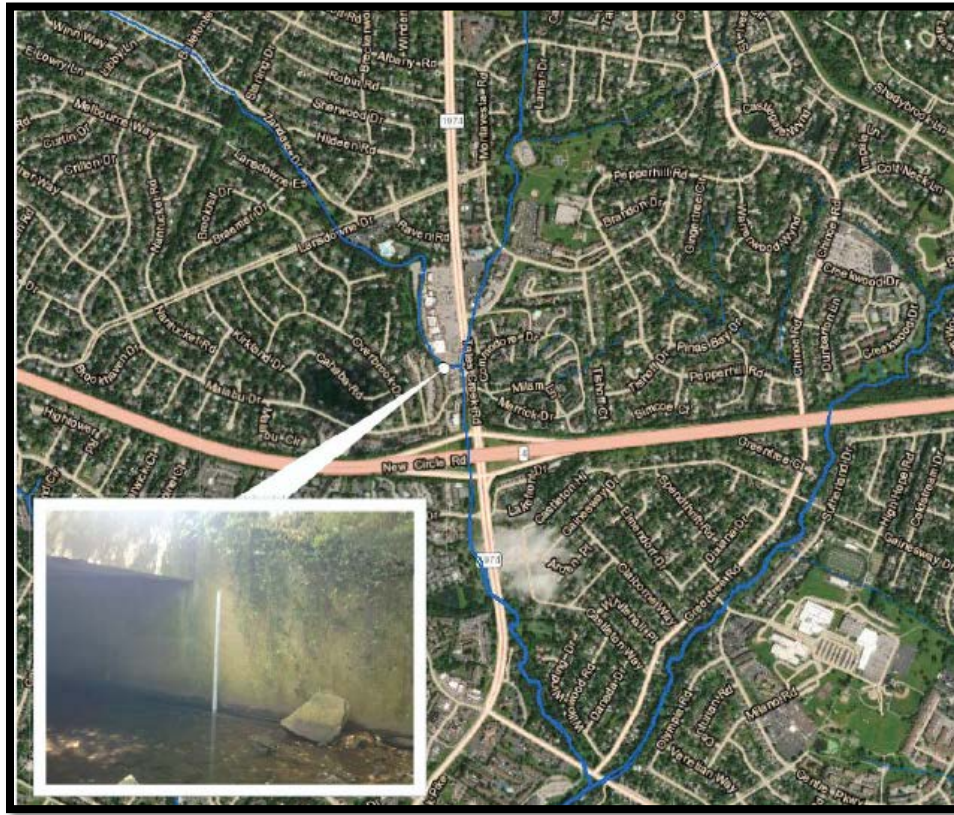
**Figure 4-17: Monitoring Location WH-16**

Site WH-16 is located within The Lansdowne Tributary in the central portion of the watershed. The site is located just upstream of the confluence with Bates Creek, approximately one mile upstream of the confluence with West Hickman Creek. Site WH-16 is accessible via Bates Creek Road. The Lansdowne Tributary discharges to impaired waters per the 2016 303(d) list published by KDOW. Site WH-16 is characterized by low density residential land use. The site is immediately downstream of the Lansdowne Shopping District. Notable features upstream of this site include St Michaels School and Zandale Park. Upstream neighborhood associations include Lansdowne, Zandale, Glendover, and Southern Heights. This site represents one of the two tributaries to the Lansdown Drive Tributary. Site location and photo can be seen in Figure 4-17 on page 98.

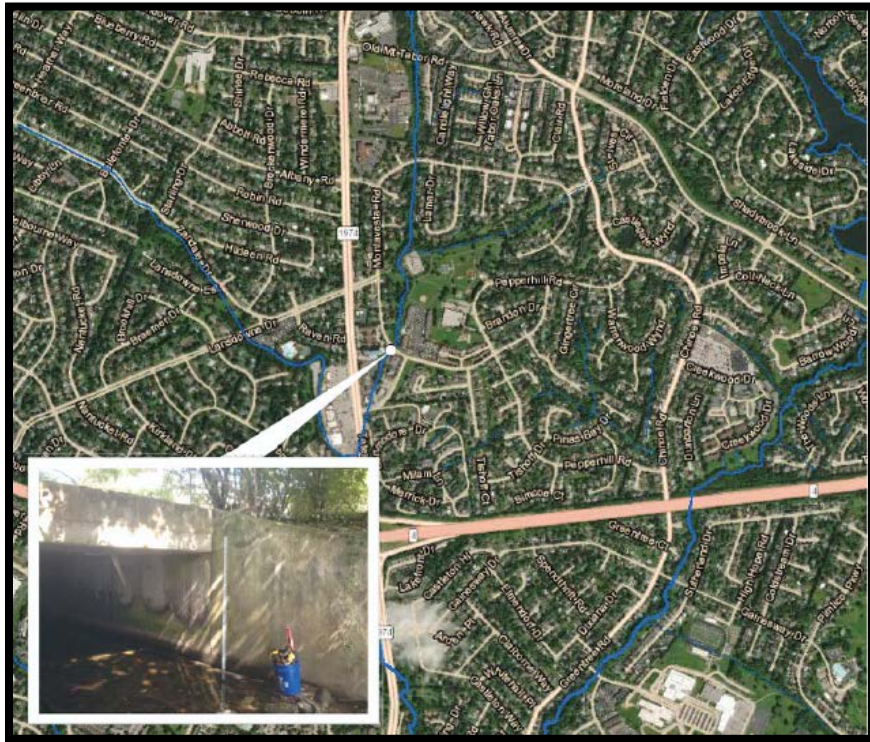
Figure 4-18: Monitoring Location WH-17

Site WH-17 is located along Bates Creek in the central portion of the watershed. The site is located approximately 1,400 linear feet upstream of the confluence with the Lansdowne Tributary and 6,600 linear feet upstream of the confluence with West Hickman Creek. Site WH-17 is accessible via Dove Run Road. Bates Creek discharges to impaired waters per the 2016 303(d) list published by KDOW. Site WH-17 is characterized by low density residential land use. The site is downstream of Lansdowne Merrick Park and the southeastern portion of the Lexington Arboretum. The site is also downstream of a large complex of three churches including Immanuel Baptist, Bates Creek Christian, and Centenary United Methodist Church, all with significant impervious surfaces. Notable features upstream of this site include Julius Marks Elementary, Glendover Elementary, Lexington Christian Academy, Ecton Park, Castlegate HOA and Shadeland Community Association. This site represents one of the two tributaries to Lansdowne Drive Tributary. Site location and photo can be seen in Figure 4-18 on page 99.

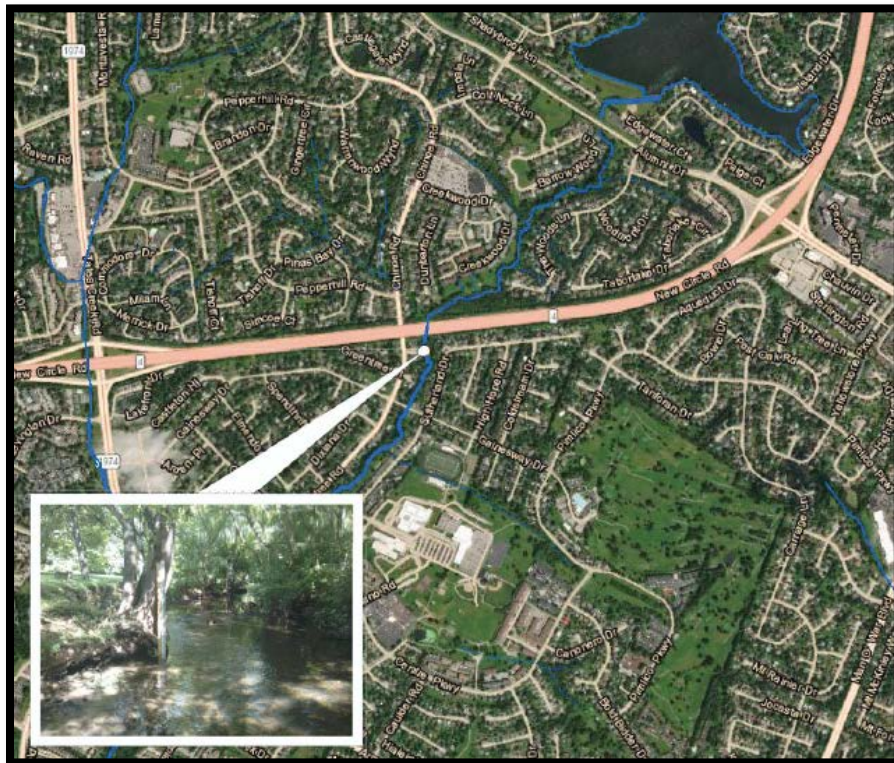
Figure 4-19: Monitoring Location WH-19

Site WH-19 is located along West Hickman Creek in the central portion of the watershed just south of New Circle Road. The site is located approximately one mile upstream of the confluence with Bates Creek and approximately one mile downstream of the reservoir. Site WH-19 is accessible via Greentree Circle. The site is within the limits of impaired waters per the 2016 303(d) list published by KDOW. Site WH-19 is characterized by low density residential land use. Notable features upstream of this site include the Woods Street Maintenance Association and the Lansdowne-Merrick Neighborhood Association. Site location and photo can be seen below in Figure 4-19 on page 99.

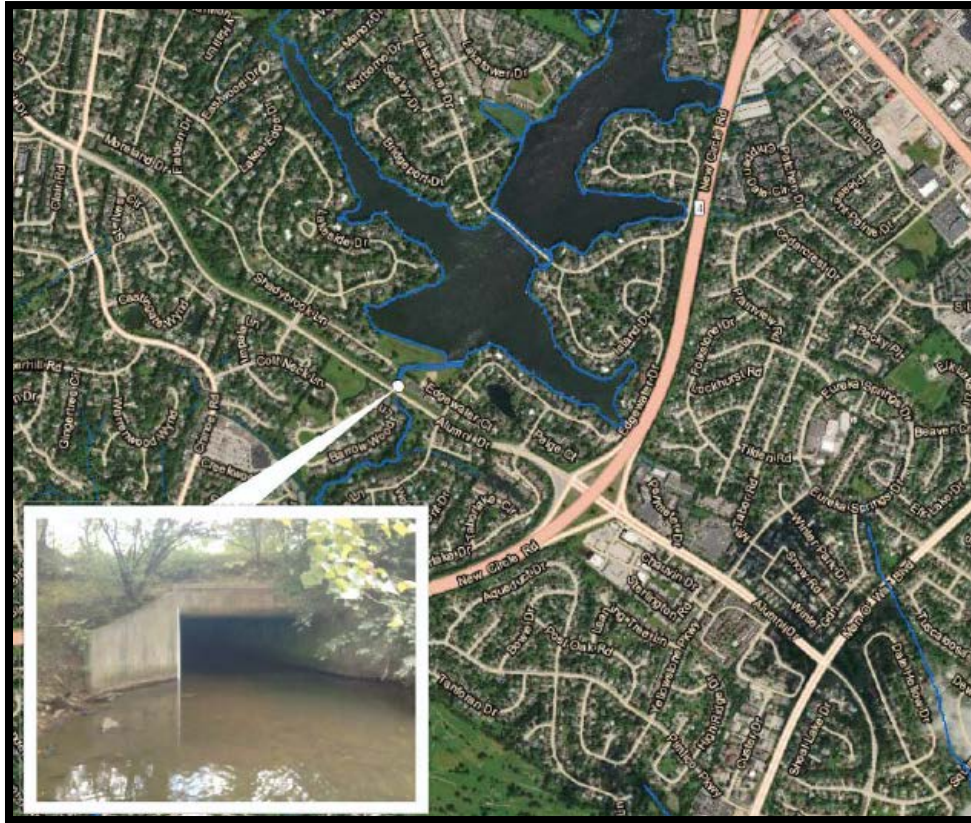
**Figure 4-20: Monitoring Location WH-20**

Site WH-20 is located at the reservoir spillway in the northern portion of the watershed. Site WH-20 is accessible via Edgewater Court. The site is within the limits of impaired waters per the 2016 303(d) list published by KDOW. Site WH-20 is characterized by low density residential land use. Notable features upstream of this site include Henry Clay High School and Lakeview Park. Upstream neighborhood associations include Patchen Woods, Lake Area, Lakeview Island, Lakeshore Village and Lakeshore Estates. The site is downstream of reservoirs 1, 2 and 3. Site location and photo can be seen below in Figure 4-20.

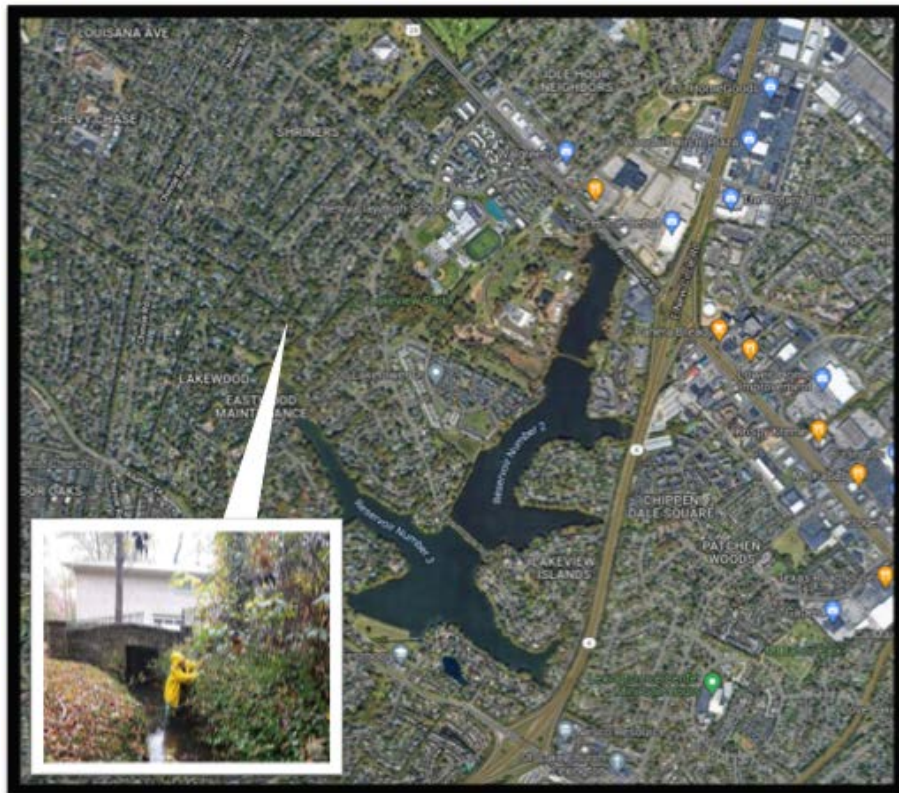
**Figure 4-21: Monitoring Location WH-21**

Site WH-21 is located within an unnamed tributary in the northern portion of the watershed. The site is located approximately 1,000 linear feet upstream of the reservoir. Site WH-21 is accessible via the bridge along East Brannon Road or from Ivybridge Drive. The unnamed tributary discharges to impaired waters per the 2016 303(d) list published by KDOW. Site WH-21 is characterized by low density residential land use, on which most was built prior to 1980. The site is upstream of reservoir 3. Site location and photo can be seen in Figure 4-21 on page 101.

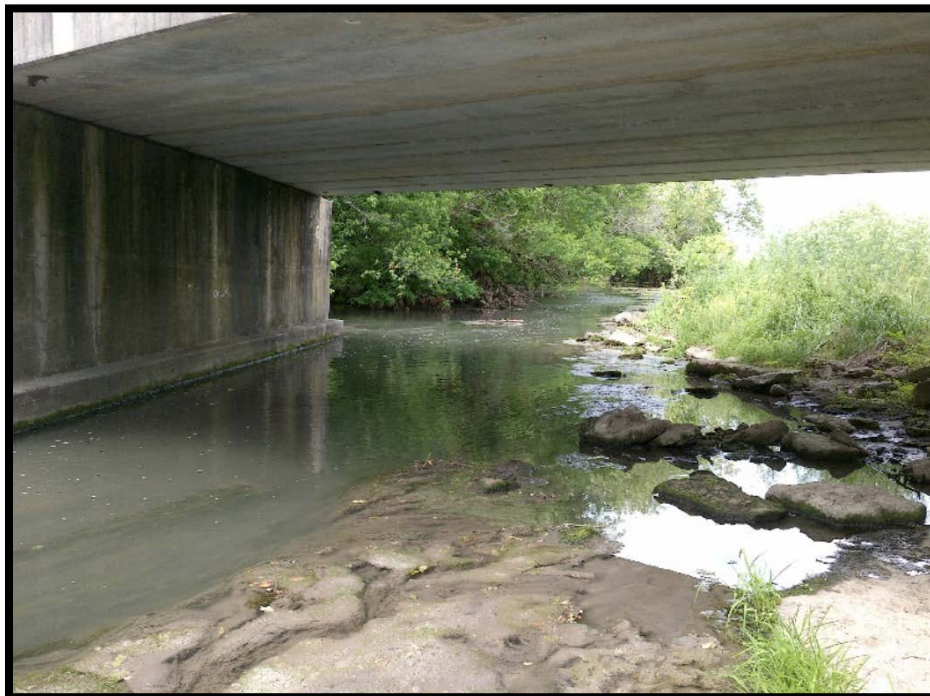
Figure 4-23: Monitoring Location WH-23

Site WH-23 is located along Hickman Creek in the southern portion of the watershed. The site is the furthest downstream in the study and is located approximately one mile downstream of the Fayette County/Jessamine County line. Site WH-23 is accessible via Ash Grove Road. The site is within the limits of impaired waters per the 2016 303(d) list published by KDOW. Site WH-23 is characterized by low density residential and agricultural land use. The site is immediately downstream of the West Hickman Wastewater Treatment Plant. Site location and photo can be seen in Figure 4-23 on page 102. Comparison of flow data from collection events and clean water release from the WWTP indicated that nearly 50% of flow at this site could be from the WWTP.
