## **EMERGENCY AWARENESS BULLETIN**

**(BULLETIN – NO. 1 – 2025)**

### **Accident Scene/Electrical Trailing Cable**

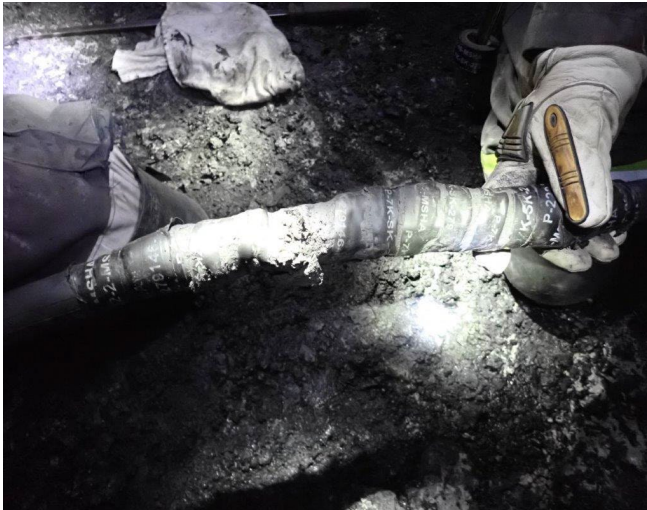
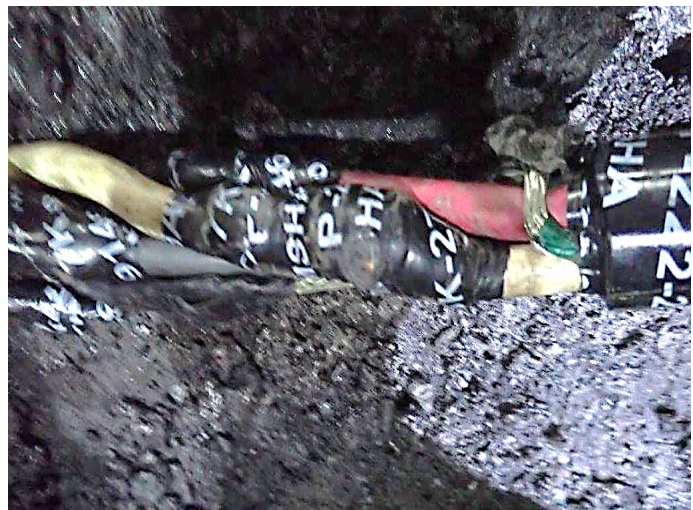
The accident happened while the miner was hanging the electrical trailing cable of the Fletcher Roof Bolter. He sustained an electrical shock after coming into contact with an exposed phase connector in a splice of the cable. This connector, which was carrying 277 volts from a 480-volt supply, resulted in a burn on his hand. As a consequence of the injury, the miner required a hospital stay for observation and faced ongoing medical complications

- (1) De-energize, lock and tag out all electrical trailing cables prior to handling them.
- (2) Miners must wear proper gloves and boots in good condition when handling energized electrical cables.
- (3) Use guarding or placement to prevent damage to power cables.
- (4) Conduct daily inspections of electrical power cables in use before operation or handling.
- (5) The electrical circuits should be maintained in their original condition.
- (6) Maintain all electrical cable splices in accordance with the splicing material manufacturers' specifications.
