ENERGY AND ENVIRONMENT CABINET DEPARTMENT FOR NATURAL RESOURCES

EMERGENCY AWARENESS BULLETIN

NO 3 – 2025) ▲

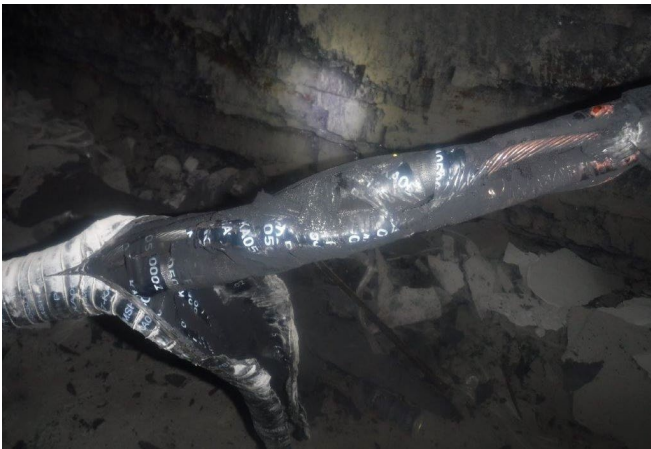
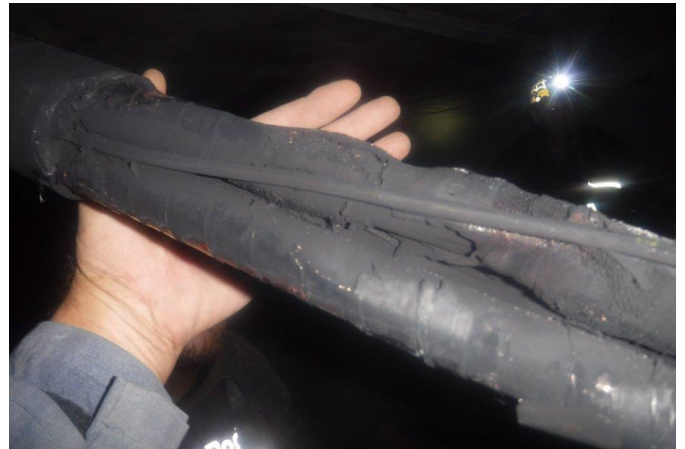
Accident Scene

The miner was on his knees operating a Fletcher double-head roof bolter when a high-voltage power cable energized with 12,470 volts, out by the section, short-circuited at a splice. This resulted in momentarily energizing the ground conductor wires in the mine.

- (1) High voltage splices shall be maintained in accordance with the splicing material manufacturer's specifications.
- (2) Use properly sized connectors when splicing high-voltage cable for repair.
- (3) High voltage systems should be tested as frequently as needed to maintain safe operation.
- (4) Power cables will be protected by location by guarding to protect against damage.
- (5) The outer repair jacket of high voltage cables shall be adequately insulated to the dielectric rating of the cable.
