### SAFETY ALERT BULLETIN No. 3 – 2026

#### Kentucky Division of Mine Safety SAB No. 3 – Fall of Highwall

A non-injury highwall failure occurred at a surface mine in the Pikeville branch.

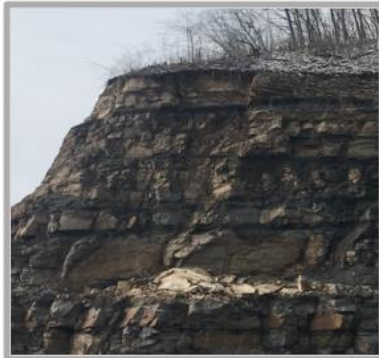
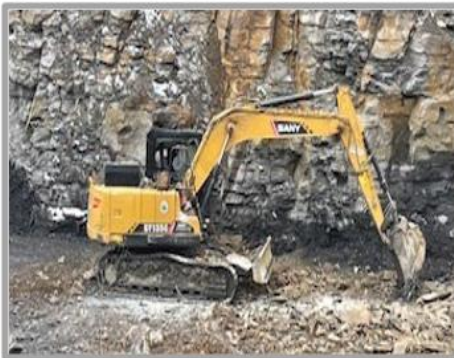
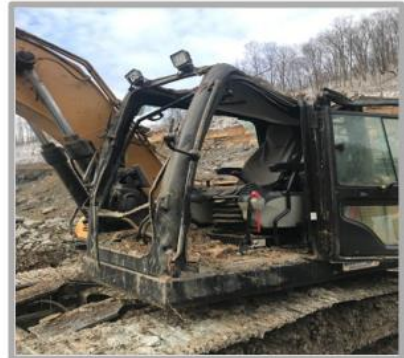
#### *Scene of the Incident*

On March 17th, a section of a highwall at a surface mining site collapsed onto a Sany SY 135C excavator. The fallen material was roughly 12-feet high, 8-feet wide, and 8-feet thick. A portion of the falling material broke apart when it landed on the safety bench 30-feet below the peak of the highwall, overfilling the bench, causing a portion of the material to land on the excavator approximately 60 feet below the fall area in the coal pit.

1. All employees shall be trained in identifying signs of highwall instability.
2. Perform an adequate number of examinations during fluctuating winter weather, particularly during freezing and thawing conditions and periods of excessive rain.
3. 805 KAR 3:030 (2) All loose and hazardous material shall be stripped for a safe distance from the edge of the highwall.
4. The cabs of track-mounted equipment with side-mounted cabs, such as drills and excavators, will be positioned away from the high wall at times to ensure the cab is not placed between the machine's boom or drill mass and the high wall when the machine is operating near the toe of the high wall, unless it can be demonstrated that the failure of the high wall will not impact the operator.
