The Banklick Watershed Action Plan

Kenton and Boone Counties, Kentucky

A Comprehensive Approach to Watershed Improvement

Publication Date: November 2005
First Printing

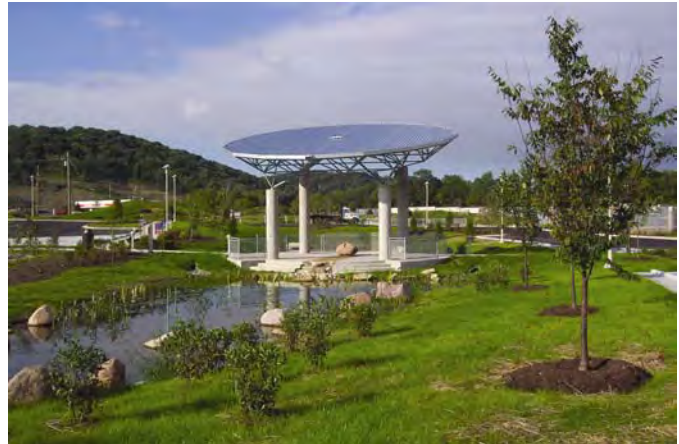
SD#1 Public Service Park. Photo courtesy of SD#1

- ✓ SD1 has opened an award-winning regional stormwater park designed to demonstrate BMP's and educate all age groups about issues related to water quantity and quality.

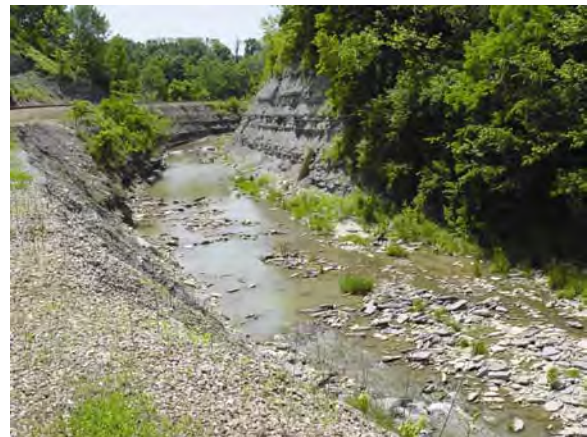
Banklick Creek re-channelized for railroad.
