Karst Groundwater Tracer Tests and Basin Delineation,
Wayne and Clinton Counties,
South Central Kentucky

Robert J. Blair, P.G.
and
Sean M. Vanderhoff

May 2019

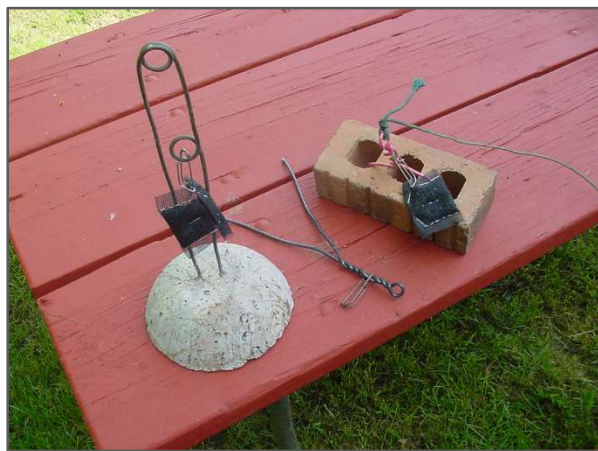
Figure 7. Dye Receptors and Anchors

During movement of tracers through monitored sites, fluorescent dyes were adsorbed and accumulated onto activated carbon samplers. In some cases, when the dye receptor was missing, dye presence was determined by collecting a water sample for laboratory analysis. The carbon dye receptors were deployed in flowing water of springs, streams, and caves and anchored with either a modified "gumdrop" anchor (Quinlan, 1986), or a brick fitted with a vinyl-clad copper wire. The receptors were secured to the anchor with a commercially available "trot line clip" (Figure 7).

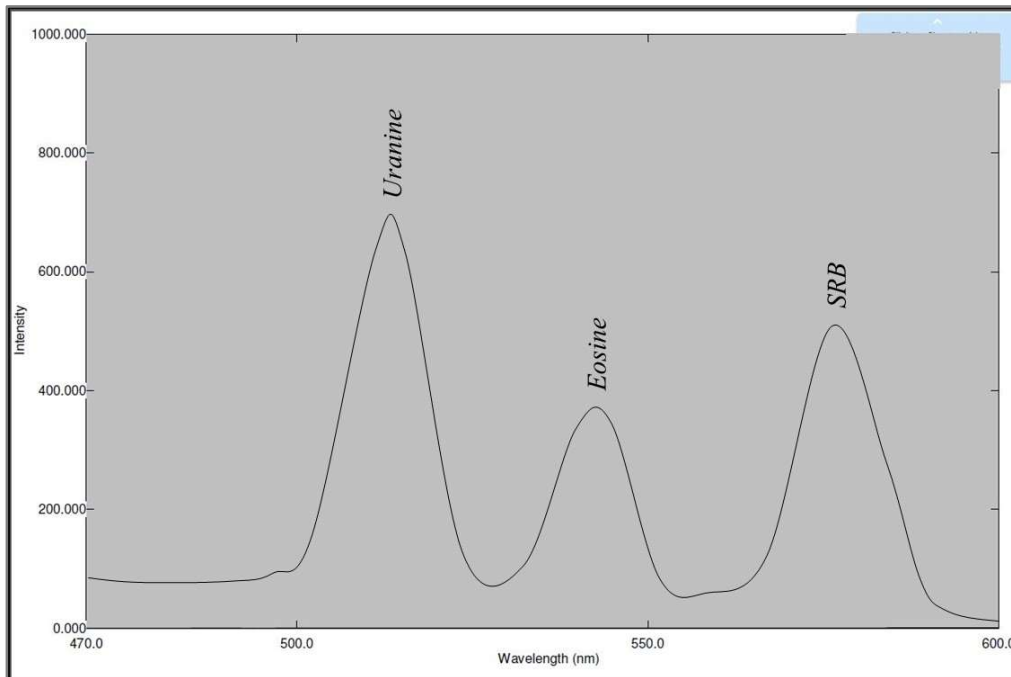
Figure 8. Typical Dye Curves on Spectrofluorophotometer

Sample preparation and analysis was conducted at the DOW Groundwater Laboratory. For analytical processing, samples of the retrieved carbon dye receptors were rinsed with de-ionized water and eluted at room temperature for at least 15 minutes in a solution of 50% 1-propanol, 30% de-ionized water, and 20% ammonium hydroxide (NH₄OH). The eluted samples were analyzed for the absence or presence and relative intensity of tracer dye using a scanning spectrofluorophotometer (Shimadzu RF-5301). All results of dye analyses are archived as PDFs. Figure 8 shows typical dye curves analyzed on the spectrofluorophotometer. The horizontal position (x axis) of a dye peak indicates the fluorescence wavelength, which identifies the type of dye. The vertical height (y axis) of the curve indicates the relative fluorescence intensity of the recovered dye and thus the qualitative confidence level of the positive dye recovery.
