# Oversight News

Newsletter of the Commonwealth's Environmental Oversight of the Paducah Gaseous Diffusion Plant (PGDP)

## C-400 Update: Phase 2A Operations Successful Despite Record Cold Winter

## Tornado Damages Portions of USEC Facility

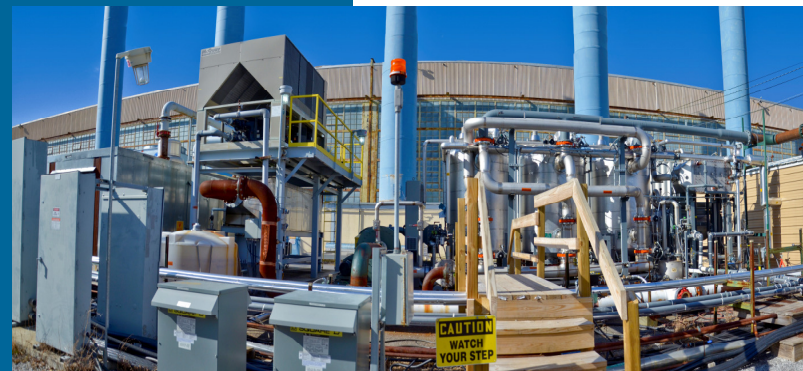
Phase IIa of the C-400 TCE cleanup operations began during the fall of 2012 with the installation of an electrical resistance heating (ERH) system consisting of 52 electrical heating electrodes and 33 vapor extraction wells. The system is designed to remove TCE from soils down to approximately 70 feet below ground surface near the C-400 Building. It accomplishes this by heating the soil and groundwa-

ter to a temperature of 194 F, which is hot enough to vaporize TCE. The vapor extraction wells in turn are used to extract the TCE vapor so that it can be treated to remove the TCE.

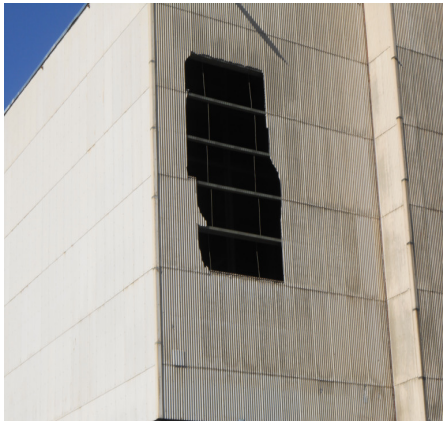
The PGDP sustained storm damage from a tornado that struck the plant on the afternoon of Nov. 17, 2013. Areas damaged included portions of the C-333 Process Building. Large steel roll-up doors and some transite panels located on the west side of the building were blown inward. The southeast corner of the building sustained more significant damage (below) when the storm ripped off at least 12 large transite panels. The

largest pieces of transite found on the ground were about 6 to 8 inches wide and 10 to 12 inches long. These were removed by USEC personnel. An inspection conducted by PGDP Section personnel of areas east of the building failed to locate any additional pieces of transite paneling. Repairs to a large hole left in the side of the building were completed by the afternoon of November 22.
