Oversight News

Newsletter of the Commonwealth's Environmental Oversight of the Paducah Gaseous Diffusion Plant (PGDP)

C-410 Update: Demolition Continues

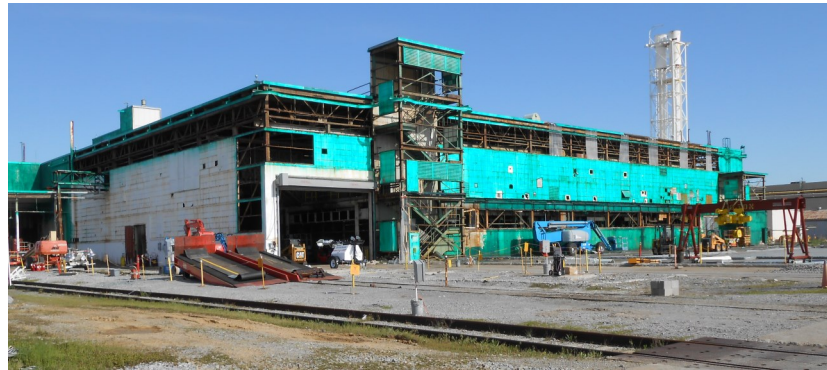
C410 on May 12, 2014

Department of Energy (DOE) contractors are making highly visible progress on the removal of the C-410 Feed Plant. The Feed Plant is the last of 25 inactive facilities to be razed under the Decontamination and Decommissioning (D&D) Program for Inactive PGDP facilities that began in the late 1990s.

Substantial work on the interior of the facility to address infrastructure, stored material and hazardous material abatement has been ongoing since an Action Memorandum was signed by DOE in 2002. Beginning on March 31, DOE contractors began removing asbestos-cement (transite) siding panels from the structure. About 2,600 panels, each weighing about 175

pounds, are being carefully removed to ensure the asbestos is not rendered friable. Demolition of the structure began in mid-May.

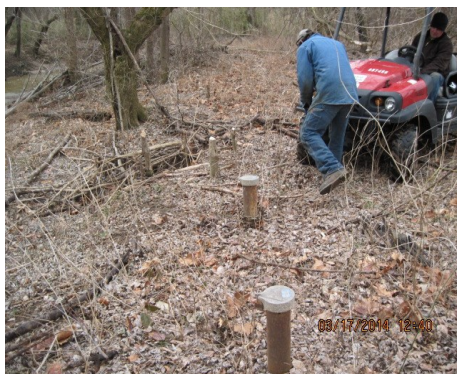
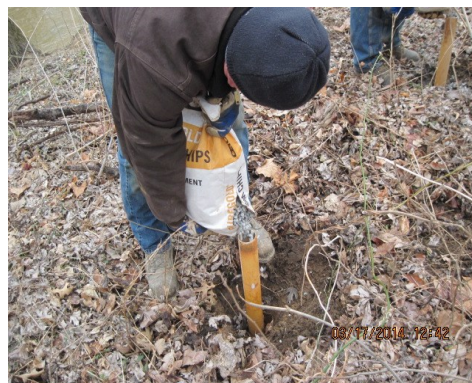
Ten piezometers (water level monitoring wells) were recently abandoned by Chase Environmental under contract with Kentucky AIP. The abandonment was observed by Kentucky AIP staff. All ten piezometers were located in close proximity to Bayou or Little Bayou Creek. The University of Kentucky originally installed

the piezometers during the 1990s to assess the interaction between groundwater and the creeks. The piezometers had not been used for several years and were in a state of disrepair. Abandonment protocol includes removing all above-ground portions of the well after filling the below-

ground portions with bentonite (clay) chips. The purpose of the clay chips is to seal (by expansion) the subsurface void spaces left once the piezometer has been removed. The locations where the wells once existed have now been restored.
