A Newsletter of the Kentucky Underground Storage Tank Program

Volume 6, Issue 3  
2014

## Field Notes: Water in Spill Buckets. What's the Big Deal?

## UST Response Quarterly

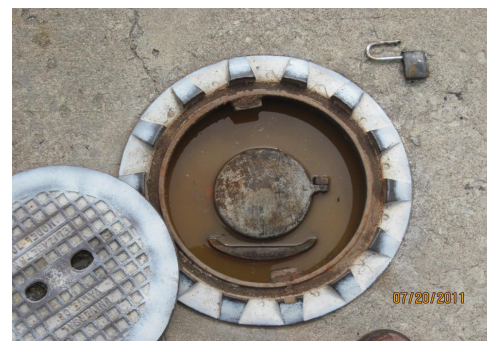
Water-filled spill bucket (Photograph by Chase Whittis)

Nearly 90 percent of all underground storage tank inspections have documented violations for the presence of water in spill buckets. Owners/operators often ask the question, "What's the big deal?" The "big deal" is that water in spill buckets can result in costly repairs and cleanup for owners/operators.

Having water in the spill bucket limits the amount of fuel a spill bucket can accept from a delivery hose in the event of an overfill. If a spill bucket is full of water and a fuel spill were to occur, the subsequent overflowing of the bucket would be considered an uncontained spill, which could result in a costly cleanup.

Aging spill buckets often develop stress cracks in the baffles and sidewalls of the bucket. This is a direct pathway for excess fuel from the delivery hose to escape the spill bucket into the environment, defeating its purpose. In addition, accumulated water in spill buckets can inadvertently enter the underground storage tank via the drain plug or a loose-fitting fill cap. Consequences of water entering a UST include system shut-

down and delivery prohibition by the Environmental Response Branch, degradation to UST components due to acute corrosion and loss of fuel in the tank due to phase separation. Even worse, angry customers and expensive repair bills may result if phase-separated fuel ends up in your customers' vehicles.

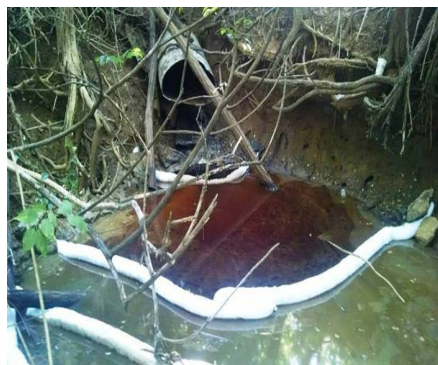
*Free product in the storm water basin. (Photograph by Michael Albright)*

Lexington Fayette Urban-County Government (LFUCG) reported what appeared to be fresh gasoline in a storm drain and outfall off of Loch Ness Drive in late August 2014. The Lexington Fire Department responded and flushed the fuel from the storm drain to reduce the chance of a fire or explosion. An environmental contractor was called to address the fuel outside the storm drain in soil and groundwater.

A breakthrough occurred when LFUCG provided a sewer camera, and we observed a seam in the storm drain through which fuel was entering. This seam in the storm drain was located adjacent to the tank pit. Soil borings placed between the tank pit and storm sewer indicated the presence of fuel. Based on this evidence and continued losses in inventory, ERT directed the removal of product from the regular unleaded tank and implemented emergency delivery prohibition.

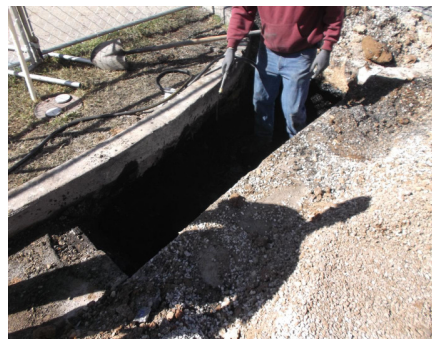
*Water line excavation after repair (Photograph by Stephen Kellerman)*
