North Fork: Whitesburg Tributaries Watershed Plan, Letcher County, KY

Date: April 2020

Prepared by:

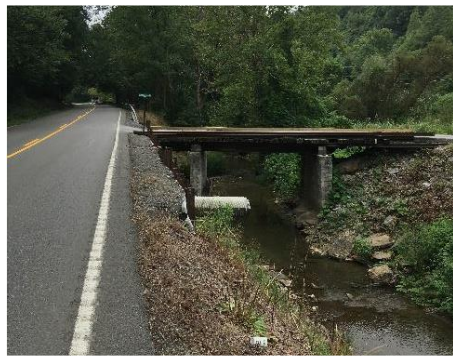
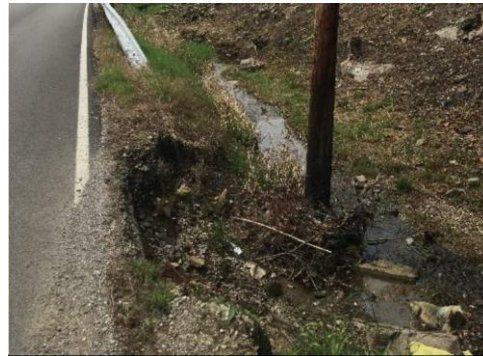
(Left) Metal posts have been inserted to address roadway washout associated with erosion on Sandlick Creek near Dan's Crossing Road. (Right) Roadway washout along Dry Fork near Heartbreak Ridge due to erosion.

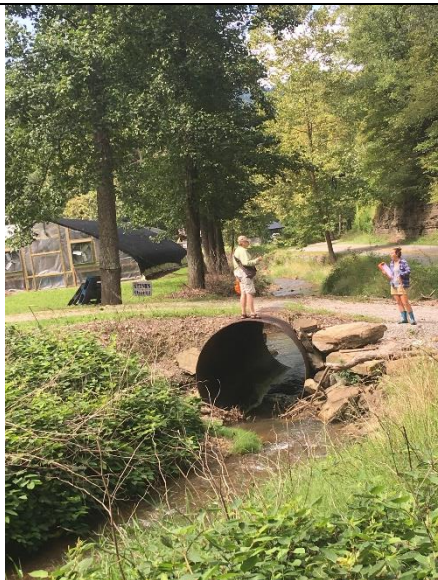
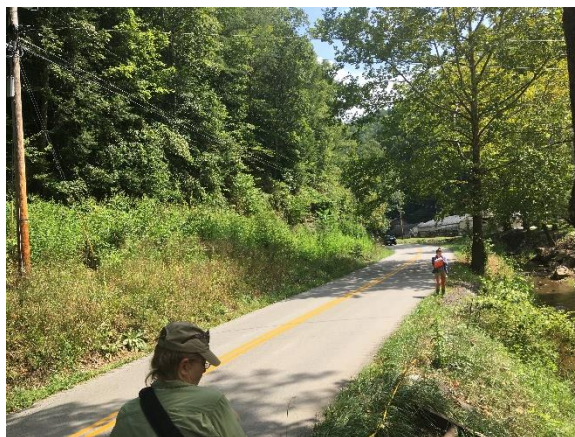
Site #	DF #1
Reach Start	37.12176, -82.87387
Reach End	37.12304, -82.87082
Site Description	Directly in front of Vendor's mall.
Erosion Type	Widening
Erosion Cause	Channelization due to road construction
Reach Length (Meters)	173 Meters
Average exposed bank height	2.6 Meters
Present Land Use: Left (looking downstream)	Lawn, paved area, rural housing
Present Land Use: Right (looking downstream)	Road, embankment, paved area, shrubs, small trees
Threat to Infrastructure	Yes: Road washout.
Severity (1-Severe, 5-Minor)	3
Correctability (1-Severe, 5-Minor)	4
Access (1-Severe, 5-Minor)	3
NOTES

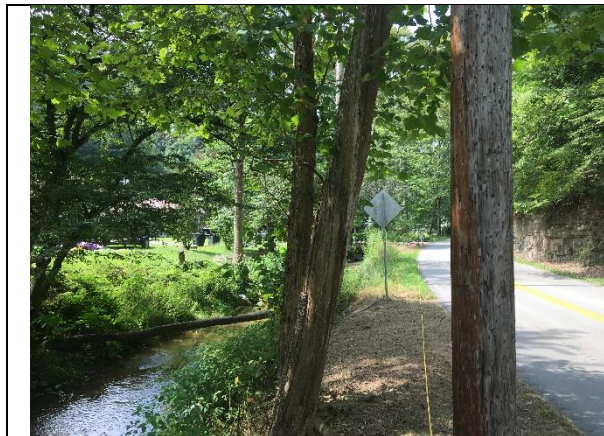
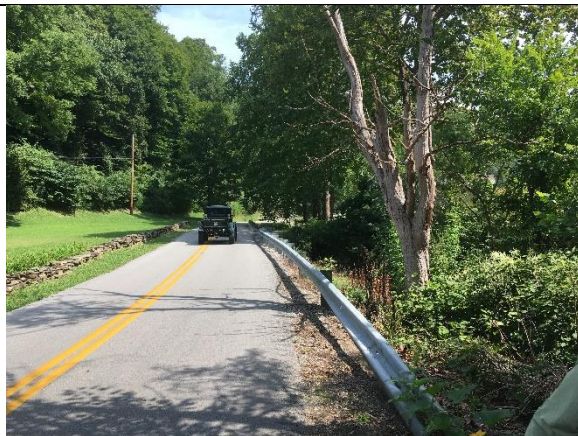
Site #	DF #2
Reach Start	37.12869, -82.86479
Reach End	37.12962, -82.8637
Site Description	50 meters upstream of El Paso Drive (@ KRWV Site by sub station) to 114 meters upstream of Brewer Dr.
Erosion Type	Widening
Erosion Cause	Channelization due to road construction
Reach Length (Meters)	314 Meters
Average exposed bank height	2.4 Meters
Present Land Use: Left (looking downstream)	Paved area, lawn, rural housing
Present Land Use: Right (looking downstream)	Paved area, shrubs and small trees, road/embankment
Threat to Infrastructure	Yes: Road washout, potential house flooding.
Severity (1-Severe, 5-Minor)	2
Correctability (1-Severe, 5-Minor)	4
Access (1-Severe, 5-Minor)	3
NOTES	Recent road repair

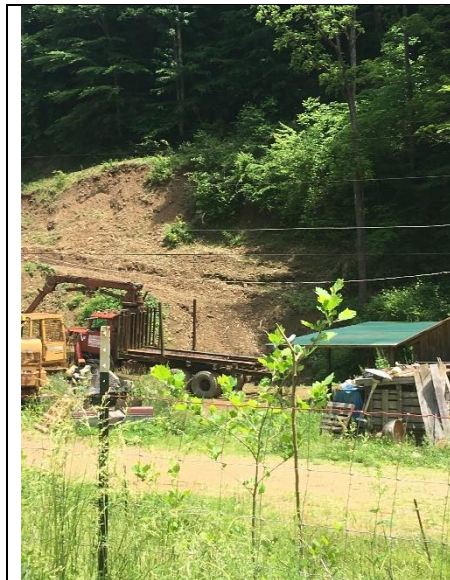
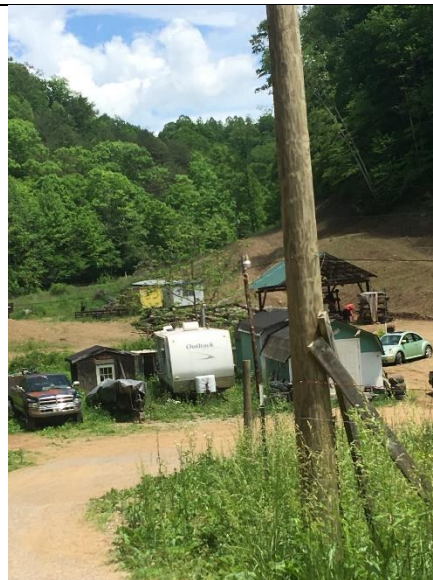
Date	08/25/18
Sub-Watershed	Dry Fork
Site #	DF #3
Reach Start	37.15103, -82.8584
Reach End	37.15001, -82.85937
Site Description	Loggy Hollow (.10 mile windshield assessment)
Type	Severe sediment in riparian area
Cause	Land use change upstream, logging road, vegetation removal
Length (Meters)	.10 Miles* (approx 160 meters)
Height	50 - 100 Meters
Present Land Use: Left (looking downstream)	Pasture, shrubs, temporary road (e.g. logging road)
Present Land Use: Right (looking downstream)	Against slope, no development
Threat to Infrastructure	No
Severity 1-Severe, 5-Minor	1
Correctability 1-Severe, 5-Minor	2
Access 1-Severe, 5-Minor	3
NOTES	Good site; would need landowner permission for access * <i>stream inaccessible-- length approximated by car odometer</i>

DF#3- focus area of severe erosion

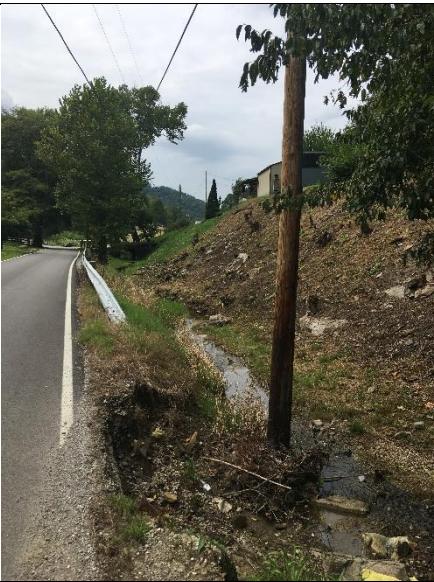
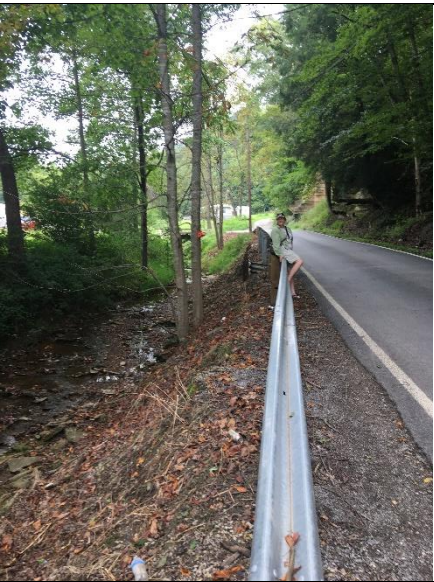
Sub-Watershed	Dry Fork
Site #	DF #4
Reach Start	37.14726, -82.8442
Reach End	37.14626, -82.84521
Site Description	Heartbreak Ridge- mailbox #105 to end of guardrail downstream of mailbox 893.
Type	Widening
Cause	Channelization due to concrete/industrial plant site
Length (Meters)	140 Meters
Height	1.6 Meters
Present Land Use: Left (looking downstream)	Paved area, road
Present Land Use: Right (looking downstream)	Lawn, paved area, shrubs, small trees, rural housing, concrete/industrial plant
Threat to Infrastructure	Yes: Road fallout
Severity 1-Severe, 5-Minor	2
Correctability 1-Severe, 5-Minor	2
Access 1-Severe, 5-Minor	3
NOTES	Downcutting with gravel runoff into stream

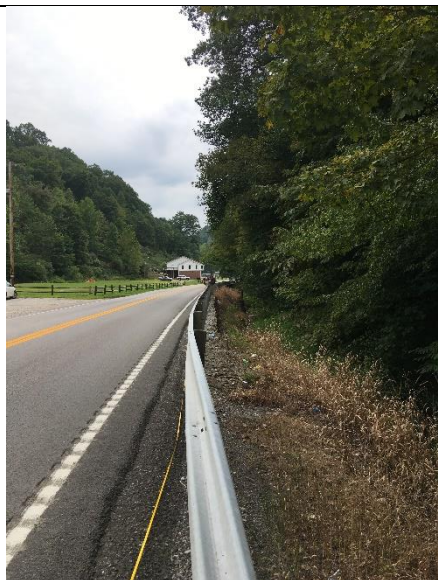
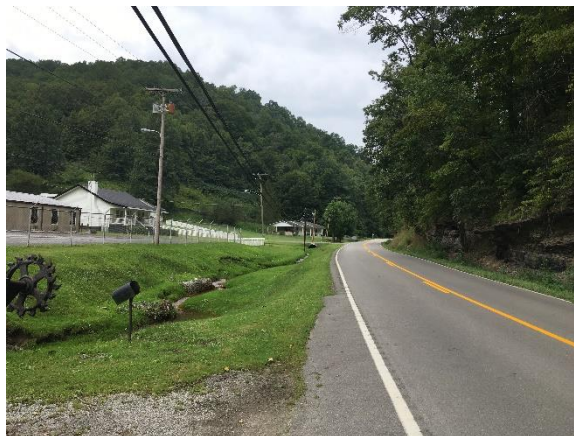
Subwatershed	Sandlick
Site #	SL #1
Reach Start	37.16347, -82.82565
Reach End	37.15922, -82.8245
Site Description	2801 Sadlick just down from Hall office to parking lot at the end of the fire department.
Type	Widening
Cause	Channelization due to road placement
Length (Meters)	493 Meters
Height	1.75 Meters
Present Land Use: Left (looking downstream)	Road and embankment/mountain
Present Land Use: Right (looking downstream)	Lawn, paved area, shrubs, small trees, rural housing
Threat to Infrastructure	Yes: Road fallout, power lines, phone poles
Severity 1-Severe, 5-Minor	4
Correctability 1-Severe, 5-Minor	1
Access 1-Severe, 5-Minor	1
NOTES	Stream contouring and vegetation one of most correctable

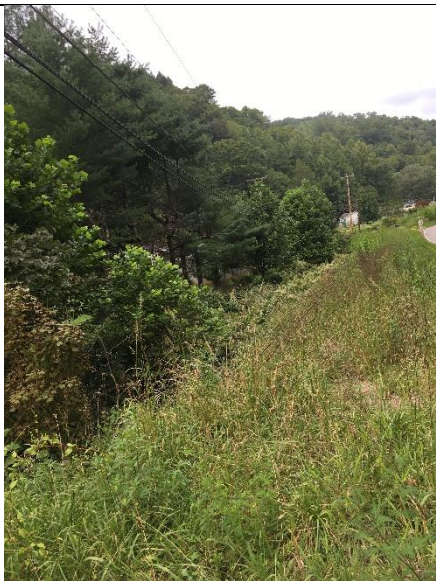
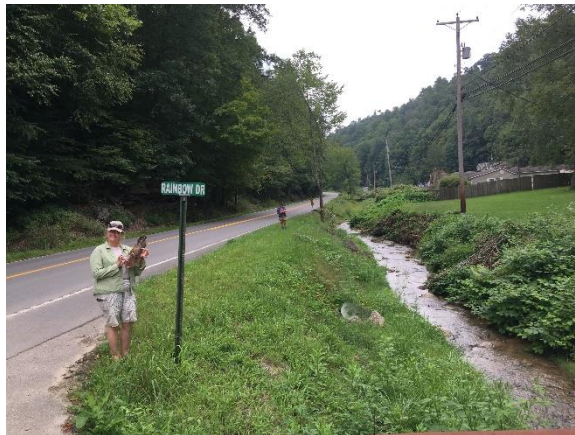
Subwatershed	Sandlick
Site #	SL #2
Reach Start	37.14783, -82.82176
Reach End	37.146, -82.82204
Site Description	Fairchild Dr. (abandoned home next to 1961 Sandlick) to Rainbow Dr.
Type	Widening
Cause	Channelization due to road placement
Length (Meters)	224 Meters
Height	2.2 Meters
Present Land Use: Left (looking downstream)	Road and embankment/mountain
Present Land Use: Right (looking downstream)	Lawn, paved area, shrubs, small trees, rural housing
Threat to Infrastructure	Yes: Road fallout, power lines, phone poles
Severity 1-Severe, 5-Minor	3/4
Correctability 1-Severe, 5-Minor	2
Access 1-Severe, 5-Minor	1
NOTES

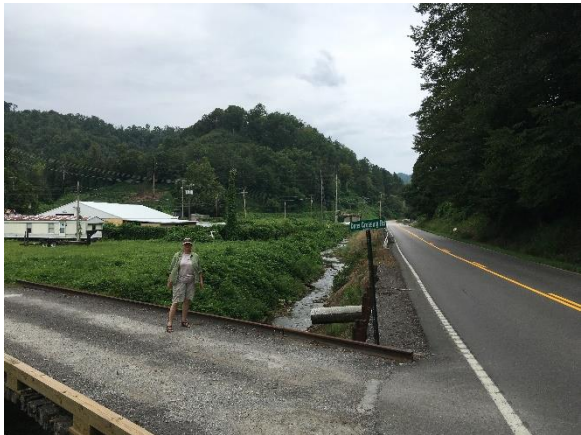
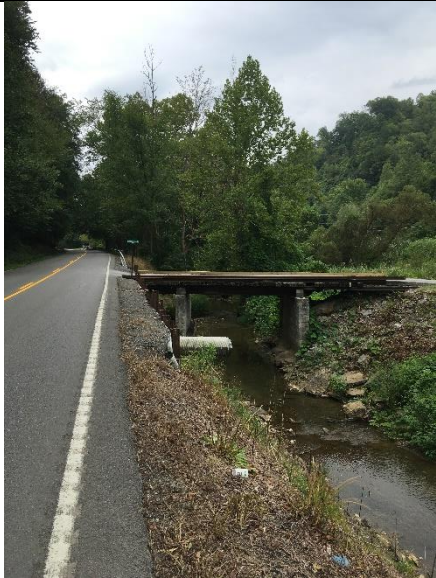
Sub-Watershed	Sandlick
Site #	SL #3
Reach Start	37.13093, -82.83035
Reach End	37.12975, -82.83214
Site Description	Dan's Crossing Rd to Thompson Br. (+ .5 mi windshield assessment, almost to mouth)
Type	Widening
Cause	Channelization due to road placement
Length (Meters)	211.7 Meters
Height	4 Meters
Present Land Use: Left (looking downstream)	Road and embankment/slope
Present Land Use: Right (looking downstream)	Lawn, paved area, shrubs, small trees, rural housing, livestock, trucking storage
Threat to Infrastructure	Yes: Road fallout, power lines
Severity 1-Severe, 5-Minor	2
Correctability 1-Severe, 5-Minor	4
Access 1-Severe, 5-Minor	4
NOTES	Measured accessible reach, including power station

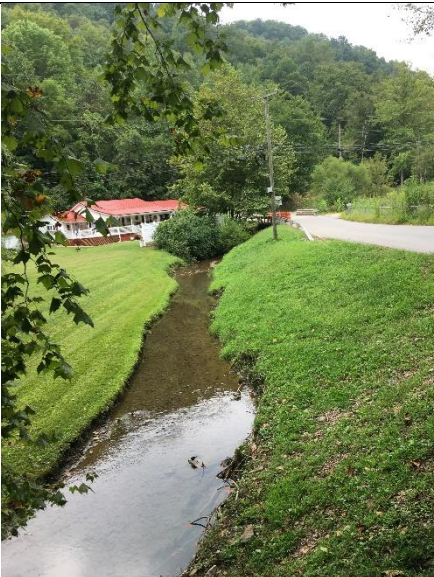
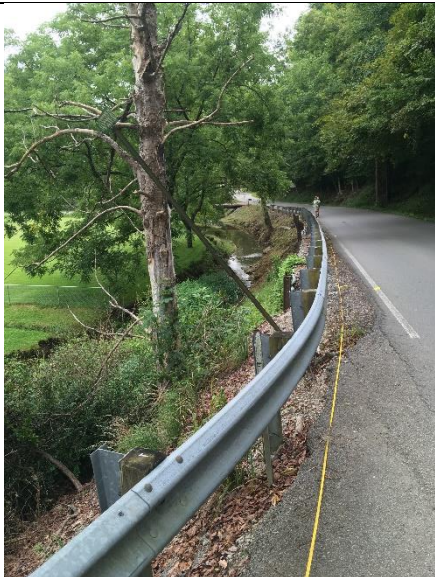
Sub-Watershed	Crafts Colley
Site #	CC #2
Reach Start	37.1389, -82.79385
Reach End	37.13728, -82.7934
Site Description	50 meters downstream of bridge. Red and white house by curve in road. 1519 Lombardi.
Type	Widening
Cause	Channelization due to road placement
Length (Meters)	192 Meters
Height	2.14 (lower), 5.5 (upper) Meters
Present Land Use: Left (looking downstream)	Lawn, paved area, shrubs, small trees, rural housing with significant yard space
Present Land Use: Right (looking downstream)	Road, hill slope/mountain
Threat to Infrastructure	Yes: Road fallout
Severity 1-Severe, 5-Minor	2
Correctability 1-Severe, 5-Minor	3
Access 1-Severe, 5-Minor	2
NOTES
