**ENERGY AND ENVIRONMENT CABINET
DEPARTMENT FOR NATURAL RESOURCES**

SAFETY ALERT

(BULLETIN – NO. 1 – 2025)

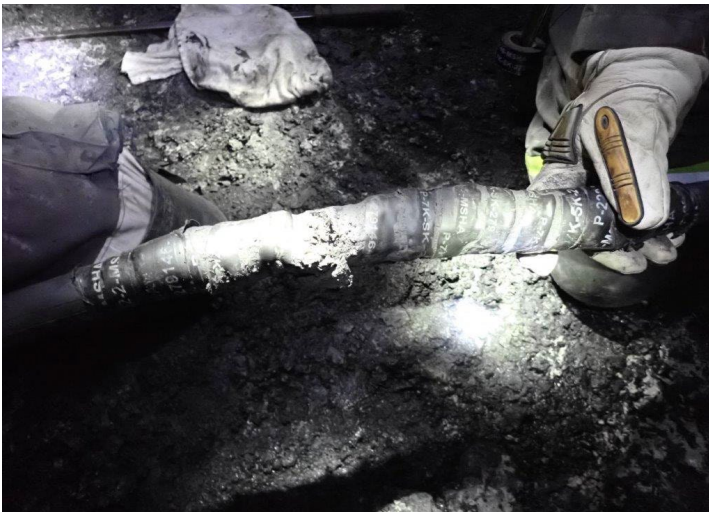
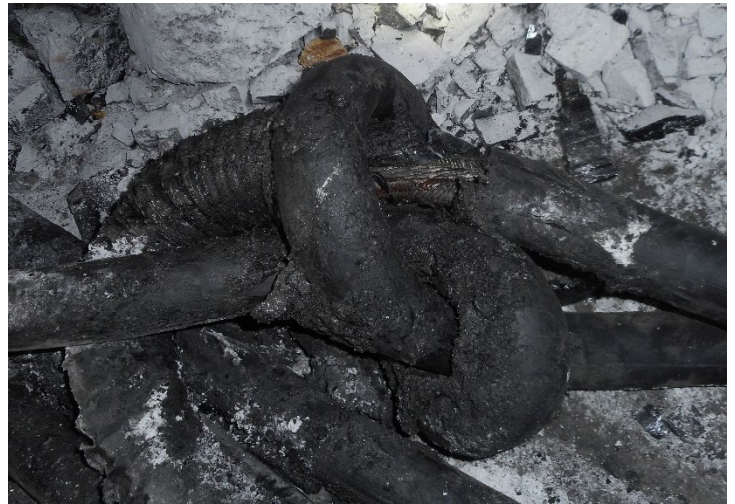
Accident Scene/Electrical Trailing Cable

In recent months, there have been several accidents involving energized trailing cables containing voltages that range from 480 to 995 volts. All of these incidents occurred while handling energized cables. It is critical to understand that the phase conductors of these cables must contact the ground conducting wire to de-energize the circuit breaker at the power center.

One of the recent injuries involved a 12,470-volt power cable out by the working section. A roof bolter operator received an electrical shock when an inadequate high-voltage splice short-circuited and dissipated the voltage through the ground grounding system. This failsafe circuit limits the voltage to 100 volts or less. Five miners reported receiving a shock from this incident.

- (1) De-energize, lock, and tag out all electrical trailing cables prior to handling them.
- (2) Miners must wear proper gloves and boots in good condition when handling energized electrical cables.
- (3) Conduct daily inspections of electrical power cables in use before operation or handling.
- (4) The electrical circuits must be maintained by a Kentucky-certified electrician.
- (5) Maintain all electrical cable splices according to the splicing material manufacturers' guidelines.
