## **SAFETY ALERT BULLETIN**

(No. 1 - 2024)

## Kentucky DMS Safety Alert No. 1 - FALL OF ROOF

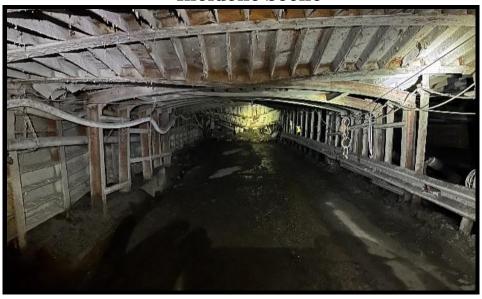
#### **Incident Scene**

A roof fall occurred on the slope travelway of an underground mine in the Hazard Branch. The post-fall results identified that the arches installed in the area had significantly deteriorated due to corrosive water that was present on the slope before the mine's rehabilitation.

- 1. Conduct a thorough and adequate preshift examination on all travelways in which miners normally travel.
- 2. When accessible, the mine roof above and ribs outside of the arches or slope structure shall be regularly examined.
- **3.** If deterioration of the slopes support structures is observed, they must be immediately corrected before miners travel through the affected area.
- 4. Mine examiners shall visually inspect all supplementary supports for signs of increased weightbearing stress.
